INVESTIGATION NO. 2482

THE TEXAS AND PACIFIC RAILWAY COMPANY

REPORT IN RE ACCIDENT

FEBRUARY 7, 1941

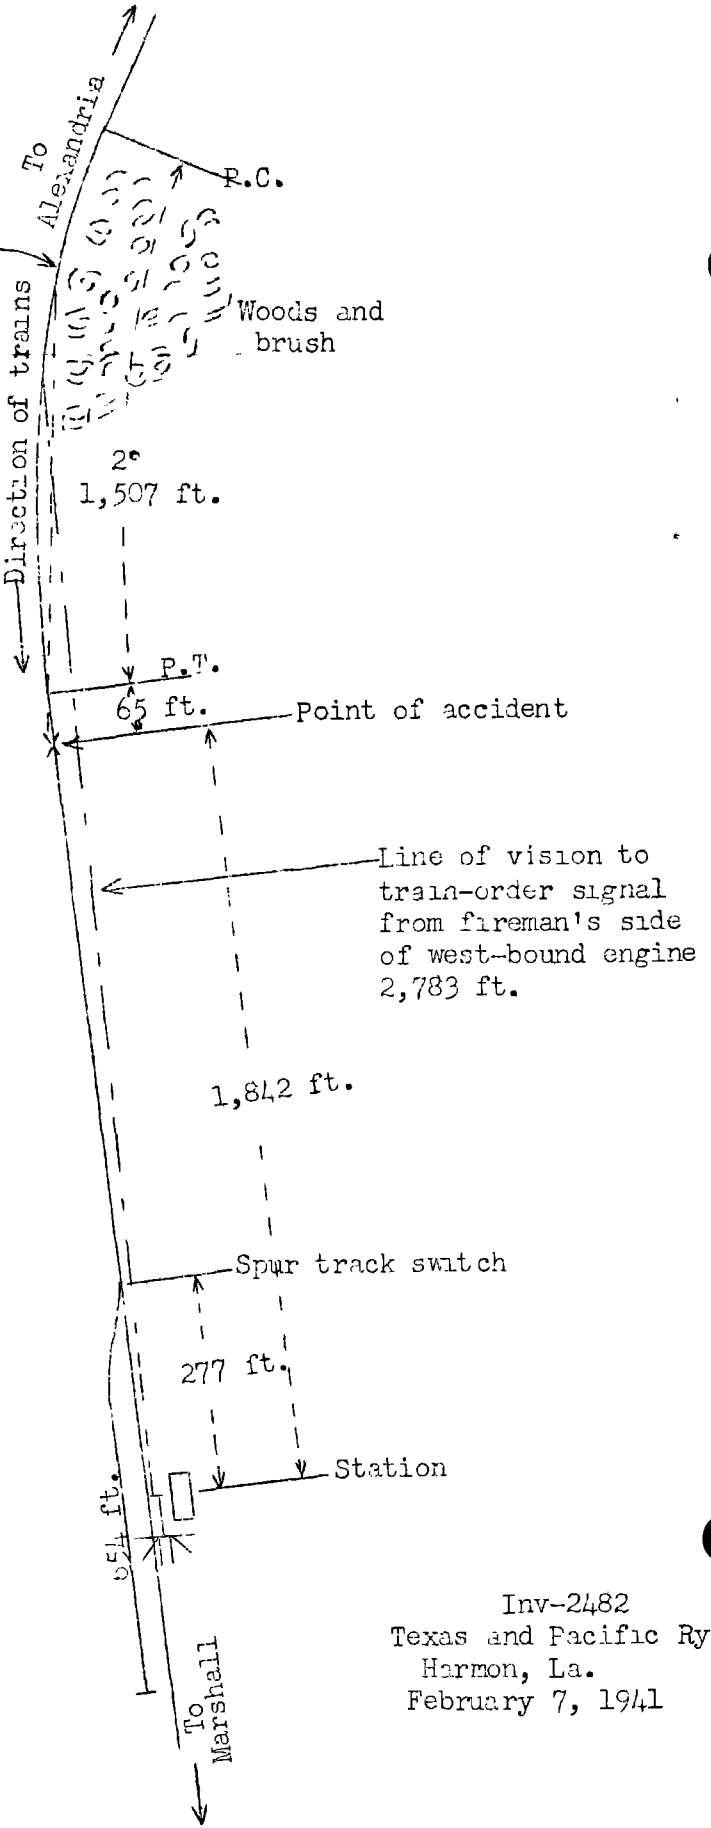
Line of vision to point of collision from fireman's side of west-bound engine 1,219 ft.
