INVESTIGATION NO. 3042
THE TEXAS AND PACIFIC RAILWAY COMPANY
REPORT IN RE ACCIDENT
AT LORAIN, TEX., CN
NOVEMBER 27, 1946

Railroad: Texas and Pacific
Date: November 27, 1946
Location: Loraine, Tex.
Kind of accident: Derailment
Train involved: Freight
Train number: 67
Engine number: 611
Consist: 56 cars, 2 cabooses
Estimated speed: 60 m. p. h.
Operation: Timetable, train orders and
automatic block-signal system
Track: Single; 1° curve; 0.80 percent
descending grade westward
Weather: Clear
Time: 12:30 a. m.
Casualties: 4 killed, 1 injured
Cause: Shifting of lading in car combined
with irregularities in alinement
and surface of track

Accident at Loraine, Tex., on November 27, 1946, caused
by shifting of lading in car combined with irregular-
ities in alinement and surface of track.

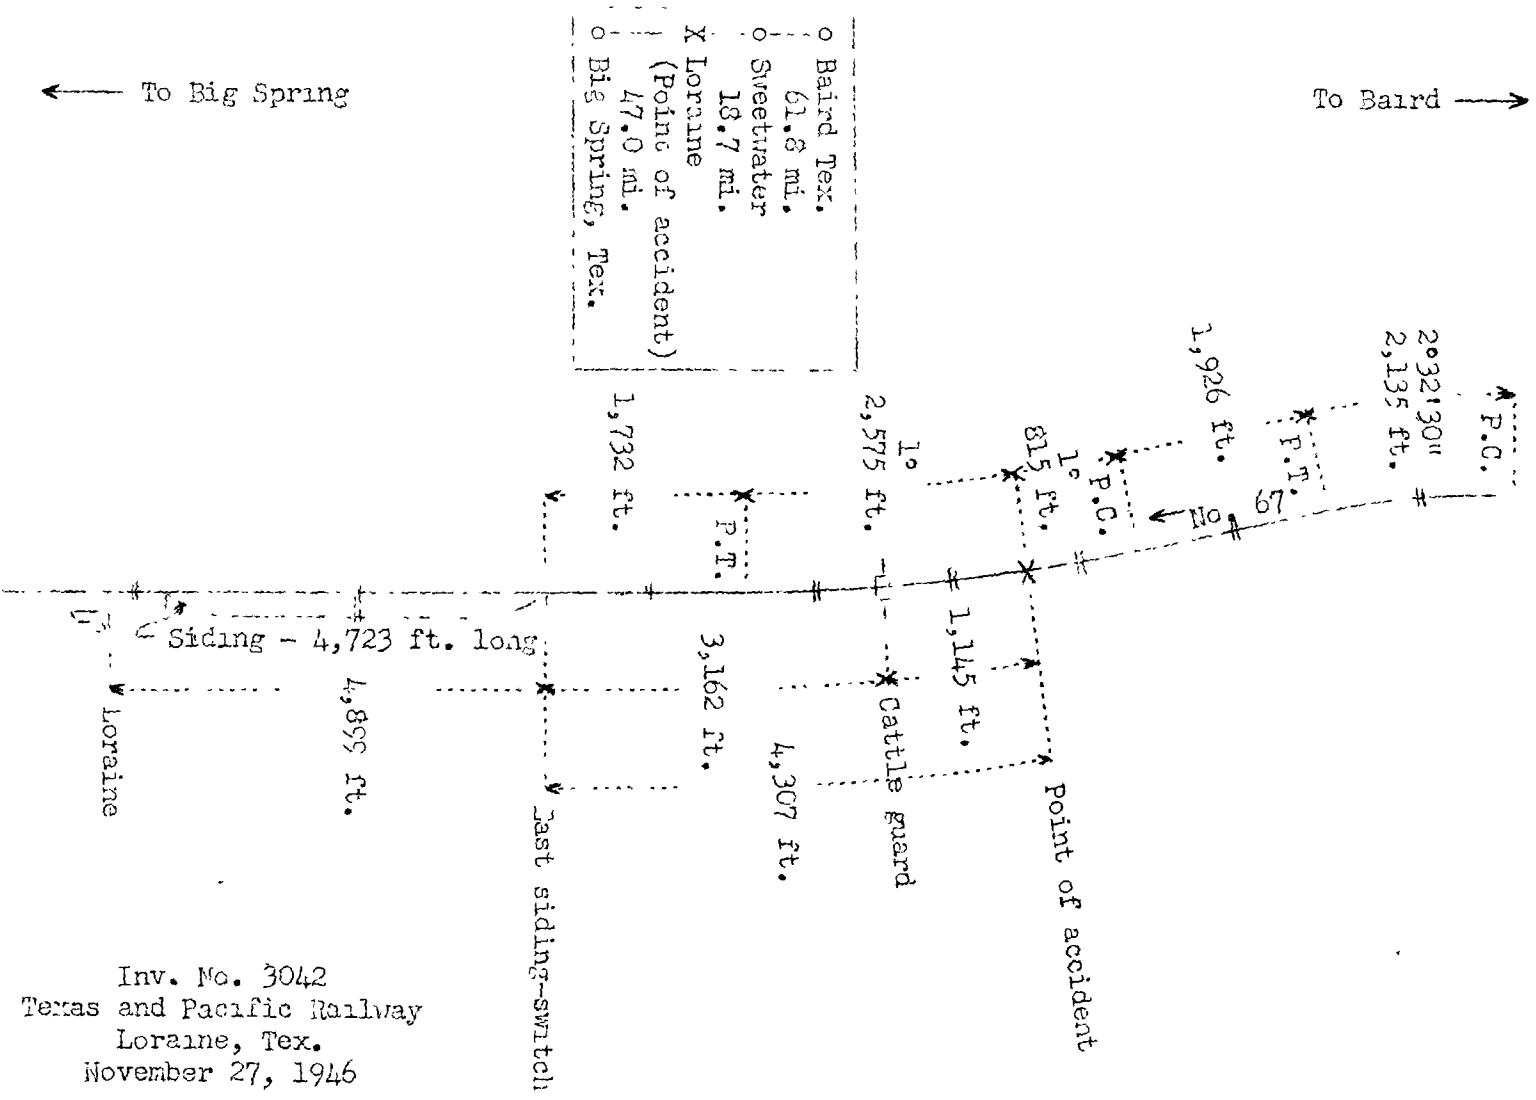
Inv. No. 3042
 Texas and Pacific Railway
 Lorraine, Tex.
 November 27, 1946

The first mark of derailment was a flange mark on top of the high rail at a point 815 feet west of the east end of the curve. This mark continued diagonally outward across the top of the head of the rail a distance of 17 feet, then flange marks appeared on the ties inside the north rail and outside the south rail throughout a distance of 1,128 feet to a cattle guard. From this point westward 3,162 feet to the east siding-switch, wheel marks appeared on the track structure inside the north rail and outside the south rail. There were scraping marks on the inner surface of the left front wheel of the front truck of the seventeenth car of No. 67 and on the outer surface of the right front wheel. The marks on the rail, on the ties and on the front wheels of the front truck of the seventeenth car indicate that this pair of wheels was the first to become derailed.

The track in this vicinity was last inspected by a member of the track force about 36 hours prior to the time the accident occurred, and no unusual condition was observed. After the accident measurements of the track on the curve disclosed that within a distance of 393 feet immediately east of the point of derailment the superelevation varied between 2-1/2 inches and 3-1/2 inches, and the gage varied between 4 feet 8-1/8 inches and 4 feet 8-3/4 inches.

The investigation disclosed that A.T. & S.F. 151016, the seventeenth car of No. 67, was loaded at Marrero, La., on November 22, and was destined to Los Angeles, Calif. The lading consisted of asphalt siding-sheets 12 feet long and 4 feet wide, and extending about 7 feet in height. The inside width of the car is 9 feet 4 inches. The rules of the Association of American Railroads, prescribing methods for loading, bracing and blocking of lading in closed cars, provide that the lading must be placed in the car and secured in such manner that there will not be more weight on one side of the car than on the other, and that the lading will not shift or roll in transit either horizontally or laterally. Examination after the accident indicated that no bracing or blocking had been provided to prevent shifting of the lading, and marks on the surface of the floor of the car indicated that the lading had shifted laterally approximately 16 inches. There was no defective condition of the car. It was the opinion of officials of the railroad that lateral shifting of the lading caused the body of the car to become overbalanced. It is apparent that this condition, together with the irregularity in surface and alinement of the track, permitted the left front wheel of the

front truck of the car to rise high enough for the flange to mount the rail, and then the flange continued on top of the rail to the point where it dropped outside the rail.

It is found that this accident was caused by shifting of lading in a car combined with irregularities in alinement and surface of track.
