## RAILROAD ACCIDENT REPORT.

REAR END COLLISION OF  
TWO TEXAS AND PACIFIC  
RAILWAY COMPANY  
FREIGHT TRAINS,  
MEEKER, LOUISIANA,  
MAY 30, 1975.

REPORT NUMBER: NTSB-RAR-75-9.

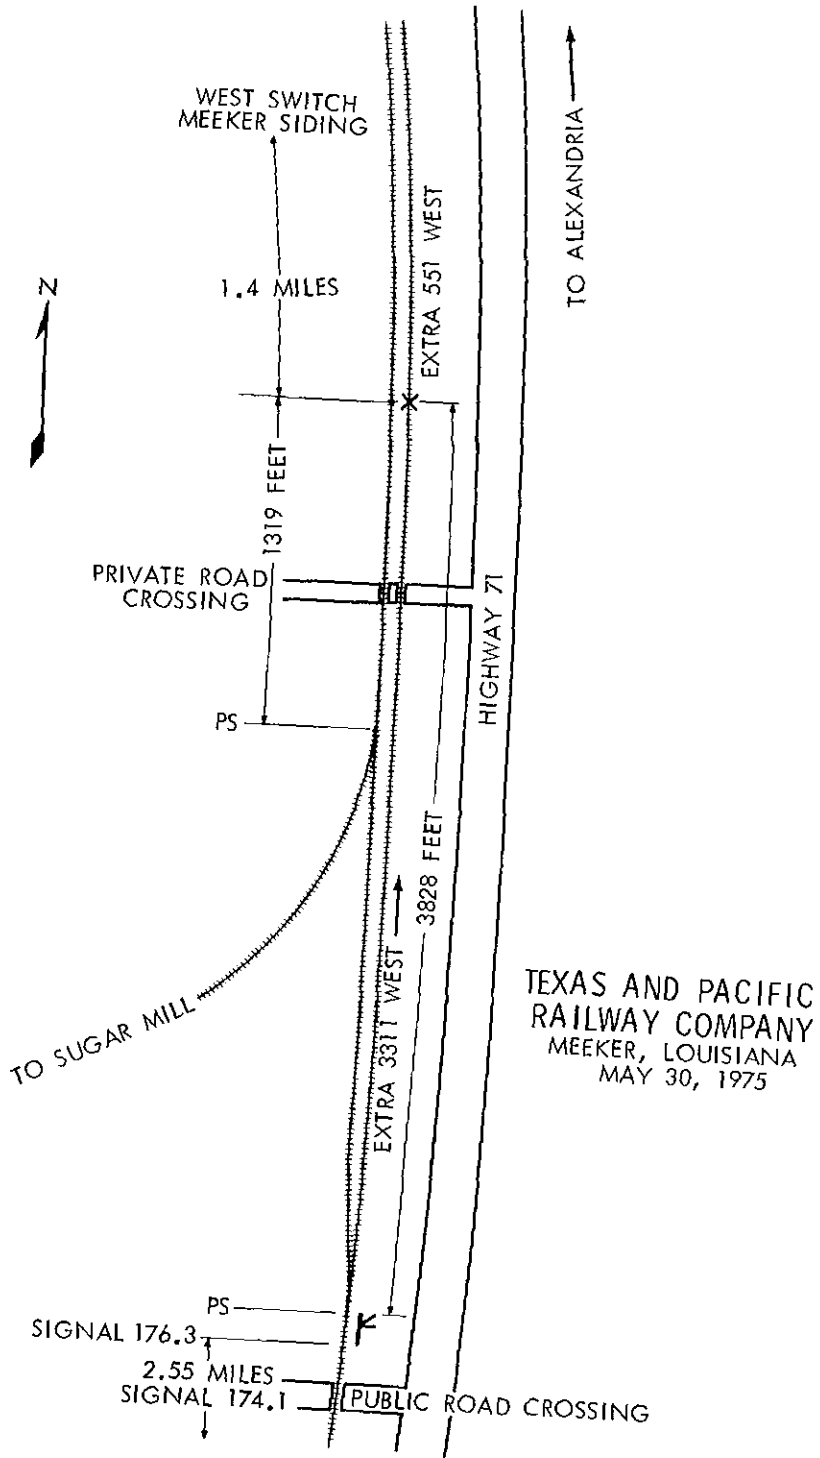
Figure 1. Accident site.

At Meeker, a siding, 2.2 miles long, parallels the single main track on the south. It is connected to the main track at each end by a spring switch. The switch of the spur track, which extends from the siding to a sugar plant, is located 2,509 feet west of the siding's east switch. A 0°10' curve to the right, 5.63 miles long, begins 1,412 feet east of signal 174.1 and extends west through Meeker. The grade on the main track descends slightly for westbound trains. (See Figure 1.)

The signals involved in this accident are color-light signals. (See Figure 1 for their locations.) When the main track between the Meeker siding switches is occupied and the switches are lined for movement on the main track, signals 174.1 and 176.3 will display the following aspects: (The carrier's rules require that trains will be operated as indicated.)

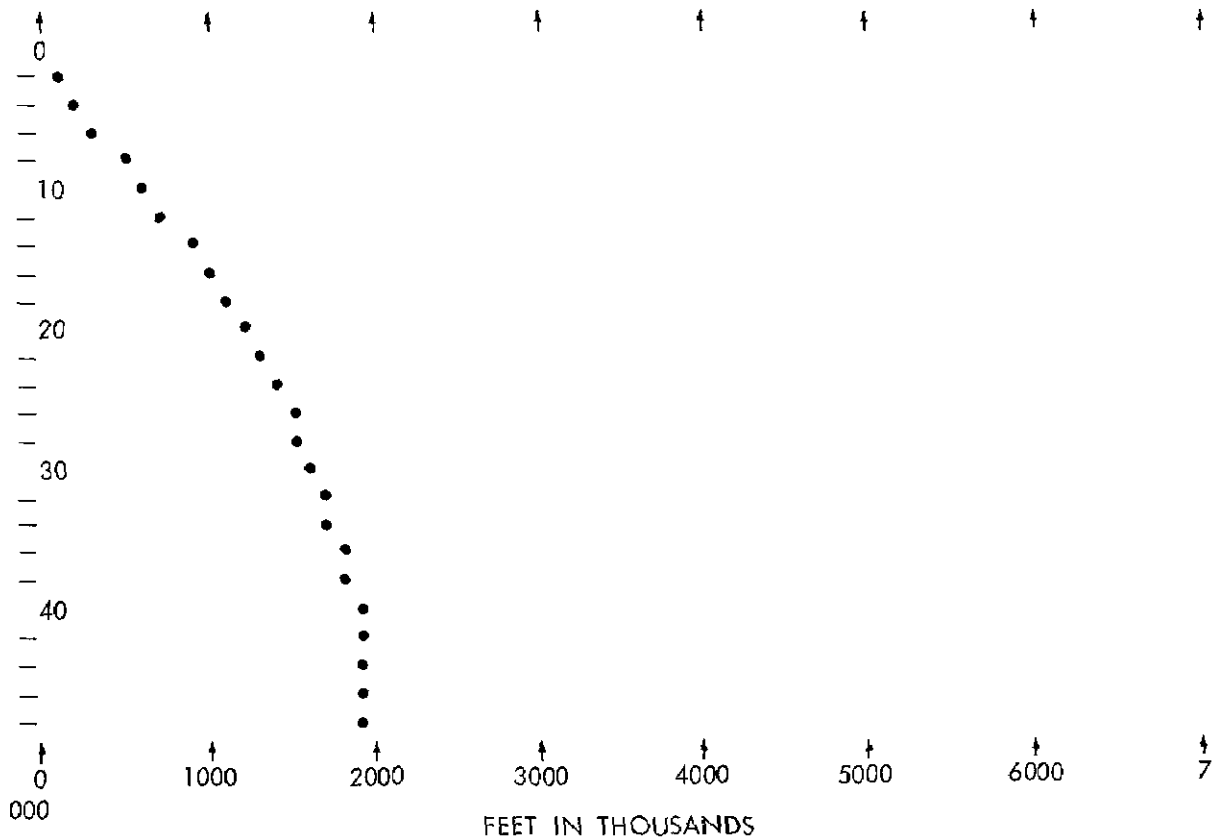
GRAPHIC REPRESENTATION OF  
TIME AND DISTANCE

The stopping distance for Extra 3311 West, with the brakes in emergency and while the train was moving at 48 mph, was computed to be 1,921 feet. (See Appendix B.)
