REPORT NO. 3411
TEXAS AND PACIFIC RAILWAY COMPANY
IN RE ACCIDENT
NEAR MINGO, TEX., ON
JULY 4, 1951

August 29, 1951

- Accident near Mingo, Tex., on July 4, 1951, caused by a train occupying the main track on the time of an opposing superior train without protection.
-

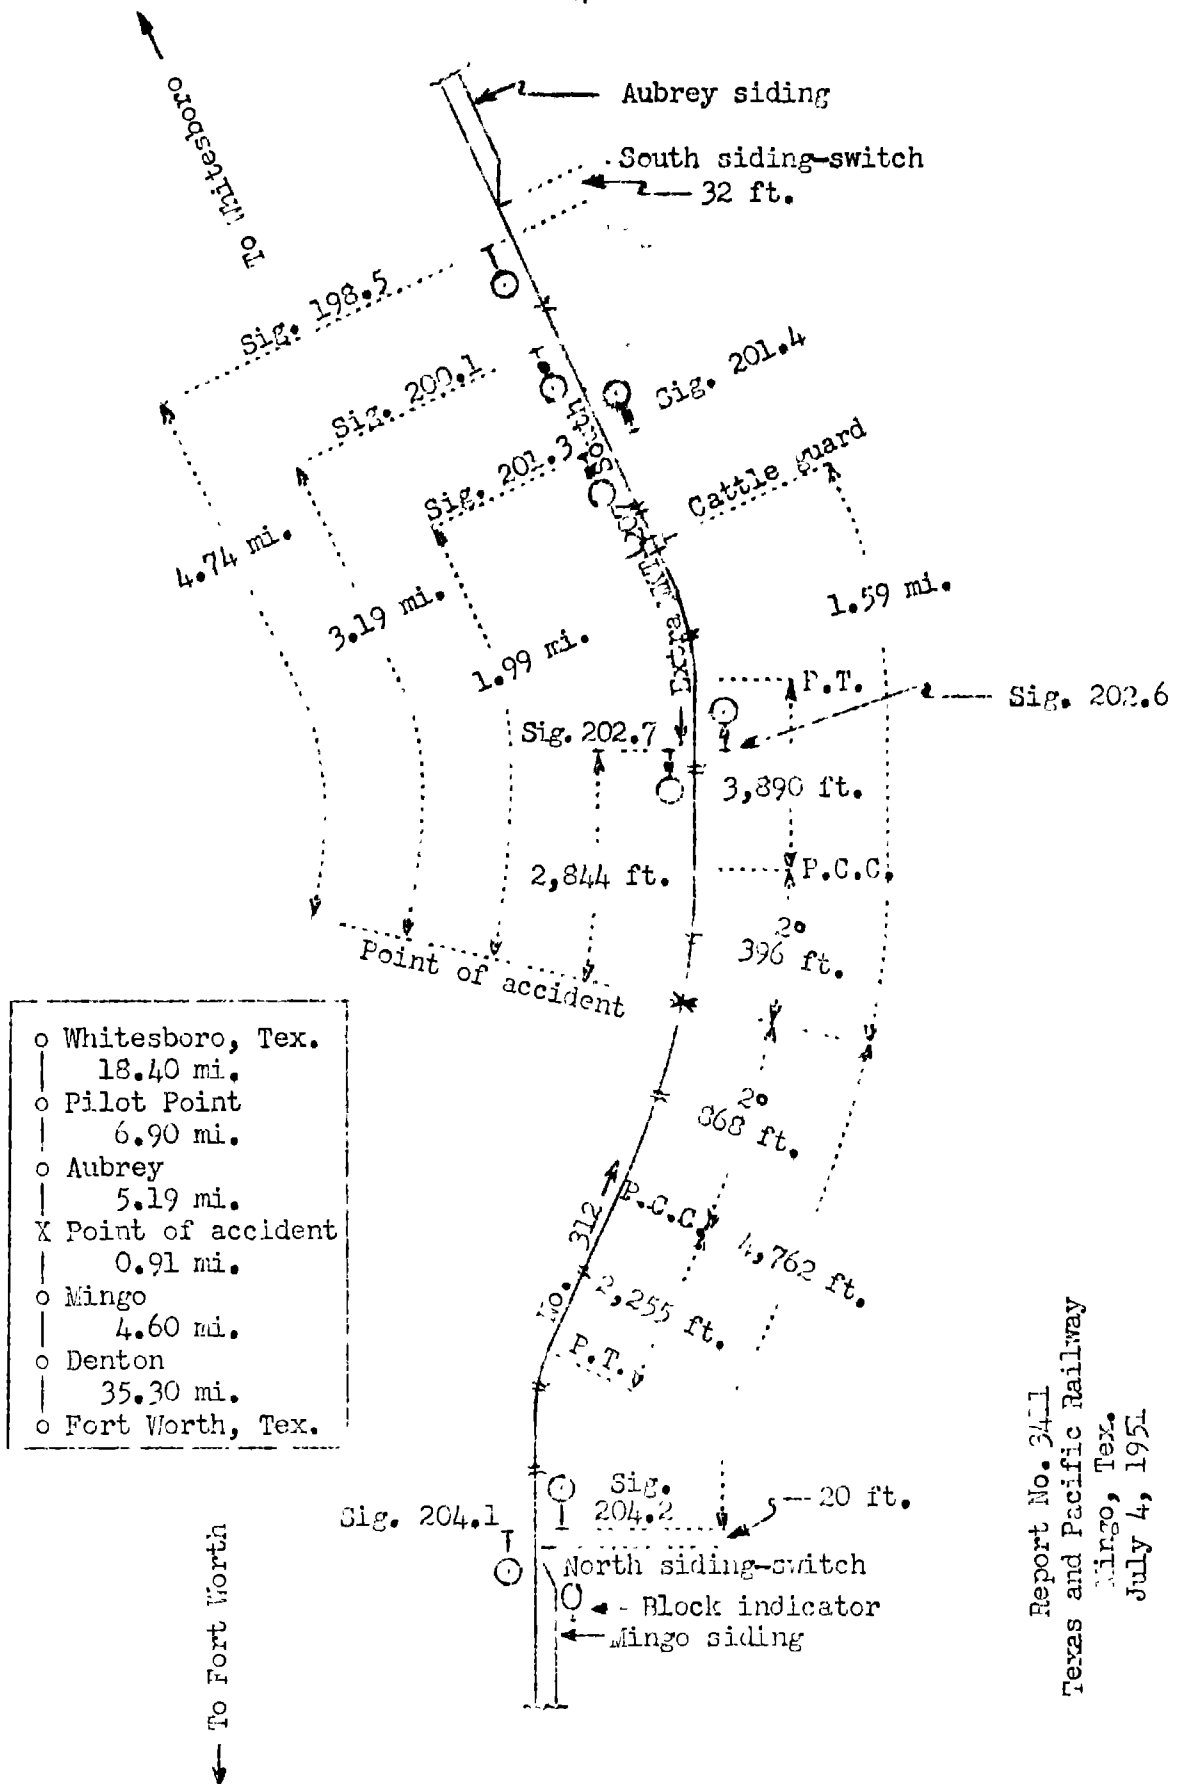
Report No. 3411
Texas and Pacific Railway
Mingo, Tex.
July 4, 1951

Denton is located 36 miles south of Whitesboro. This train departed from Whitesboro at 5:33 p. m., passed Pilot Point, 18.4 miles south of Whitesboro and the last open office, at 5:58 p. m., and stopped about 6:05 p. m., with the front of the train near a telephone in the vicinity of the north siding-switch at Aubrey. The engineer communicated with the train dispatcher and informed him that signal 198.5 indicated Stop. The train dispatcher instructed the engineer that the train could pass the signal only under flag protection. The train then proceeded southward and stopped at signal 198.5, which indicated Stop. The front brakeman proceeded southward to provide flag protection. The train passed signal 198.5 about 6:16 p. m., overtook the front brakeman at a point about 2,500 feet south of the signal, and continued southward without flag protection. Signals 200.1, 201.3, and 202.7 each indicated Stop and Proceed. The train stopped at each of the first two signals and then immediately proceeded southward. It passed signal 202.7 and stopped with the front of the first Diesel-electric unit 2,844 feet south of this signal and 4,782 feet north of the north siding-switch at Mingo. Immediately afterward it was struck by No. 312.

No. 312, a north-bound first-class M.K.T.T. passenger train, consisted of engine 391, one baggage-mail car, one dining car, one chair car and one sleeping car, in the order named. The first two cars were of conventional all-steel construction, and the other cars were of light-weight steel construction. At Denton, the last open office, the crew received copies of train order No. 68. No. 312 departed from Denton at 6:06 p. m., 6 minutes late, entered the siding at Mingo, and stopped on the siding about 6:17 p. m. It entered the main track at the north siding-switch about 6:36 p. m., passed signal 204.2, which indicated Approach, and while moving at a speed of about 10 miles per hour it struck Extra MKT 207 South.

The force of the impact canted the east rail, and the right wheels of the rear truck of the first Diesel-electric unit of Extra MKT 207 South dropped between the rails. The pilot and the front coupler of this unit were demolished. The front coupler of the engine of No. 312 was demolished, the pilot was bent and torn, and the front bumper beam was bent. The cistern of the tender was shifted forward on the frame. The front coupler of the first car of No. 312 was broken, and the other cars were somewhat damaged.
