INVESTIGATION NO. 3153
THE TEXAS AND PACIFIC RAILWAY COMPANY
REPORT IN RE ACCIDENT
AT RANCH, TEX., ON
DECEMBER 30, 1947

Accident at Ranch, Tex., on December 30, 1947, caused
by a switch being opened immediately in front
of an approaching train.

Inv. No. 3153
 Texas and Pacific Railway
 Ranch, Tex.
 December 30, 1947

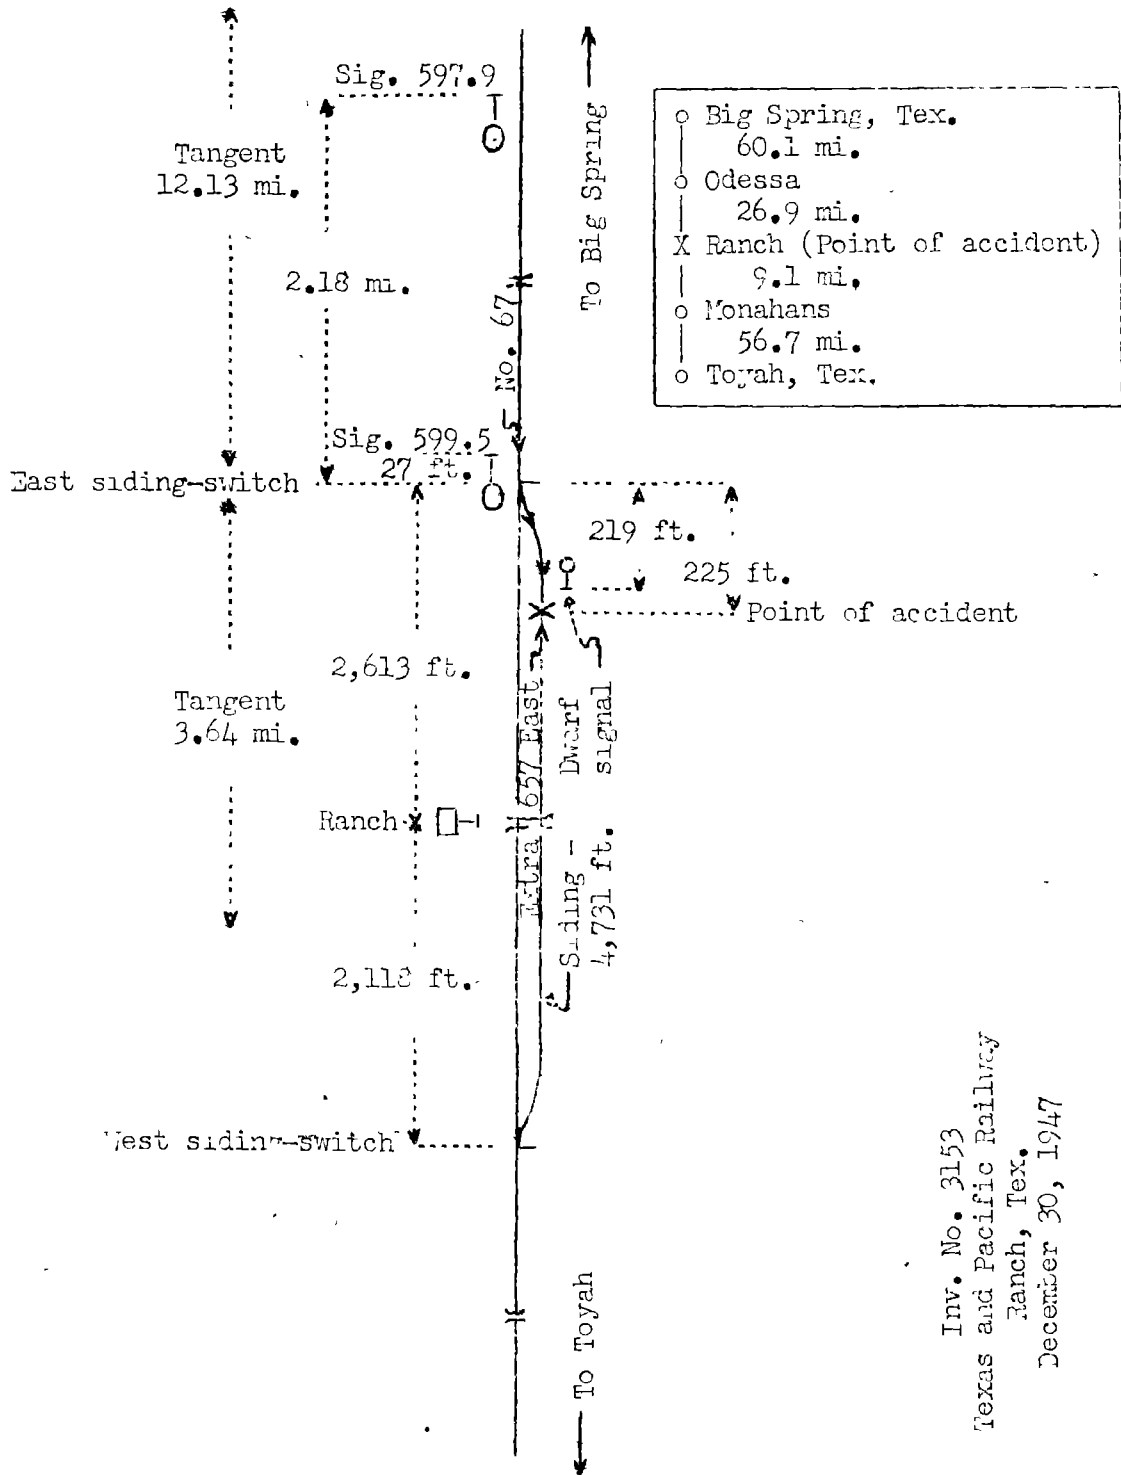
This accident occurred on that part of the Western Division extending between Toyah and Big Spring, Tex., 152.8 miles, a single-track line, over which trains are operated by timetable, train orders and an automatic block-signal system. At Ranch, 65.8 miles east of Toyah, a siding 4,731 feet in length parallels the main track on the south. The west switch and the east switch of this siding are, respectively, 2,118 feet west and 2,313 feet east of the station sign. The accident occurred on the siding at a point 225 feet west of the east-siding switch. The main track is tangent throughout a distance of 12.13 miles immediately east of east siding-switch and 3.64 miles westward. The grade is 0.51 percent descending westward.
