RAILROAD ACCIDENT REPORT

HEAD-ON COLLISION

TAFT, LOUISIANA

FEBRUARY 21, 1973

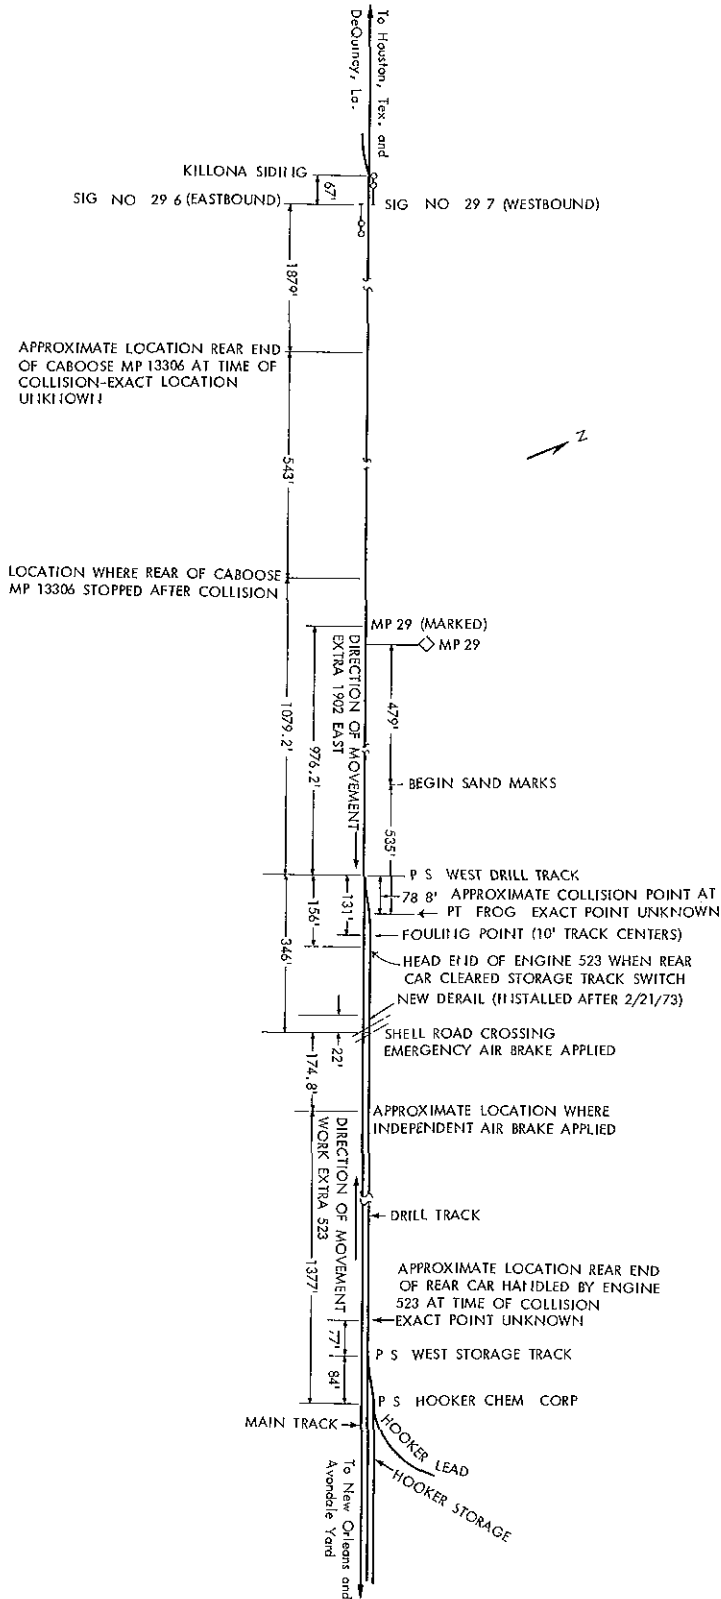
Figure 1. Accident site.

The drill track was not equipped with any kind of derail protection. The Hooker storage track diverged from the drill track 1,468 feet east of Shell Road, a private road which crossed both the main track and the drill track 346 feet east of the switch point. The Hooker lead track diverged from the Hooker storage track as shown in Figure 1.

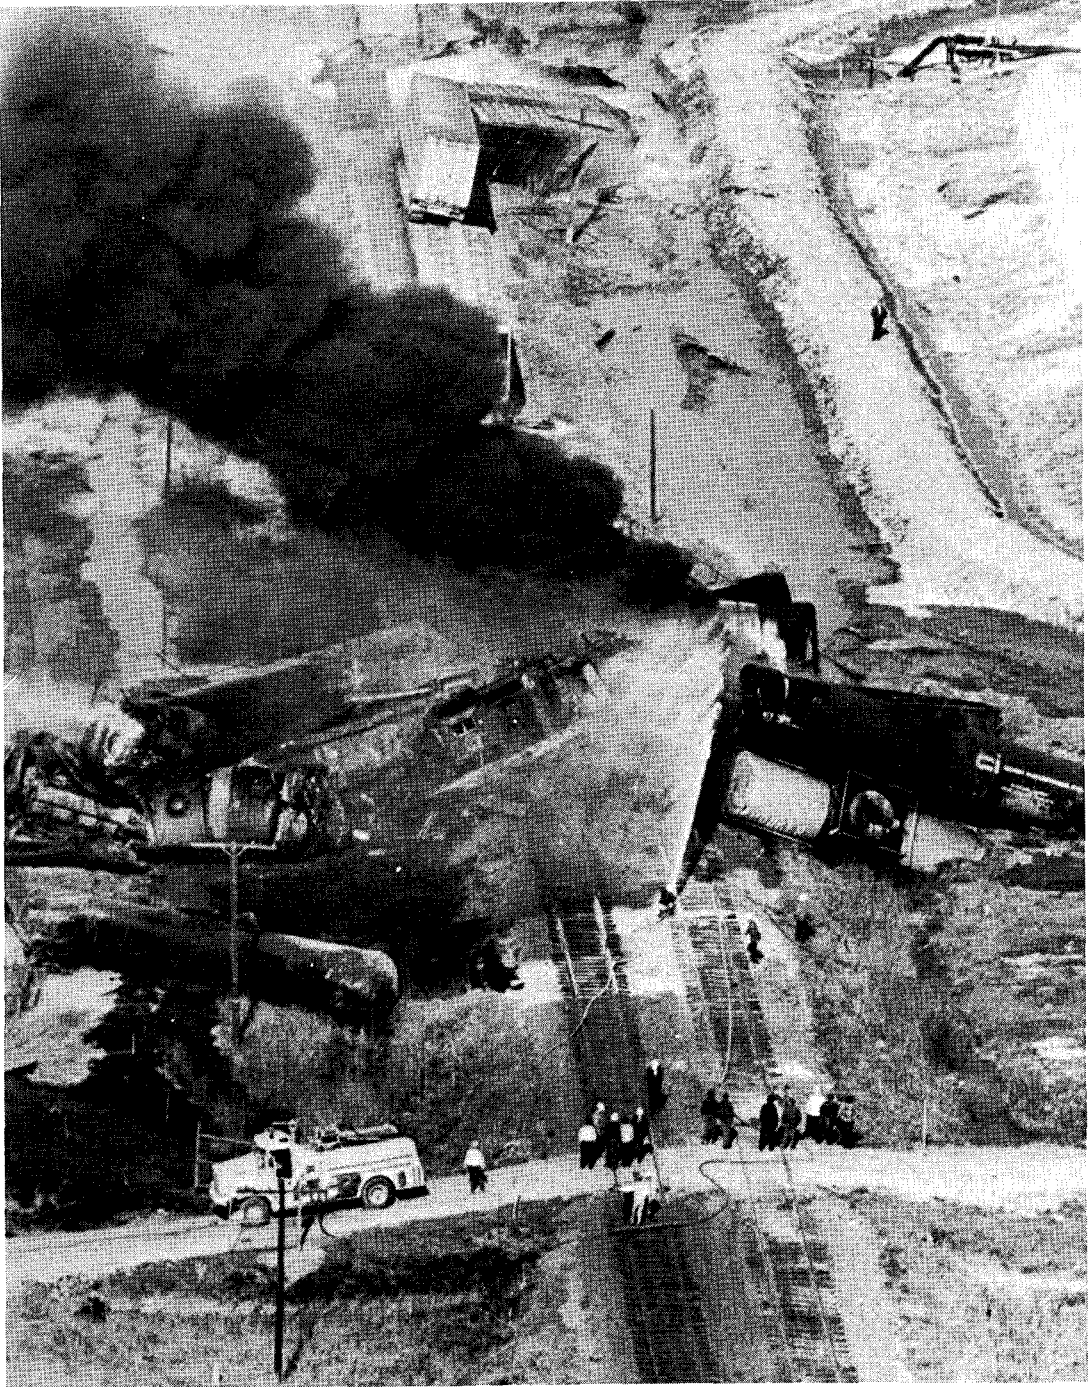
Figure 2. Aerial view of accident site.

Extra 1902 East struck slightly to the left of the coupler of Work Extra 523. (See Figures 2 and 3.) At impact, the first locomotive unit of Extra 1902 East veered southward. As the second locomotive unit underrode the frame of unit 1902, the rear truck of unit 1902 was forced against and subsequently punctured the first unit's fuel tank. The left battery box of unit 1902 was struck and destroyed. Heavy

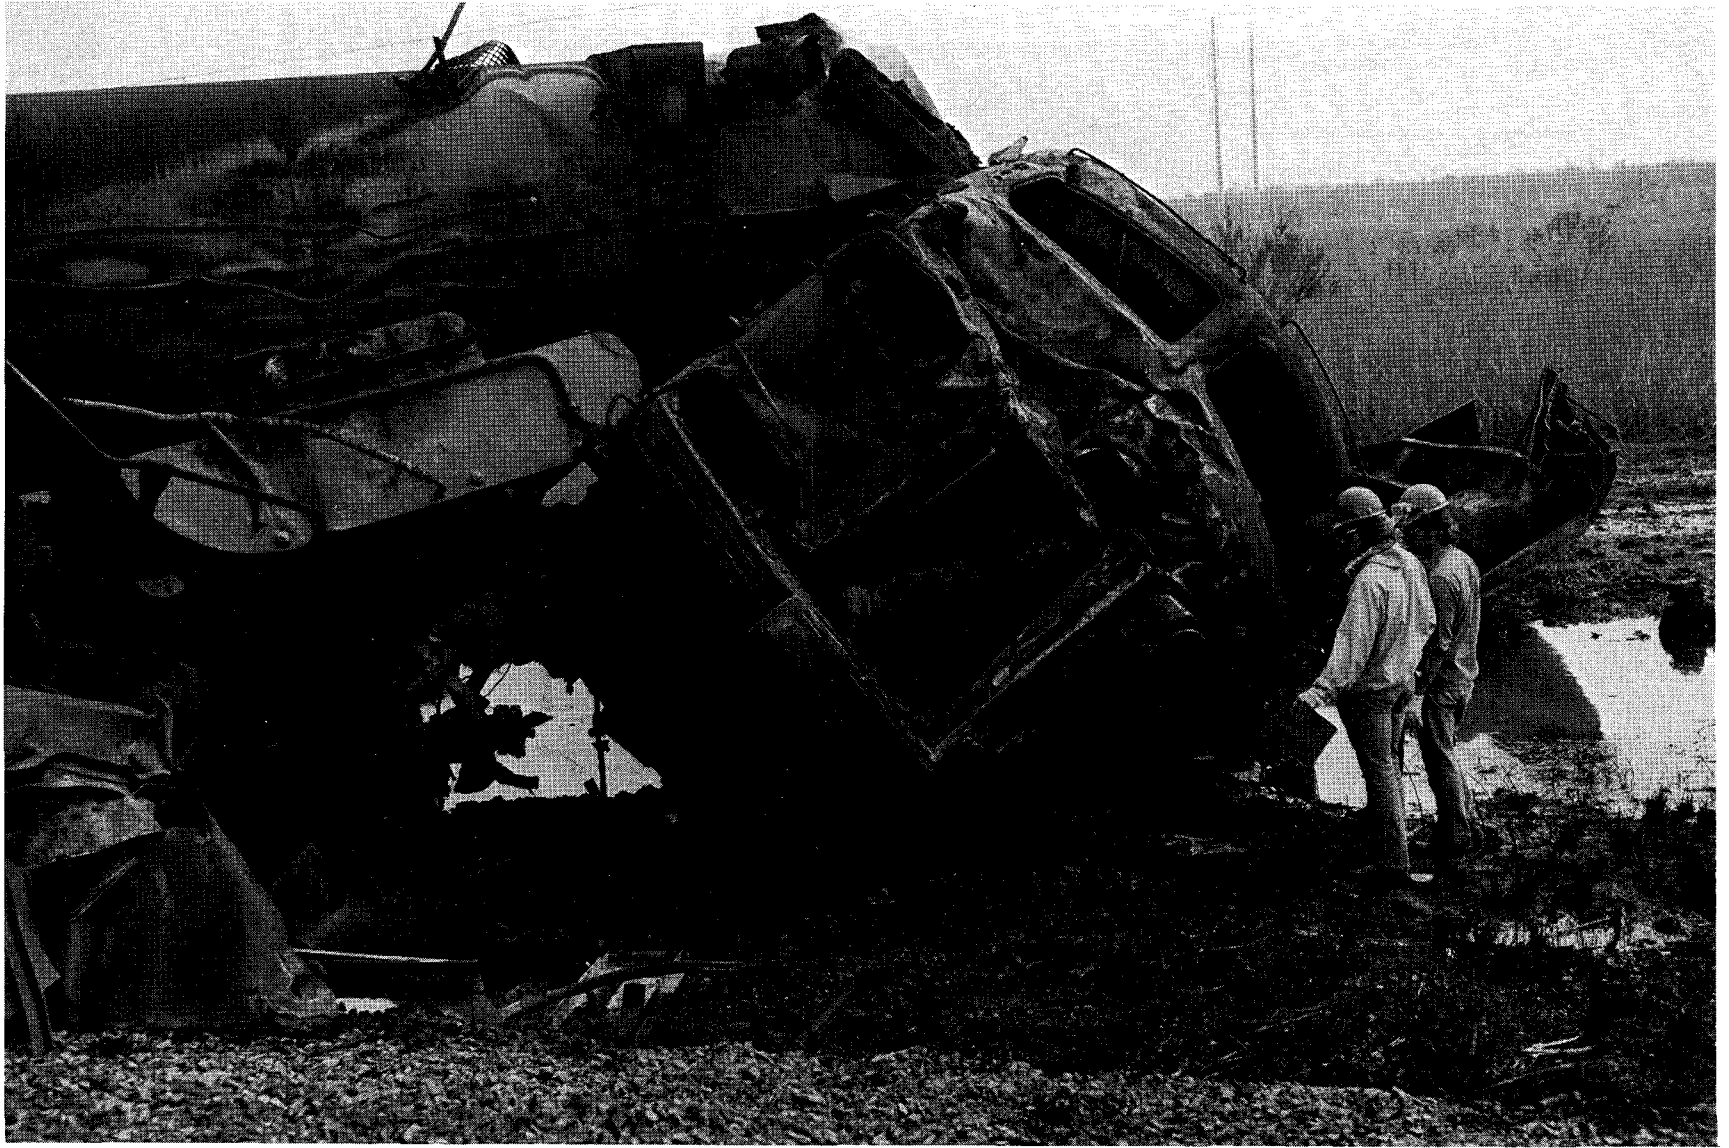
Figure 3. Locomotive unit 1902 after collision.

electrical arcing could have occurred during the destruction of the battery box. Diesel fuel which spilled from the punctured tank ignited, and fire spread to the head cars of the train.

Extra 1902 East. The three locomotive units of Extra 1902 East were destroyed by crash and fire damage. The lead locomotive unit was severely impacted just to the left front of the coupler; the nose door was torn from its hinges. The nose cowling tore at its point of attachment to the still section of the locomotive. The structure of the cab, however, was not invaded. The wooden floor of the cab was consumed by the postimpact fire. The fuel tank of the unit was punctured.

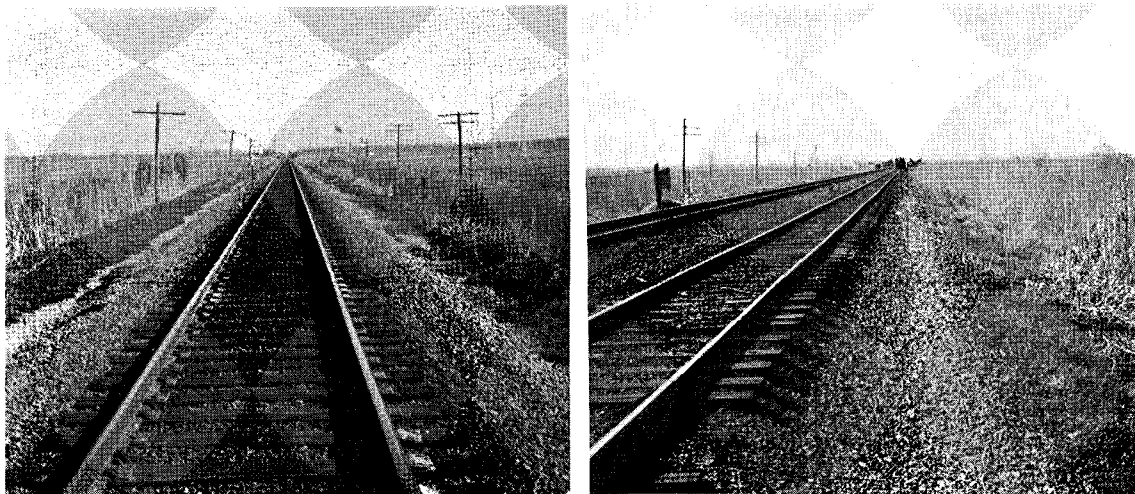
Figure 4. Approach to Taft on main track.

At the accident site, the railroad consisted of a straight and nearly level single-track line which extended in an east-west direction. (See Figure 4.) The adjacent drill track intersected the main track

976 feet east of milepost 29. The main track and the drill track were built on 15-foot centers. The switch, which was hand operated, had an unlighted switch target and was interconnected into the signal system. Thus, when the switch was aligned for movement between the main track and the drill track, opposing signals east and west of Taft displayed stop aspects.

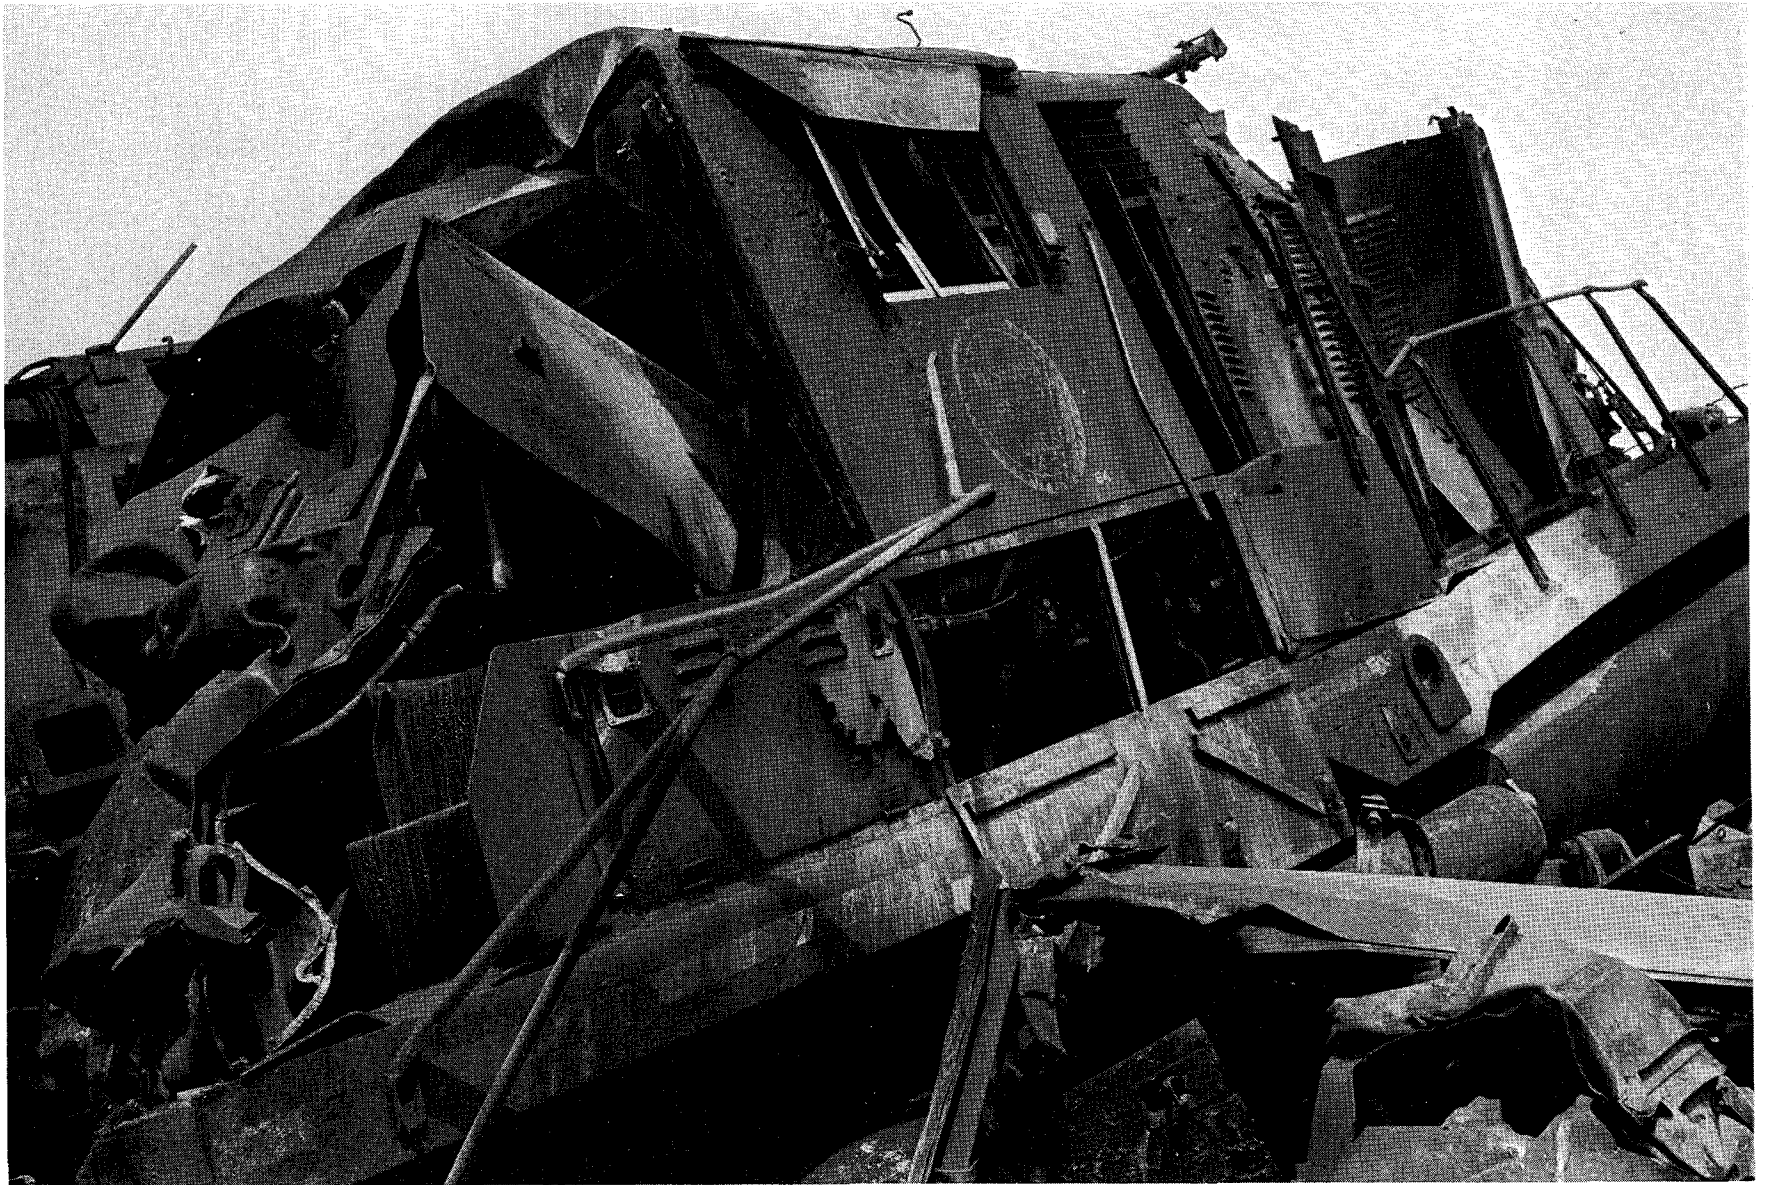
Figure 5. Locomotive unit 523 after collision.

Work Extra 523. Although locomotive unit 523 incurred considerable crash and fire damage and was a total loss, its fuel tank incurred little crash damage. (See Figure 5.) The head three cars of the train were either derail or damaged in the accident.

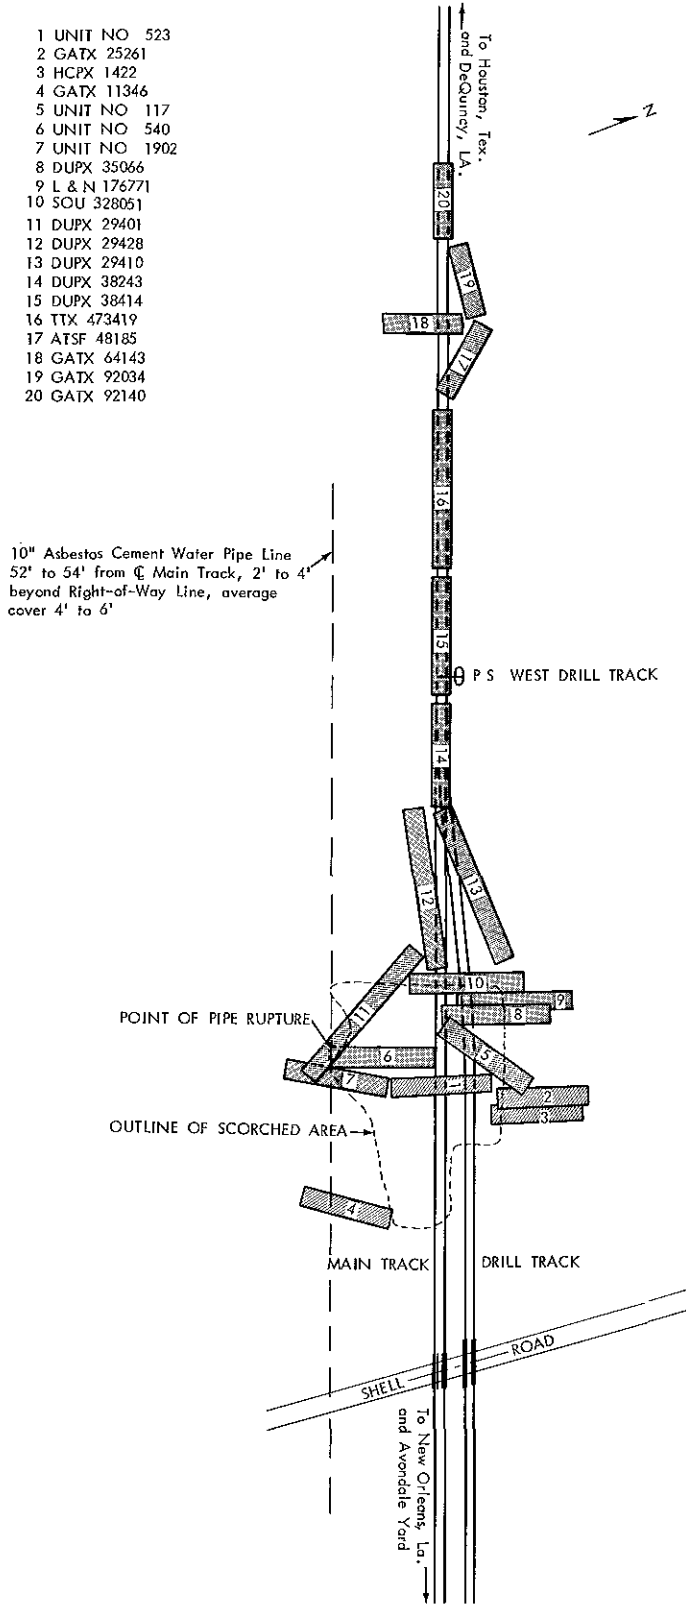
Figure 6. Position of derailed locomotive units and cars after collision.

The first ten cars on Extra 1902 East were derailed or damaged in the pileup at the point of initial impact. An internal collision within the train derailed the 17th, 18th and 19th cars and the lead truck of the 20th car. One of these cars was a tank car which contained

sulphur. The car collapsed at its center and some sulphur was spilled. The caboose was not damaged. (See Figure 6.)
