RAILROAD ACCIDENT INVESTIGATION

REPORT NO 4072

THE TEXAS AND PACIFIC RAILWAY COMPANY

DECEMBER 24, 1965

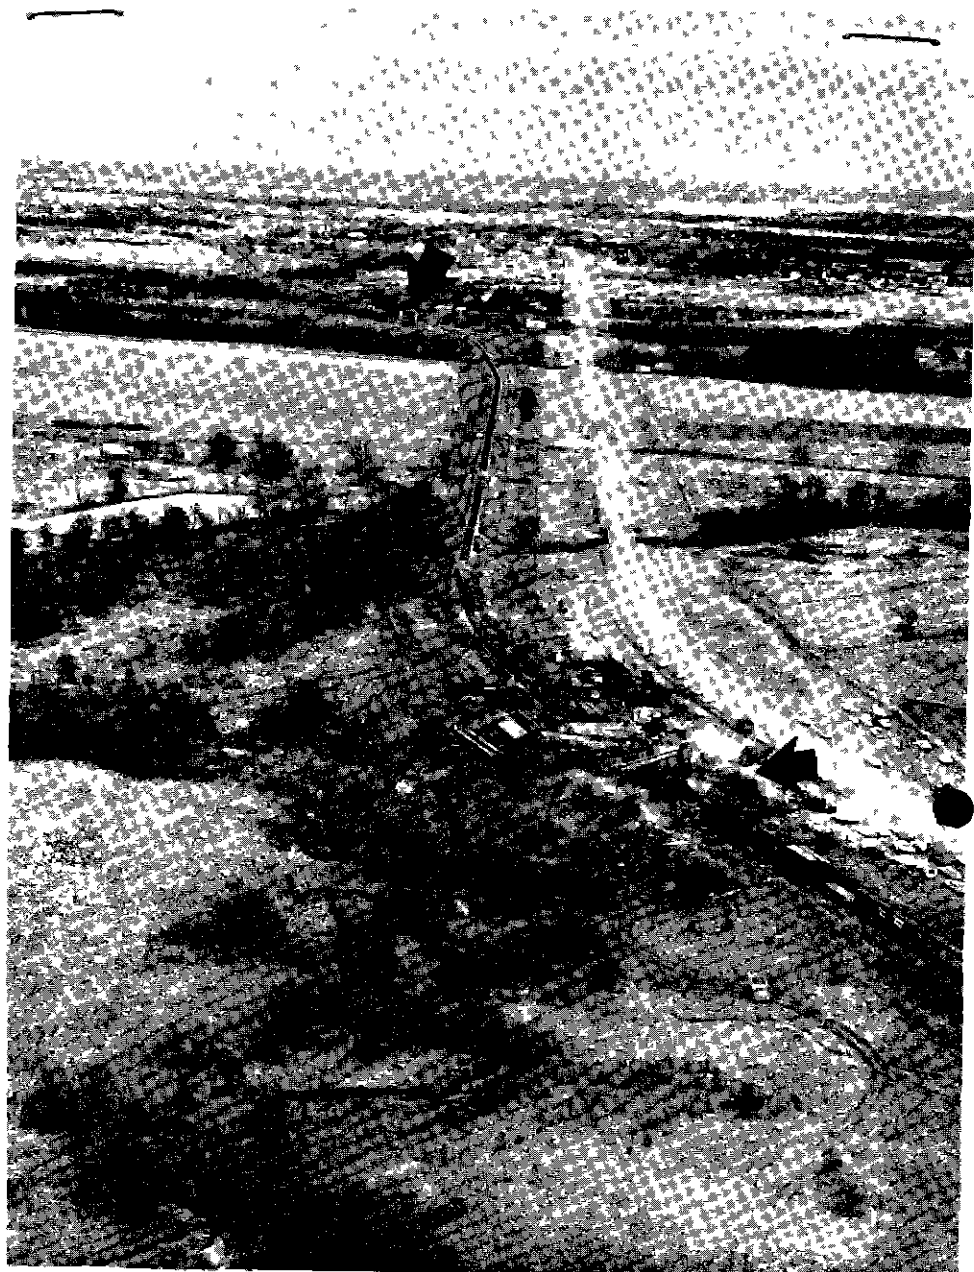
The caboose and the 101st to 126th cars, inclusive, of Extra 526 North were derailed and stopped in various positions on or near the track structure as shown in a photograph appended to this report. Of the derailed equipment, the caboose and 16 cars were destroyed, and 10 cars were heavily damaged.

Extra MKT 84C North stopped with the front end 167 feet north of the collision point. All five diesel-electric units were derailed. The 36th to 40th cars and the 55th to 60th cars, inclusive, also derailed when the train buckled due to the impact. The first diesel-electric unit overturned onto its right side and stopped on the east side of the track structure at a 45-degree angle to the track and with the front end on the east side of the track structure. The second unit stopped upright, in reverse position, alongside the underframe of the first unit. The third, fourth and fifth units stopped upright on and in line with the track structure immediately to the rear of the second unit. The derailed cars stopped in various positions on or near the track structure. The first, second and third diesel-electric units were destroyed, the fourth unit was heavily damaged, and the fifth unit was undamaged.

Northward view Arrows point to Atchison Topeka and Santa Fe Railway overpass and to derailed locomotive units of Extra MKT 84C North
