RAILROAD ACCIDENT REPORT

**DERAILMENT OF
UNION PACIFIC RAILROAD
FREIGHT TRAIN
GRANITE, WYOMING
JULY 31, 1979**

NTSB-RAR-79-12

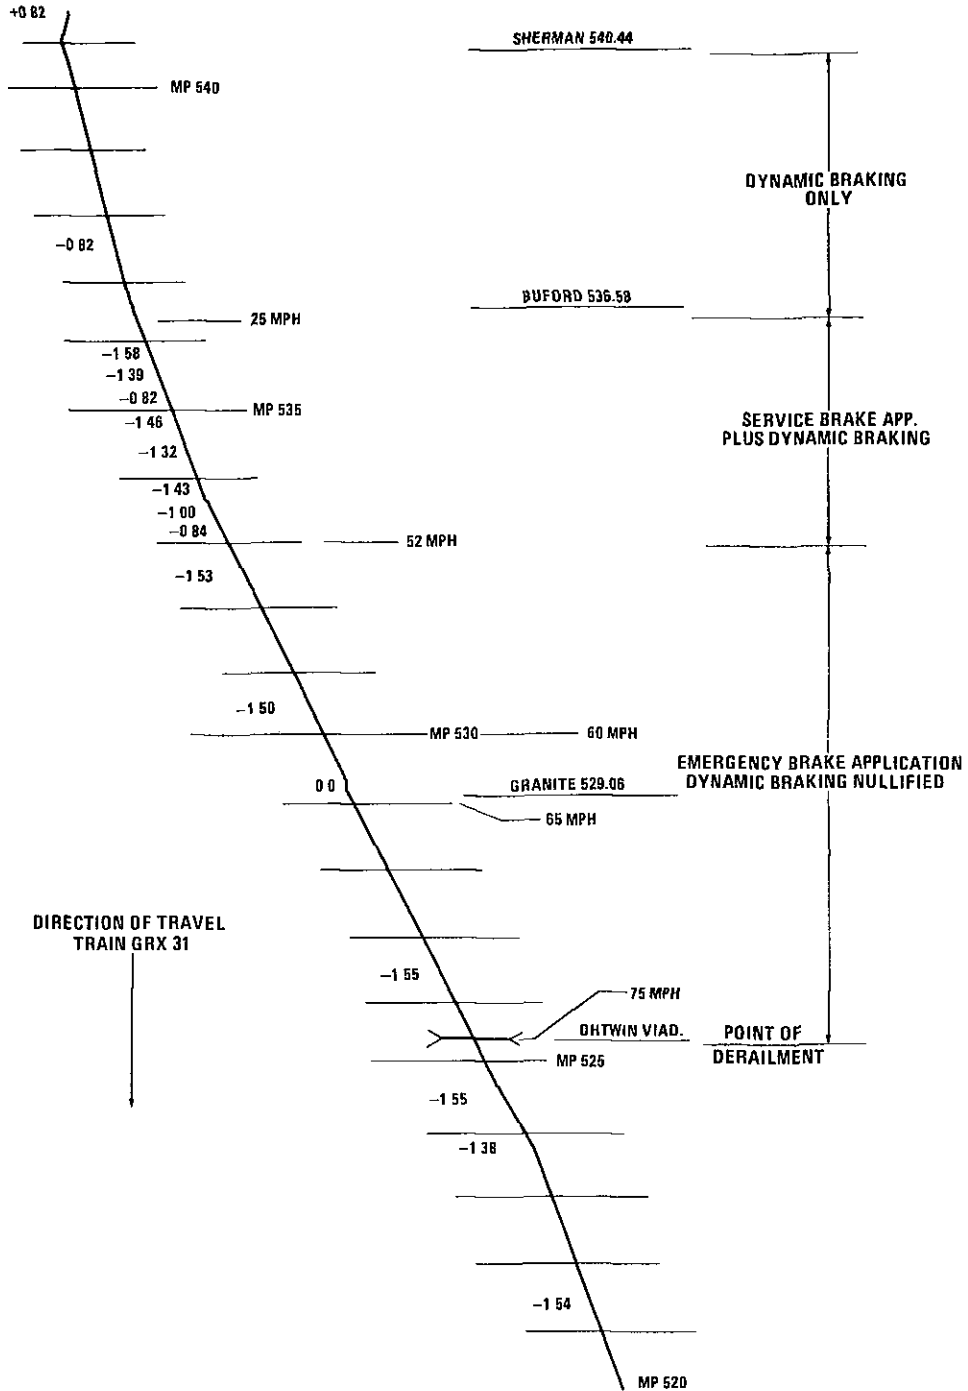
Figure 1. Profile of track between mileposts 540.44 and 520 showing speeds obtained and location of brake application.

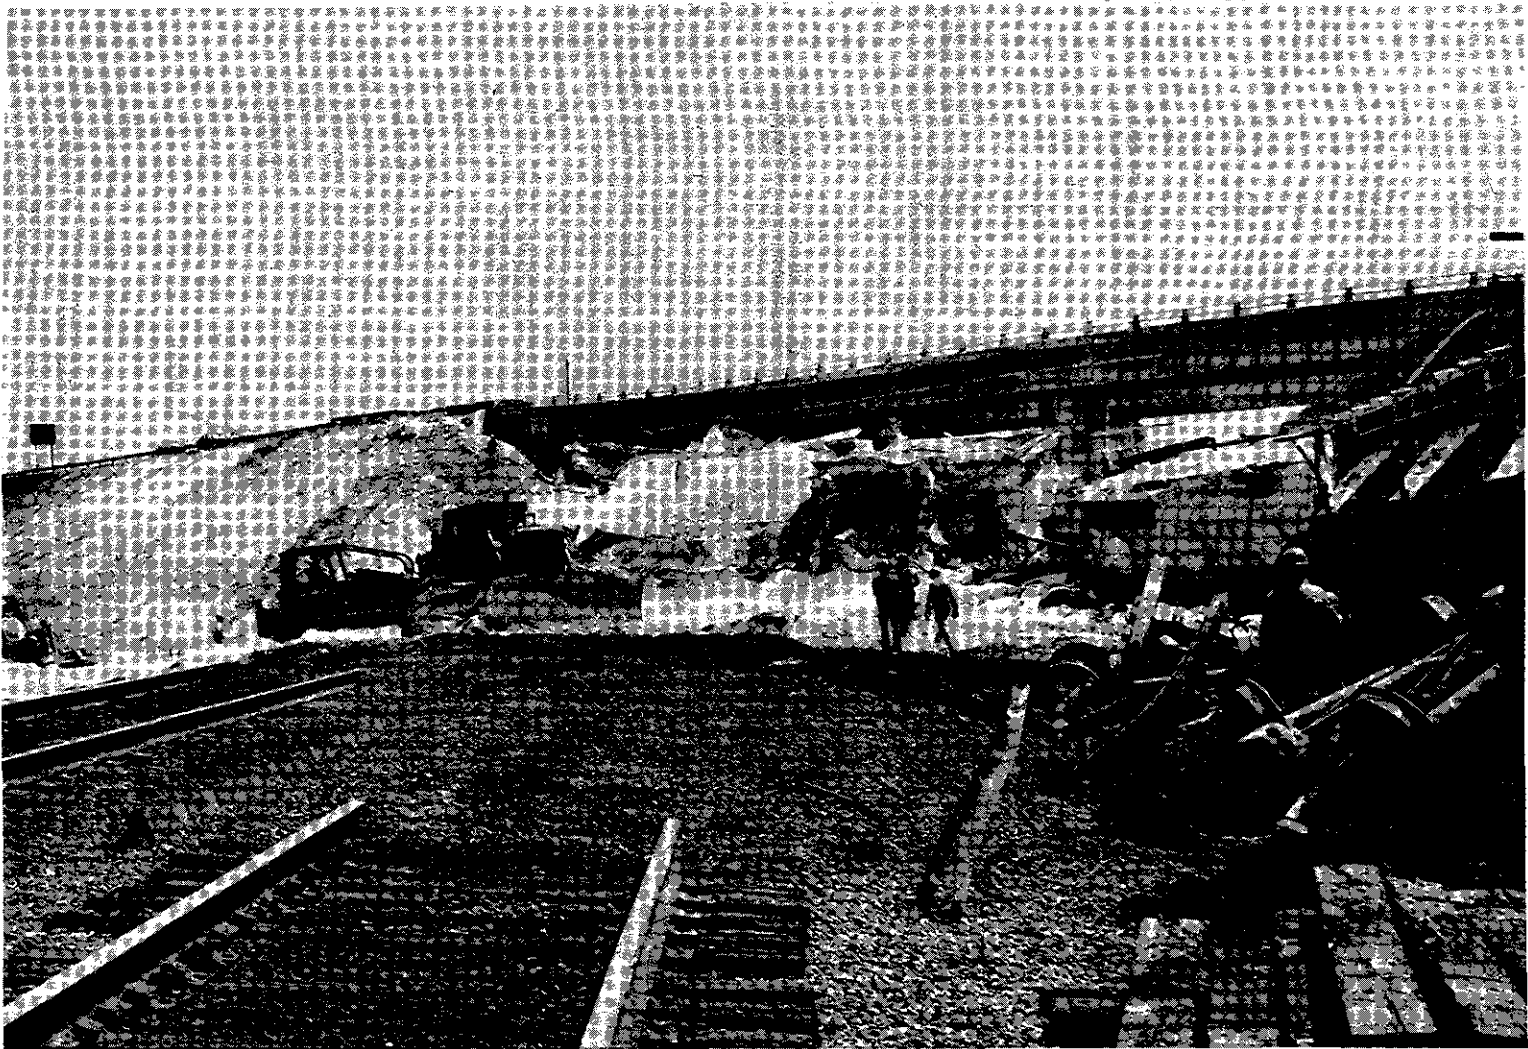
Figure 2. View to the east on track No. 2 of UPRR to the Interstate Highway overpass bridges of I-80.

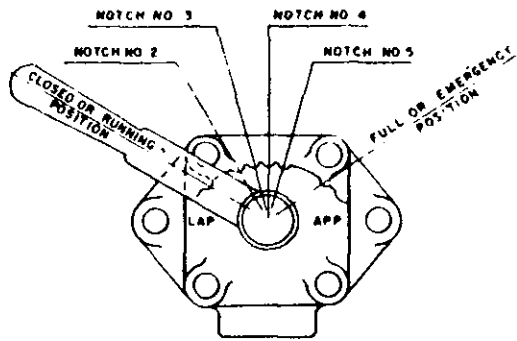
Figure 3. A-1 caboose valve.

Caboose Valve - An air valve connected to the brake pipe for the purpose of applying the brakes from the rear of a train should it become necessary for the crewmen at the rear to bring the train to a stop.

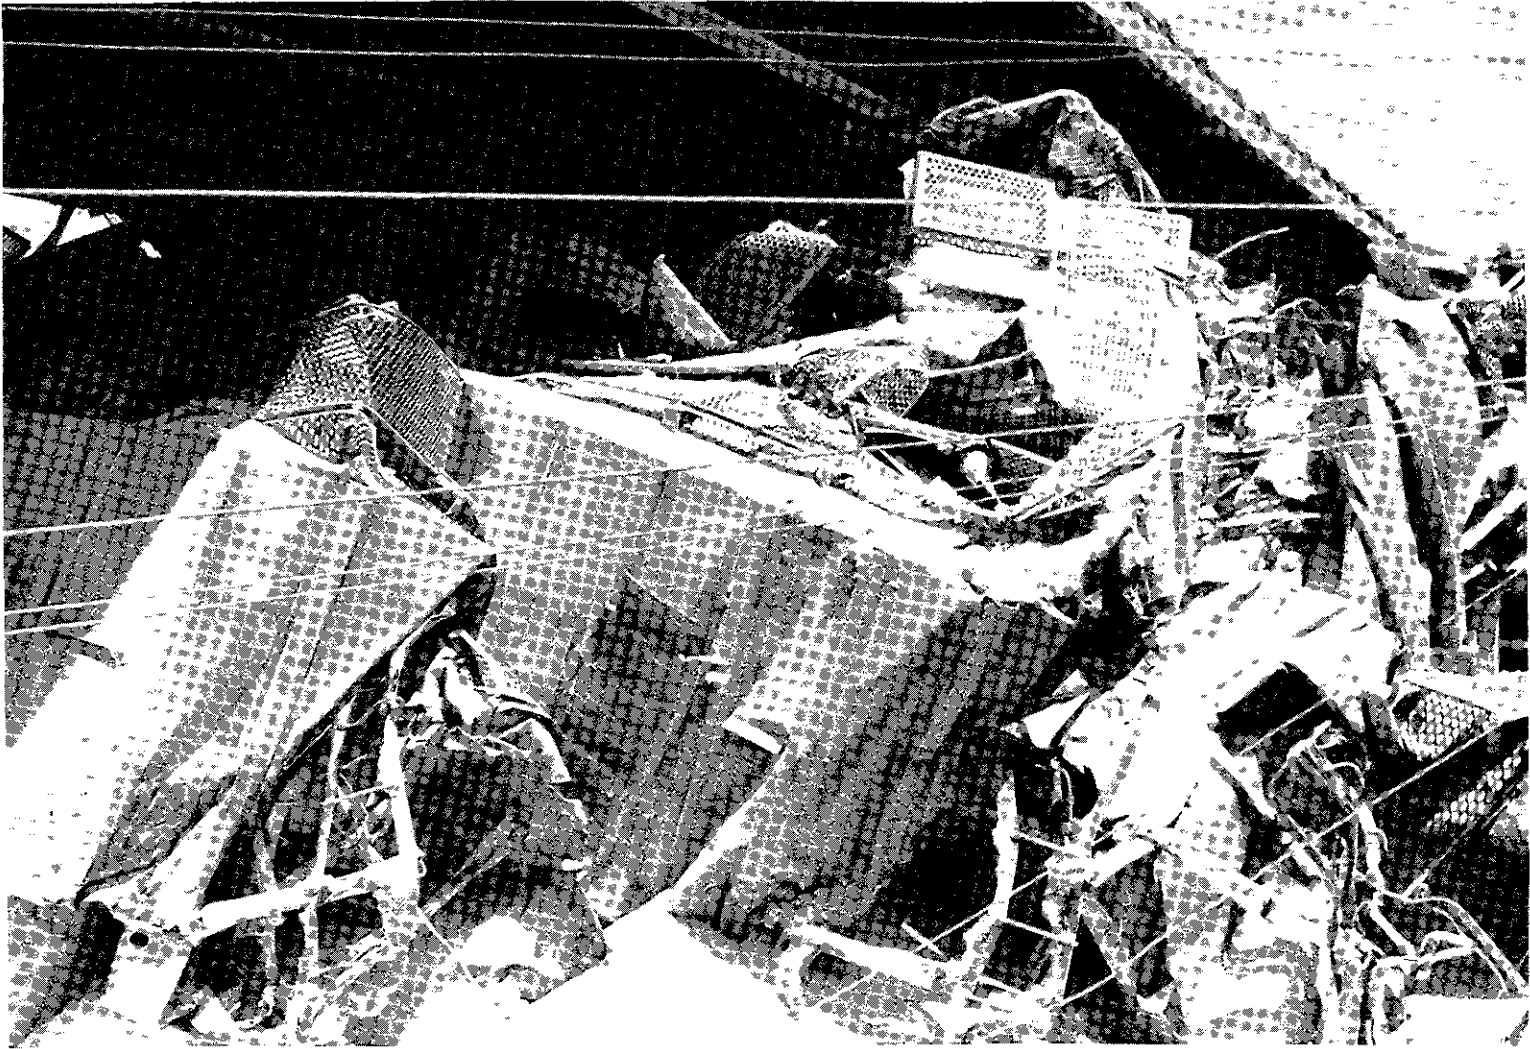
The second and third locomotive units were damaged heavily. Eighty cars were destroyed and one car was damaged extensively. Before the accident, the train was 4,906 feet long, but after the accident, the wreckage was confined to an area only 800 feet long. The lead pair of wheels on the caboose derailed. Six upright columns of the two overpass bridges of Interstate 80 were destroyed in addition to part of the roadway section. Two thousand feet of track and associated signal equipment were destroyed.

Figure 4. Crushed covered hopper cars.
