NATIONAL TRANSPORTATION SAFETY BOARD

RAILROAD ACCIDENT REPORT

REAR END COLLISION AND DERAILMENT
OF TWO UNION PACIFIC FREIGHT TRAINS
NEAR NORTH PLATTE, NEBRASKA
ON JULY 10, 1986

NTSB/RAR-87/03

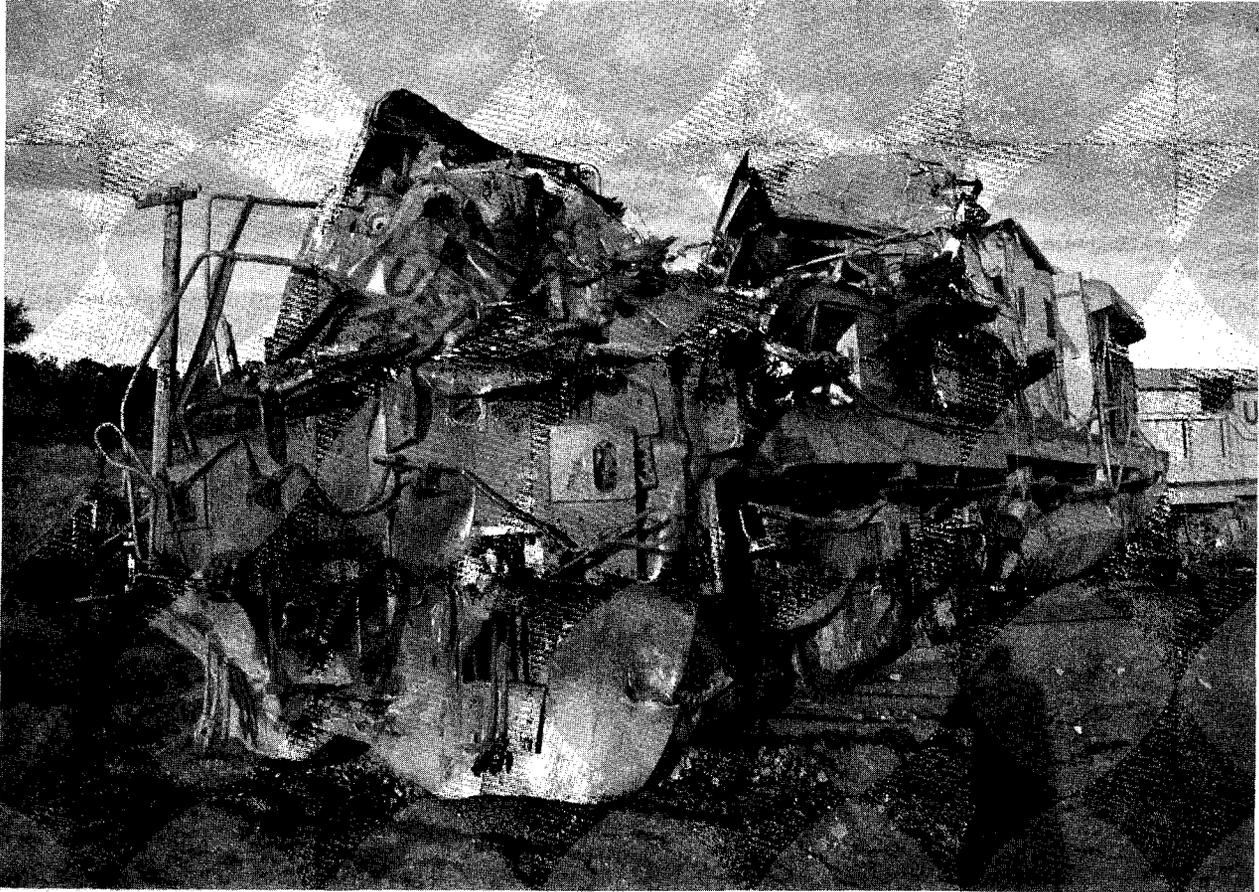
Three locomotives and 11 cars from both trains were derailed. The lead locomotive unit on train CLSA-09 was destroyed. The body of the locomotive was crushed and torn loose from the front to the engine compartment. The fireman's seat area was completely torn off the underframe. (See figure 3.) The operating console and seat were all that remained on the engineer's side of the operating compartment. All side panels and doors in the engine area and the roof panels were bent and buckled. (See figure 4.) The 11 derailed cars included the caboose of train WPX-08, 4 cars that were destroyed, and 6 cars that were moderately damaged.

Figure 3.--Damage to locomotive of train No. CLSA-09.

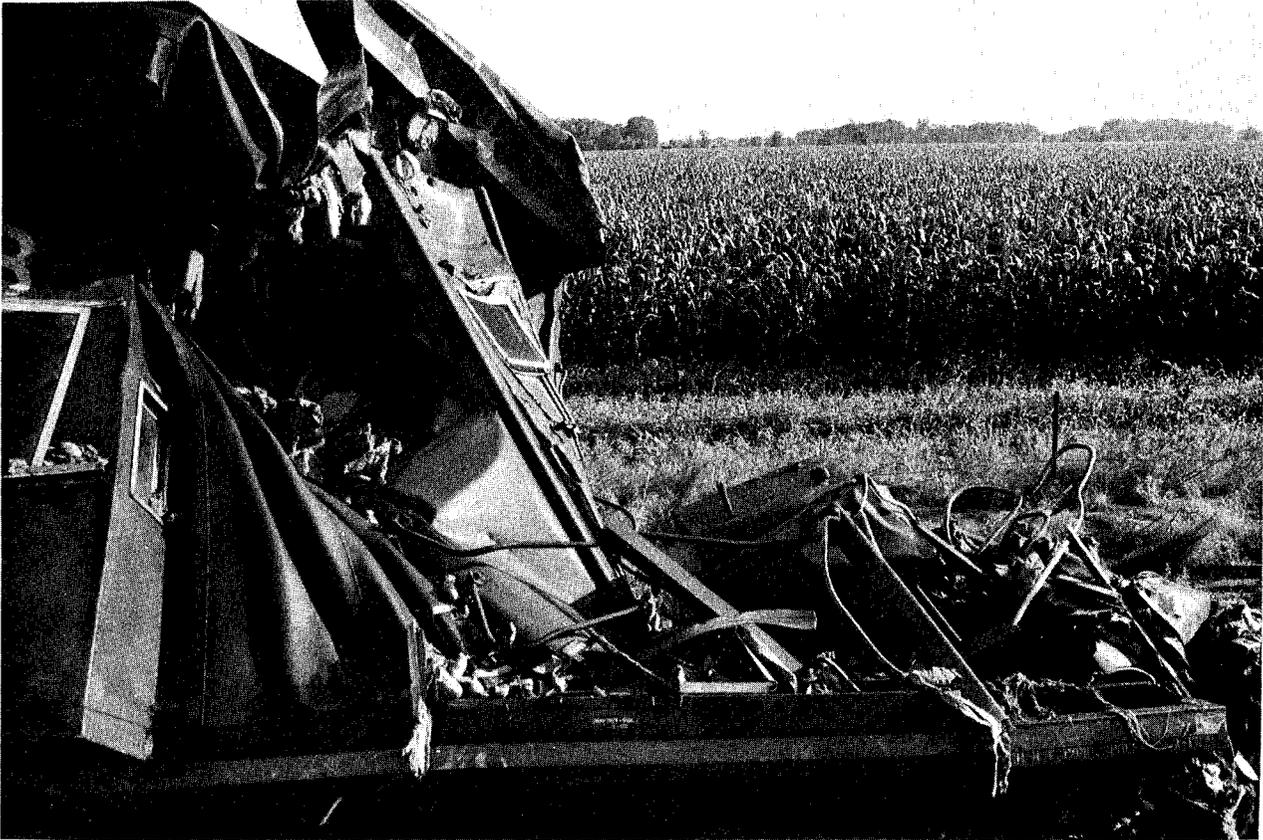
On impact, the caboose of train WPX-08 was pushed forward under the car ahead; the steel end sheets of the caboose were crushed inward, and the roof was buckled and crushed into the interior of the caboose. (See figures 5 and 6.) The seats for the conductor and rear brakeman were located in the middle of the caboose. The backrest of the conductor's seat was deformed, but the rear brakeman's seat was not damaged. (See figure 7.) Track was destroyed for 400 feet on each of the three tracks for a total of 1,200 feet.

Figure 5.—Caboose of train No. WPX-08.

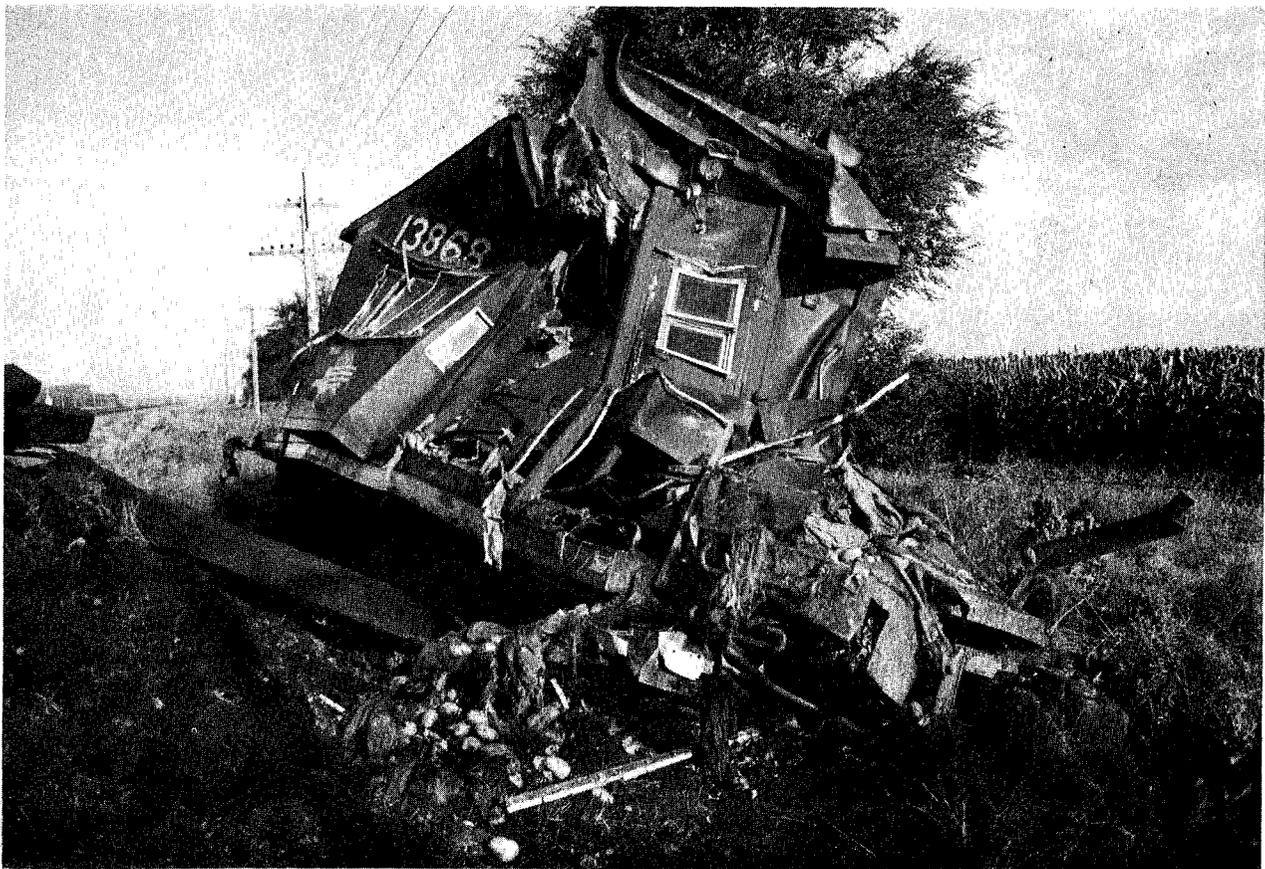
Figure 6.—Caboose of train No. WPX-08.

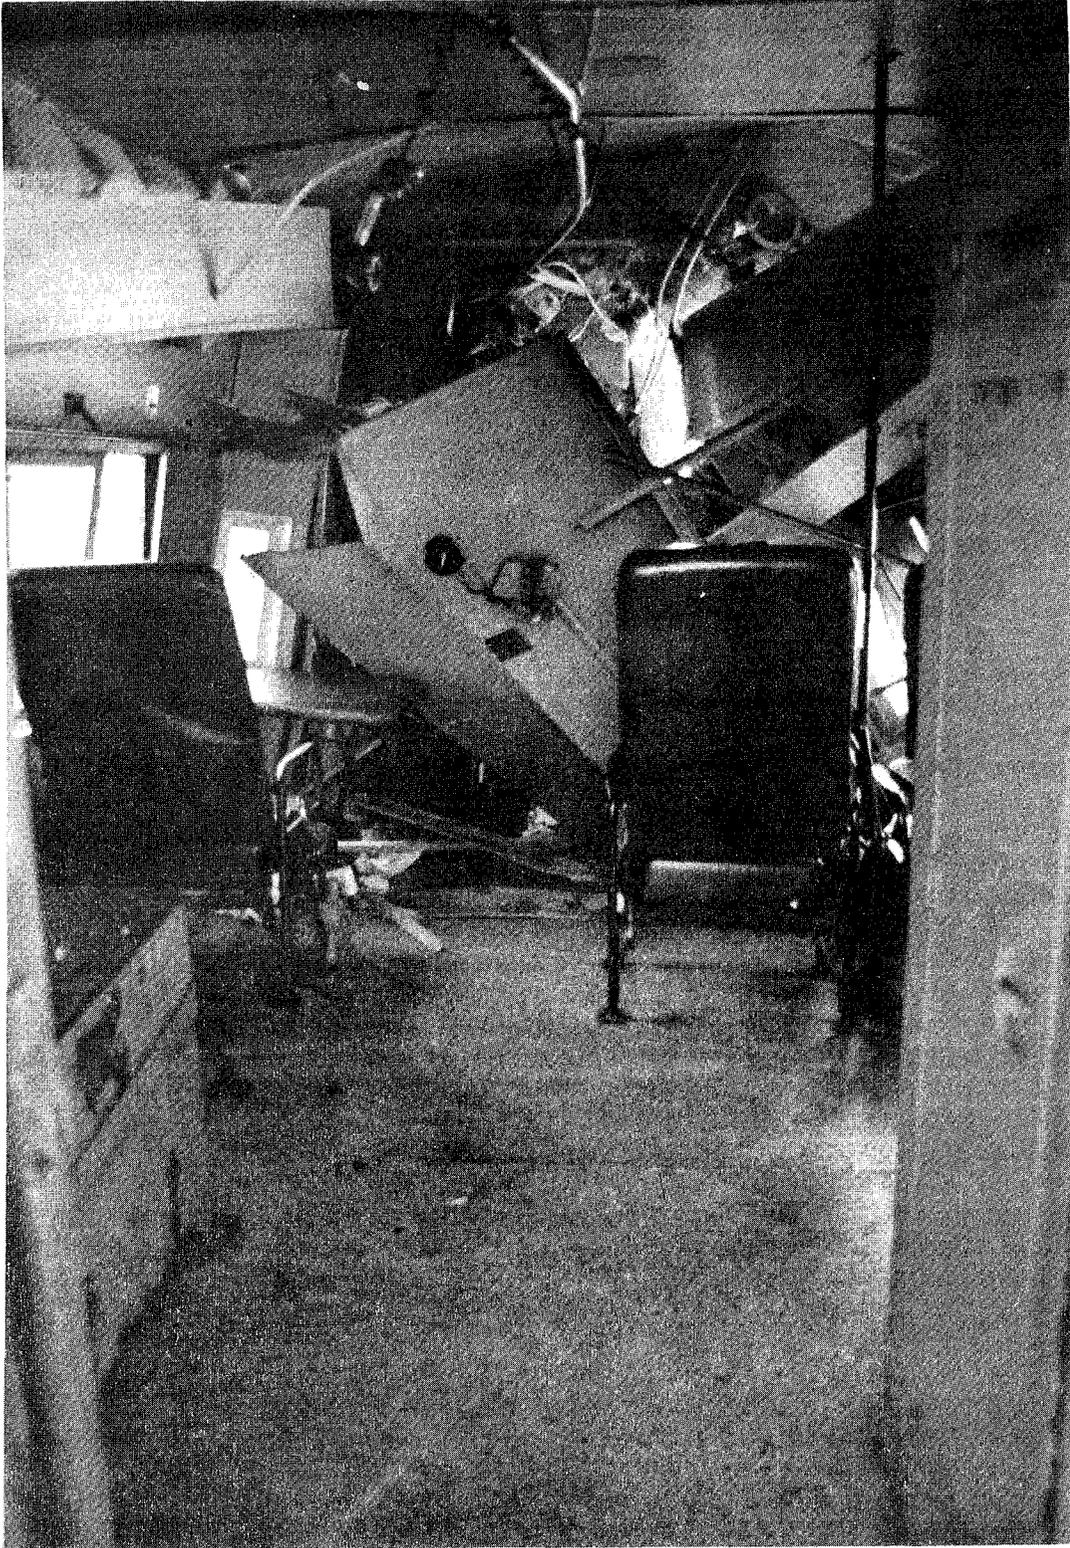
Figure 7.--Interior of caboose of train No. WPX-08.

The conductor and rear brakeman on train WPX-08 were in the caboose at the time of collision. Following the accident, there was livable space in the area of the seats. The conductor was seated on the left side of the caboose with the lapbelt unfastened. Inspection of the seat following the accident indicated that on impact, the conductor was first thrown back into the seat but then forward out of the seat and into the desk in front of him, and then to the floor. The conductor received a broken arm, broken neck, broken thumb, and cuts and bruises. According to the conductor, the rear brakeman was attempting to get to the seat on the right side of the caboose when the collision occurred. The conductor stated he did not see what happened to the rear brakeman during the accident, but the rear brakeman was found on the floor of the caboose in front of the seat on the right side. He died as a result of massive injuries.
