**REAR-END COLLISION OF TWO
UNION PACIFIC FREIGHT TRAINS
RAMSEY, WYOMING
MARCH 29, 1979**

NTSB-RAR-79-9

REAR-END COLLISION OF UNION PACIFIC
RAILROAD FREIGHT TRAINS
RAMSEY, WYOMING
MARCH 29, 1979

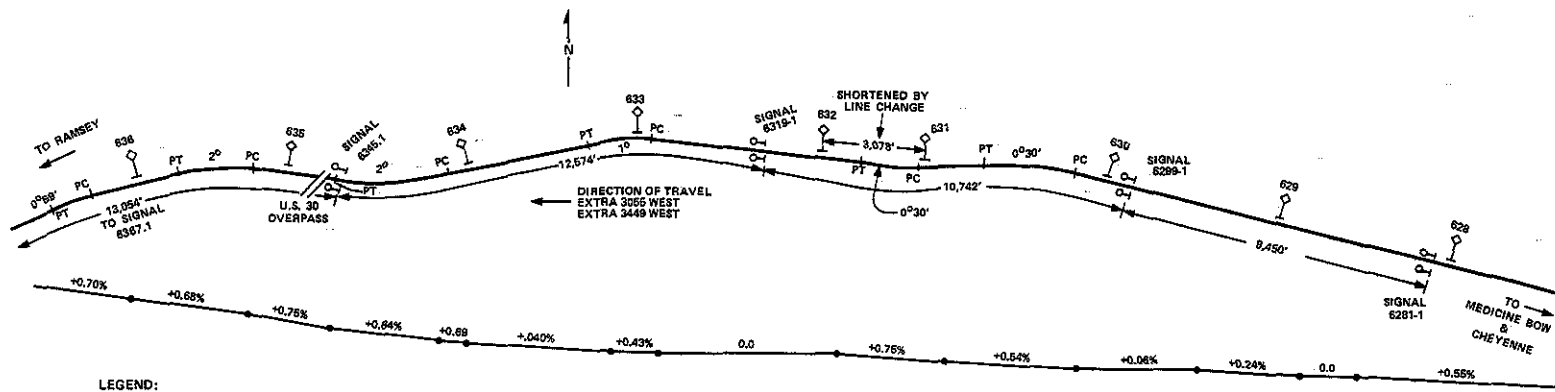
Figure 1. Diagram and profile of approach to accident location from signal 6281-1 to section shown in Figure 2.

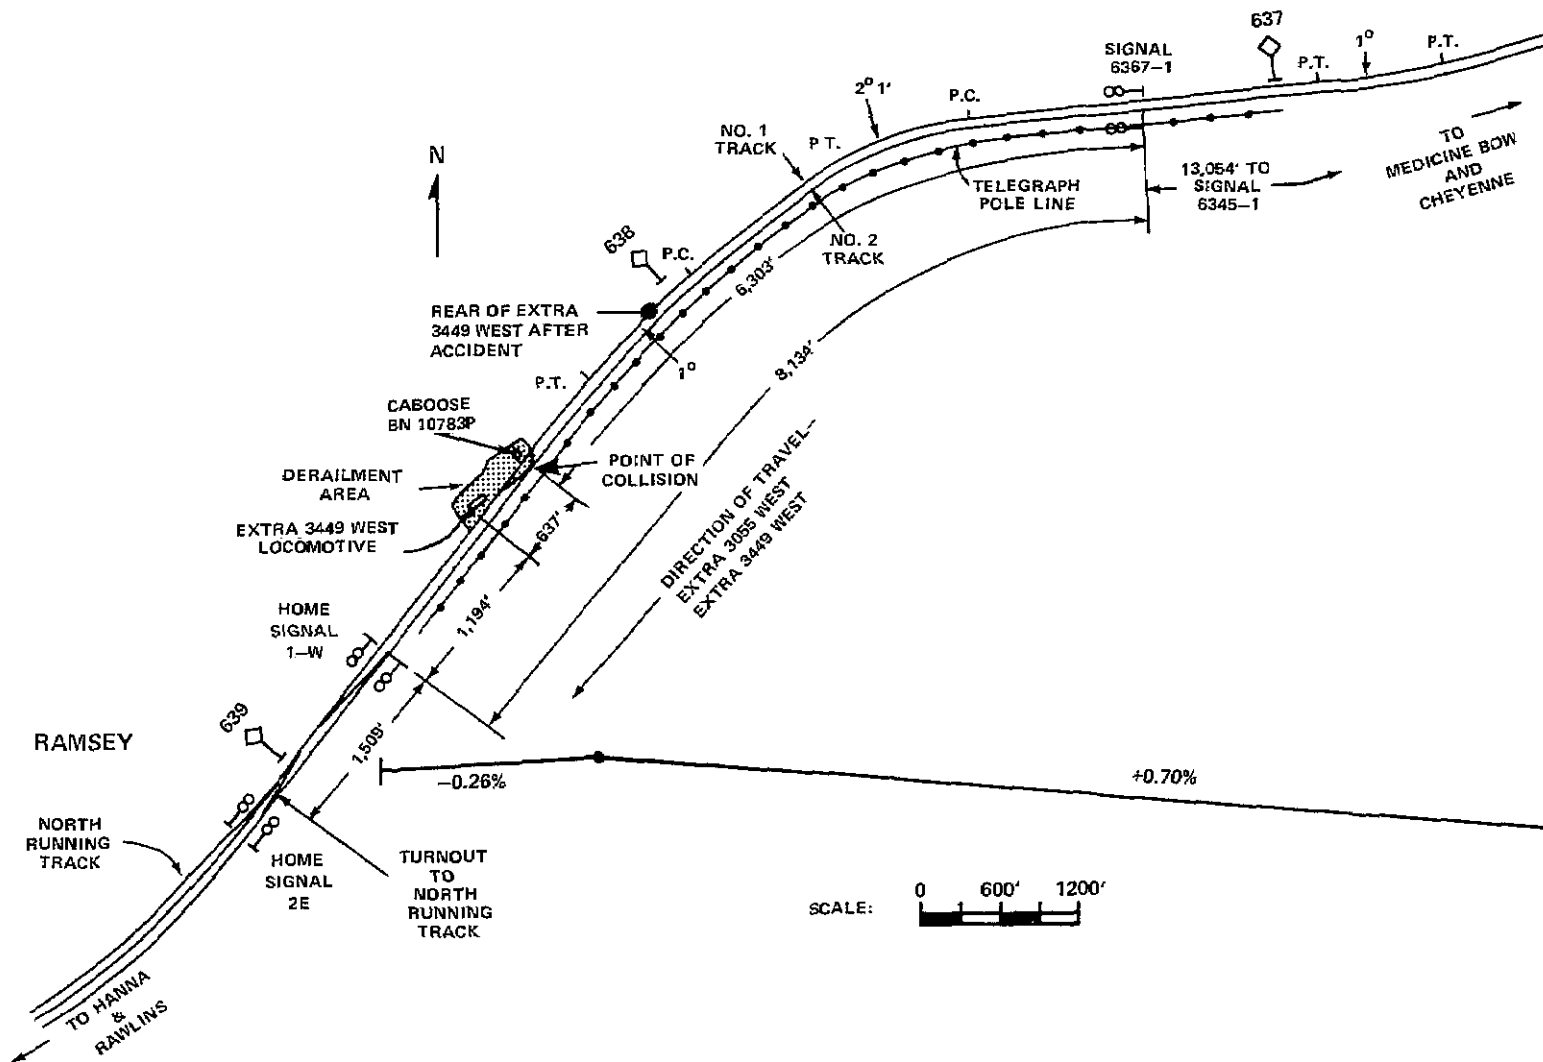
Signal 6299-1, the third signal west of Medicine Bow, can be seen from a westbound train as soon as the train passes the preceding signal more than 9,400 feet to the east. Due to track curvature and terrain, the last three intermediate signals approaching Ramsey -- 6319-1, 6345-1, and 6367-1 -- are first continuously visible to a westbound train at distances of about 3,300, 2,300, and 2,500 feet, respectively. The point of collision could first be seen from a westbound train 2,300 feet to the east. Beyond that point, a pole line south of the main track partially obscured the location. Beginning at signal 6367-1, a westbound train on the No. 1 track moves through a tangent for 1,512 feet, followed by a 2-degree, left-hand curve for 1,174 feet, a tangent of 1,289 feet, and a 1-degree, left-hand curve for 1,597 feet. The remaining 731 feet to the point of collision is tangent. Over the entire distance the grade ascends at the rate of 0.70 percent except for the last 300 feet which is 0.26 percent descending westbound. (See figure 2.)

Figure 2. Diagram and profile of accident location and approach from signal 6367-1.

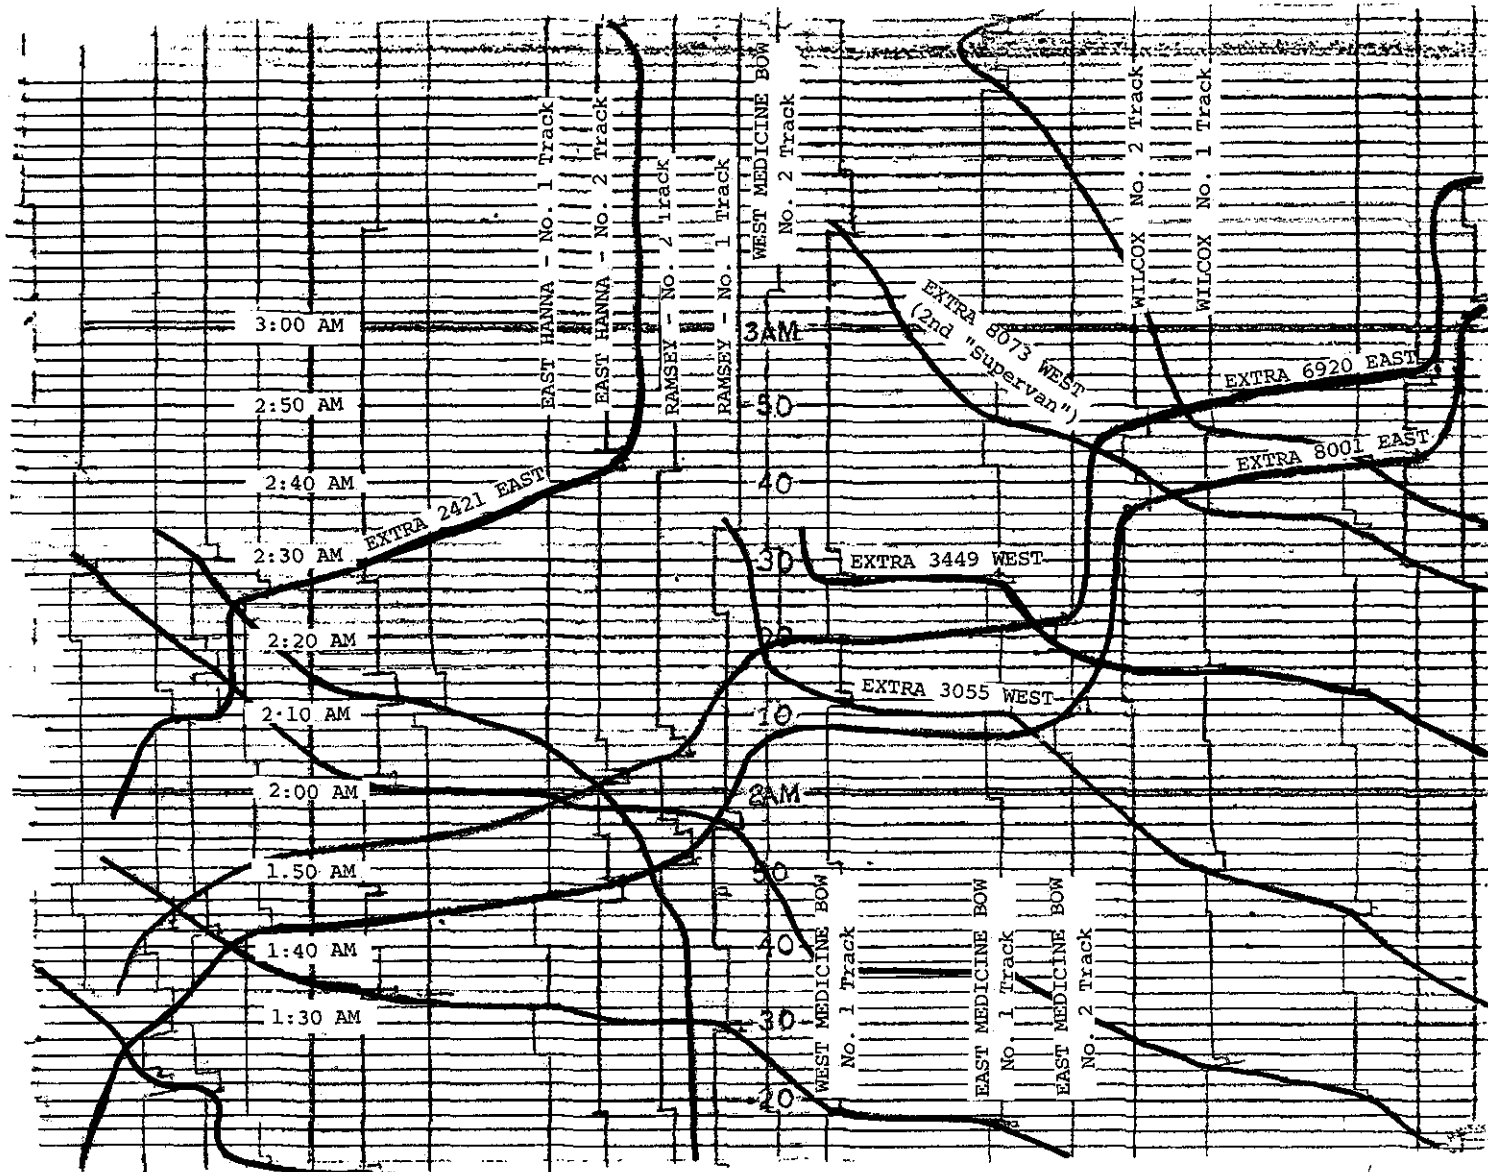
Figure 3. Centralized Traffic Control recording graph for Ramsey-Medicine Bow area from 1:30 a.m. to 3:00 a.m., March 29, 1979. Times, locations, and identification of trains have been superimposed on a copy of the original graph.

The recording graph from the dispatcher's CTC machine was inspected and the various passing times for both westbound trains and the last two eastbound trains they passed generally conformed with the times stated by crewmembers of Extra 3055 West and the eastbound trains. The accuracy of the graph was also confirmed by the passing times of the eastbound trains registered by the operator at Hanna, and by analysis of the speed recorder tapes removed from the lead units of Extra 3055 West and Extra 3449 West. (See appendix C.)

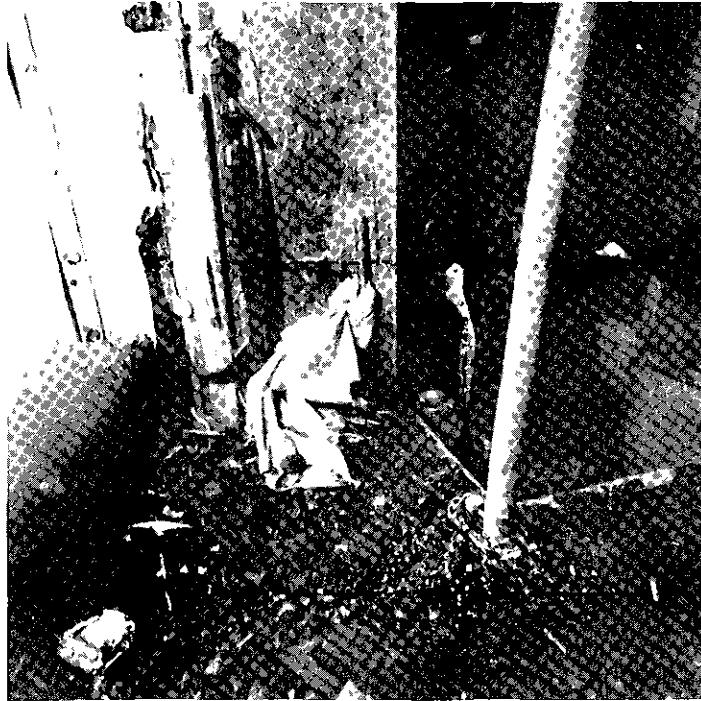
Following the accident an inspection of the cab of Extra 3449 West's lead unit revealed the throttle to be in the No. 8 power position, the automatic brake valve in handle-off position with handle removed and laying on the engineer's seat, and the independent brake valve in the running position. The overspeed and deadman control features were active with the deadman pedal in the up, or active, position. The headlight switch was on "bright" and the radio was operable. The emergency valve on the left side of the cab was in the closed position. The cab signal acknowledging device was in the "normal" position, the cab signal control switch was sealed in the "on" position, and the warning whistle was found with a large rag tied around the port. Subsequently, the head brakeman who had been on Extra 3449 West from North Platte to Cheyenne stated that he had tied the rag on the whistle to mute its sound. (See figure 4.)

The warning whistle was taken to UP's Omaha shop where a series of sound-level tests was made with the whistle installed in a unit of the same model and series as the one involved in the accident. With the cab doors and windows closed, the engine working in the No. 8 throttle position, and the whistle port unblocked, the sound level of the whistle was 28 decibels higher than the sound level of the

Figure 4. Automatic locomotive cab signal warning whistle in the cab of the lead unit of Extra 3449 West as it was found after the collision at Ramsey.

engine. With the port covered by the rag, the decibel value was virtually the same as that produced by the engine alone and it was not possible to perceive any sound from the whistle at any location in the cab.

It is possible that the last signals the engineer and head brakeman actually observed were the clear signals passed at and immediately west of Medicine Bow. For the last 15 miles of its run, Extra 3449 West was laboring in full throttle. The cab windows and doors were closed and the cab heater was on. The engineer had only napped briefly during the 18 hours preceding the accident and may have dozed off. The mere weight of the engineer's foot on the deadman pedal was sufficient to keep it depressed. The one safety device — the cab signal whistle — that could have alerted the men had been effectively muted so that it could no longer serve its intended purpose.

This accident demonstrates that the purpose of the cab signal warning whistle can be easily and effectively eliminated, and that the device, by itself, is an inadequate means of assuring the engineer's compliance with restrictive signal indications. Had the UP's locomotive cab signal system included a provision for automatic penalty application of the automatic brake system when the engineer fails to acknowledge a restrictive cab signal indication, Extra 3449 West would have been stopped long before it reached Ramsey, and the collision would not have occurred.

"Modify its locomotive cab signal apparatus to provide for an automatic penalty application of the automatic airbrake system whenever the engineer fails to acknowledge a more restrictive signal indication within the specified time. (Class II, Priority Action) (R-79-41)"

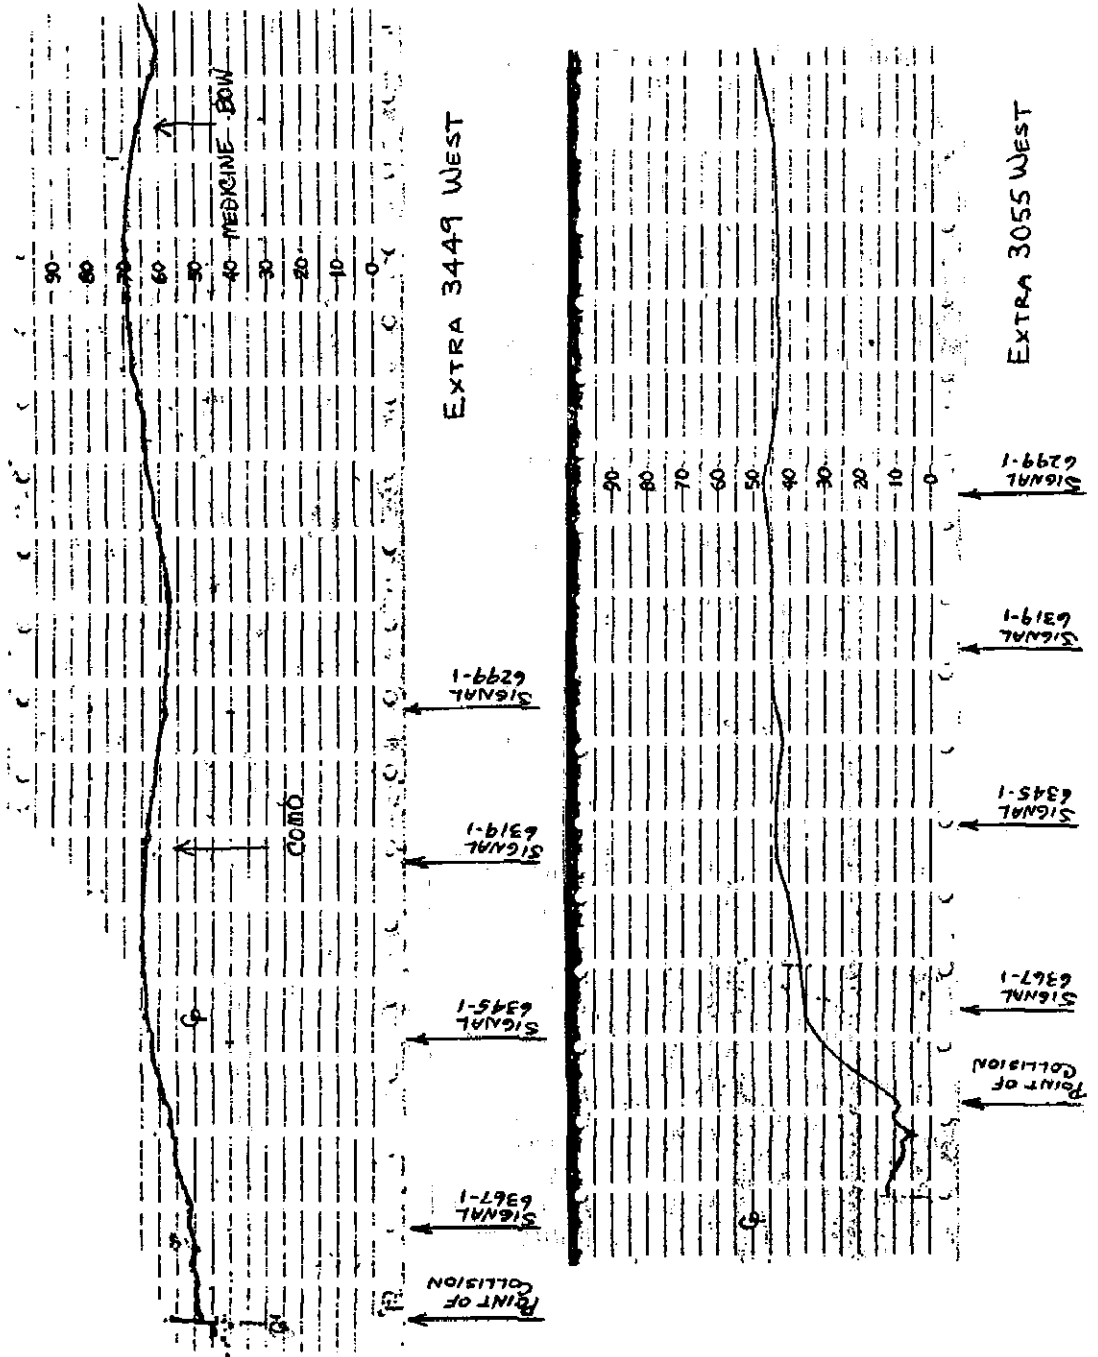
SPEED RECORDER TAPES
FROM EXTRA 3055 WEST AND EXTRA 3449 WEST

By the time Extra 3449 West reached signal 6345-1, the engineer was required to have reduced his train's speed to 40 mph. Yet the locomotive speed recorder tape indicated that the train passed the signal at 62 mph. The "approach" aspect displayed by signal 6345-1 required immediate reduction to 30 mph and the ability to stop short of signal 6367-1, yet the train passed this signal, which would have displayed a "stop and proceed" aspect, at 52 mph. The red marker light on the rear of Extra 3055 West should have been plainly visible to the engineer and head brakeman of Extra 3449 West when it was still more than 2,000 feet away. Yet Extra 3449 West struck the rear of the slowly moving coal train at a speed of 48 mph. At no time did the engineer take action to reduce from full throttle operation or to initiate any braking action. The gradual deceleration of his train was due entirely to the effect of the long ascending grade approaching Ramsey.

The speed recorder was very helpful in determining the actual speed of the train as it approached the point of the collision. This in turn provided information of the activities of the crewmembers in the locomotive. However, an events recorder would have been more beneficial in providing this information.
