INTERSTATE COMMERCE COMMISSION  
WASHINGTON

INVESTIGATION NO. 2968  
UNION PACIFIC RAILROAD COMPANY  
REPORT IN RE ACCIDENT  
NEAR CONWAY, OREG., ON  
JANUARY 19, 1946

Accident near Conway, Oreg., on January 19, 1946, caused  
by excessive speed on a sharp curve.

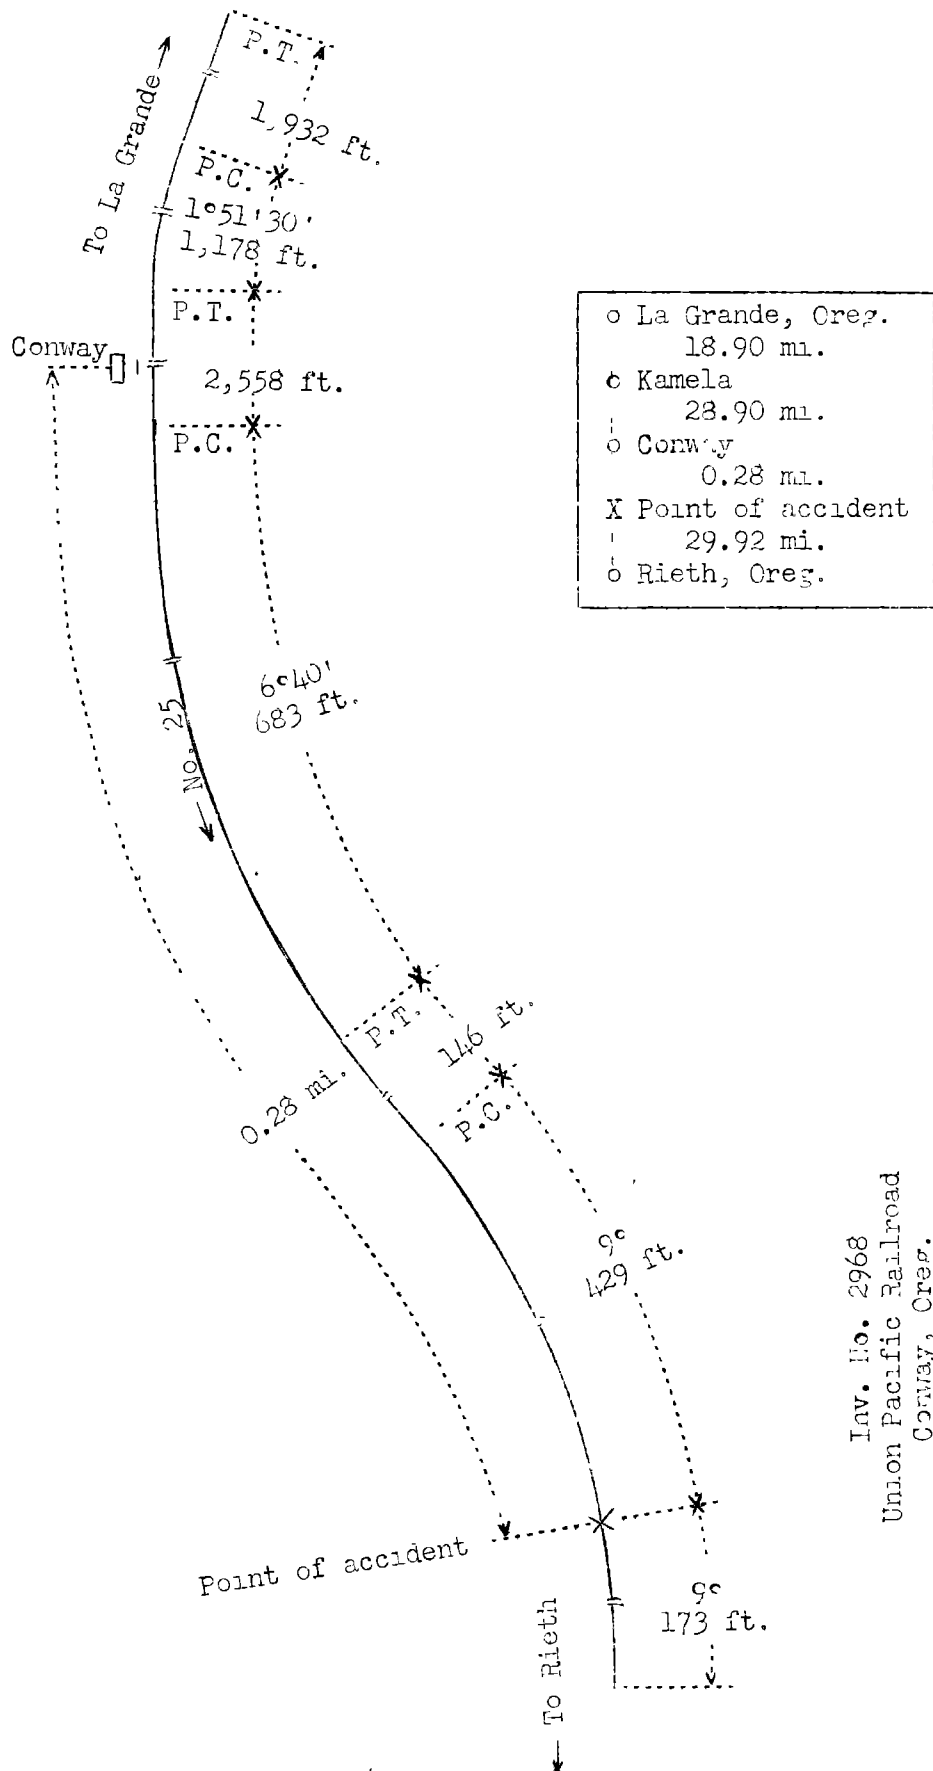
Inv. No. 2968  
Union Pacific Railroad  
Conway, Oreg.  
January 19, 1946

This accident occurred on that part of the Oregon Division extending between La Grande and Rieth, Oreg., 78 miles, a single-track line in the vicinity of the point of accident over which trains are operated by signal indications. The accident occurred on the main track 48.08 miles west of La Grande, at a point 0.28 mile west of the station at Conway. From the east there are, in succession, a tangent 1,932 feet in length, a  $1^{\circ}51'30''$  curve to the left 1,173 feet, a tangent 2,558 feet, a  $6^{\circ}40'$  curve to the left 633 feet, a tangent 146 feet and a  $9^{\circ}00'$  curve to the right 429 feet to the point of accident and 173 feet westward. The grade for west-bound trains varies between 0.74 percent and 1.34 percent descending about 4 miles, then it is 1.13 percent descending 131 feet to the point of accident and 729 feet westward.

On the curve on which the accident occurred, the track structure consists of 131-pound rail, 39 feet in length, laid new in November, 1945, on 22 treated ties to the rail length. It is fully tieplated, double spiked, provided with 6-hole angle bars, 12 rail anchors and 6 gage rods per rail length, and is ballasted with gravel to a depth of about 8 inches. The maximum superelevation on the curve was 5-3/8 inches, and the gage varied between 4 feet 0-5/16 inches and 4 feet 8-9/16 inches. At the point of derailment the superelevation was 4-3/8 inches, and the gage was 4 feet 8-5/16 inches.

No. 25 had just traversed a 6°40' curve to the left and was moving on a 9° curve to the right when the engine and the first six cars were derailed. The engine overturned to the left and stopped 293 feet beyond the point of derailment. The maximum authorized speed on the curve was 25 miles per hour.

The surface, alinement and gage of the track were well maintained for the maximum authorized speed of 25 miles per hour. The division superintendent said that the overturning speed at the point of derailment for engine 3829 was 63 miles per hour. It appears that the train was moving at overturning speed, as the engine overturned to the outside of the curve without marking the rails, and slid on its left side to the point where it stopped.
