RAILROAD ACCIDENT REPORT

UNION PACIFIC RAILROAD
FREIGHT TRAIN DERAILMENT

HASTINGS, NEBRASKA

REPORT NUMBER: NTSB-RAR-77-1

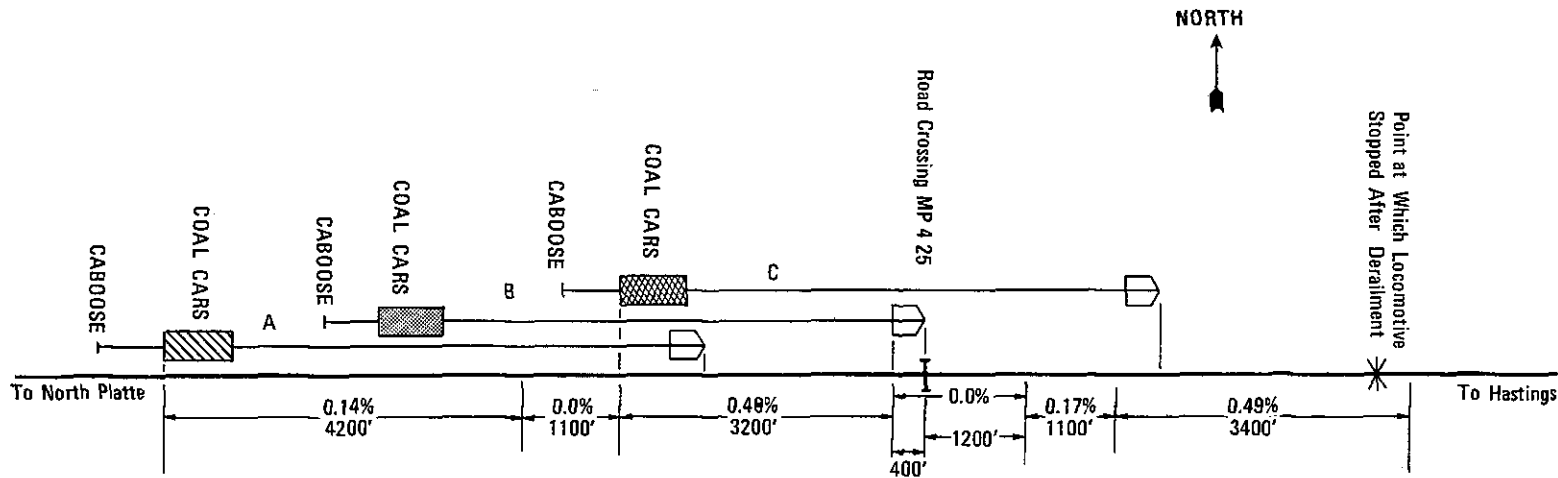
Figure 1. Plan of accident site.

Thirty-nine cars--the 42nd through the 81st--derailed immediately east of the crossing. No one was injured. Only the west trucks of the 42nd car derailed.

The track is straight from milepost 16.5 west of Hastings through the derailment area and is built on slight cuts and fills (See figure 1.) The track is maintained to the Federal Railroad Administration (FRA) Class 5 track standard.

Beginning about milepost 5.25, west of Hastings, the track is on a 0.48 percent grade that descends to the east. Between milepost 4.5 and milepost 4.25 at the crossing, the grade changes to 0.0 percent (level) which continues east through the crossing. Approximately 1,200 feet east of the crossing, the grade descends 0.17 percent.
