# NATIONAL TRANSPORTATION SAFETY BOARD

## RAILROAD ACCIDENT REPORT

REAR-END COLLISION OF  
UNION PACIFIC RAILROAD COMPANY  
FREIGHT TRAINS  
NEAR HERMOSA, WYOMING  
OCTOBER 16, 1980

NTSB-RAR-81-3

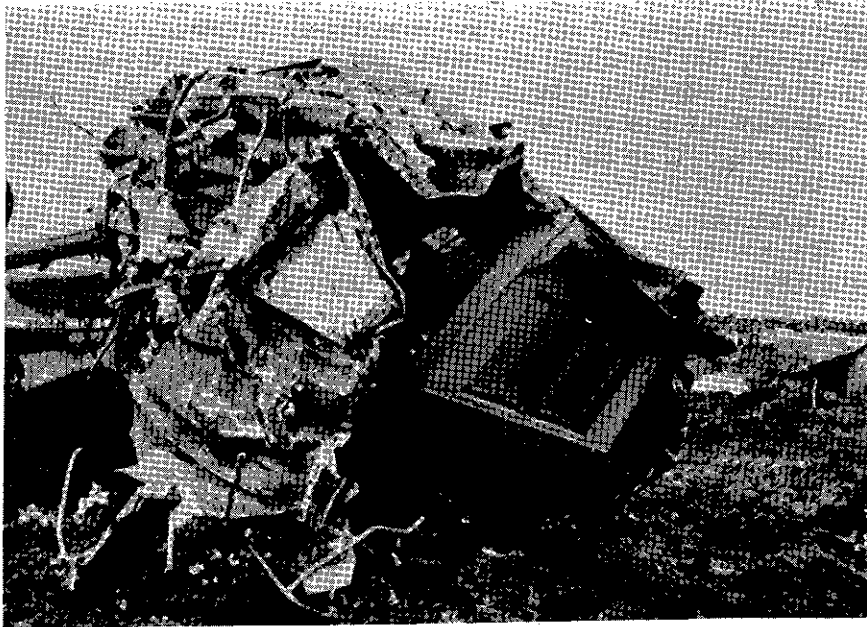
Figure 2.--Caboose of SGTLB-635.

The caboose and three rear cars of SGTLB-635 were derailed. Most of the collision force was absorbed by the caboose, which was demolished. Only a portion of the cupola and the windows on its right side were still intact. The two rear cars of grain were heavily damaged when they were derailed and overturned, one to the south and one to the north of the track. The third rear car of grain was upright in the track with its rear truck derailed.

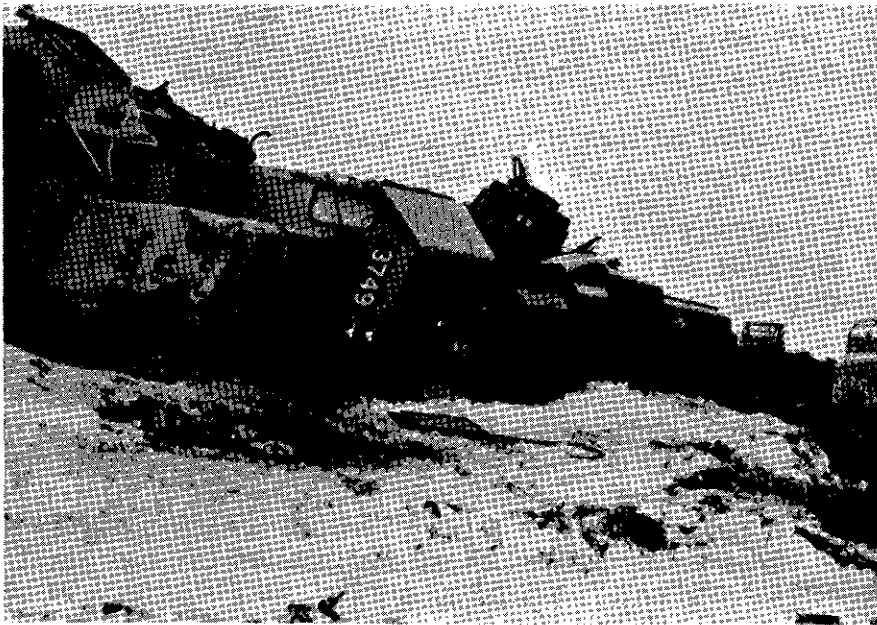
Figure 3.--Locomotive unit No. 3749 of NPH-16.

The 3 locomotive units and lead 13 cars of NPH-16 were derailed. The lead unit left the track to the south and overturned onto its left side, stopping about 155 feet west of signal No. 5517. The lead unit sustained moderate damage to its forward hood and operating compartment. The two following units jackknifed and became crosswise with the track. The second unit was heavily damaged when struck by the following unit and derailed cars. The third unit sustained only minor

The left side of the lead locomotive unit of NPH-16 was the most heavily damaged. (See figure 3.) The head brakeman was found lying on the left cab wall where the unit came to rest. He received severe multiple head and chest injuries that were instantly fatal.

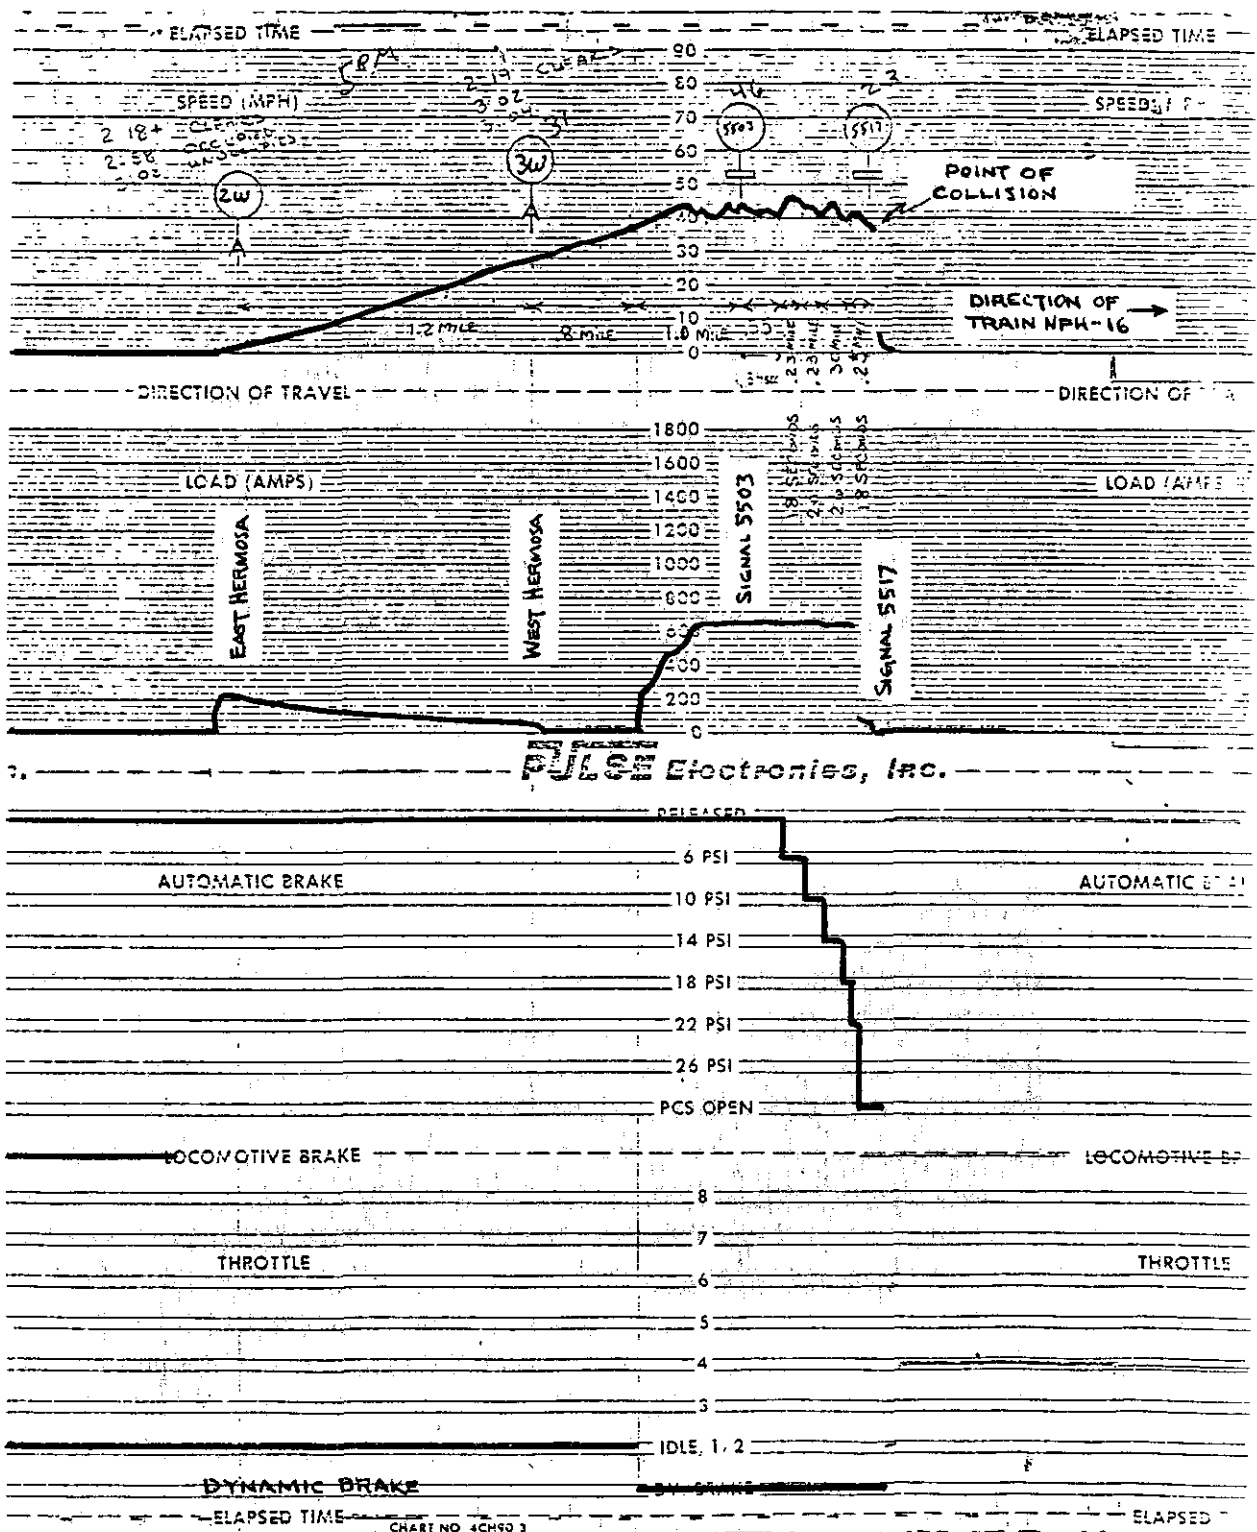
Figure 4.--Event recorder printout of NPH-16.

The event recorder printout of NPH-16 was inspected to determine how the train was actually operated between Dale Junction and the point of collision. (See figure 4.) The printout indicated that after approximately a 4-minute stop at Dale Junction, the throttle was progressively increased from idle to 8th run position. Maximum speed between Dale Junction and East Hermosa in 8th run position was approximately 22 mph. Throttle was then reduced progressively to idle, and at approximately 10 mph, the dynamic brake was applied. A very short time later, minimum brakepipe application was made and held until the train came to a stop. After the train stopped, an additional 4-pound brakepipe reduction, for a total of 10 pounds, was made. The brake valve was released and the locomotive brakes were applied. The train remained stopped for approximately 1 hour 6 minutes. Then the independent brakes were released, and throttle was increased between 1st and 2nd run until a speed of approximately 28 mph was obtained, at which time

throttle was reduced to idle position. The train drifted for approximately 0.8 mile immediately after passing the signal at West Hermosa. Then dynamic braking was applied about 1 mile east of signal No. 5503 and progressively increased to full dynamic braking while the train accelerated to a speed of about 35 mph during the next 0.5 mile. At signal No. 5503, speed had increased to about 42 mph. After approximately 0.35 mile of continued dynamic braking west of signal No. 5503, a minimum brakepipe reduction was made. This was held for approximately 18 seconds. At this time, the speed was approximately 47 mph. Then an additional brakepipe reduction of 4 pounds, for a total of approximately 10 pounds, was made; this was held for approximately 20 seconds. Then an additional brakepipe reduction of 4 more pounds, for a total of approximately 14 pounds, was made and held for approximately 21 seconds. Then brakepipe reduction of an additional 2 or 3 pounds was made and held for approximately 5 seconds. The train's brakes were then placed into emergency about 0.25 mile east of signal No. 5517 while the train's speed was approximately 40 mph. The train continued in emergency for approximately 18 seconds, at which time there was a total loss of speed signal on the event recorder, which would indicate the point of impact.

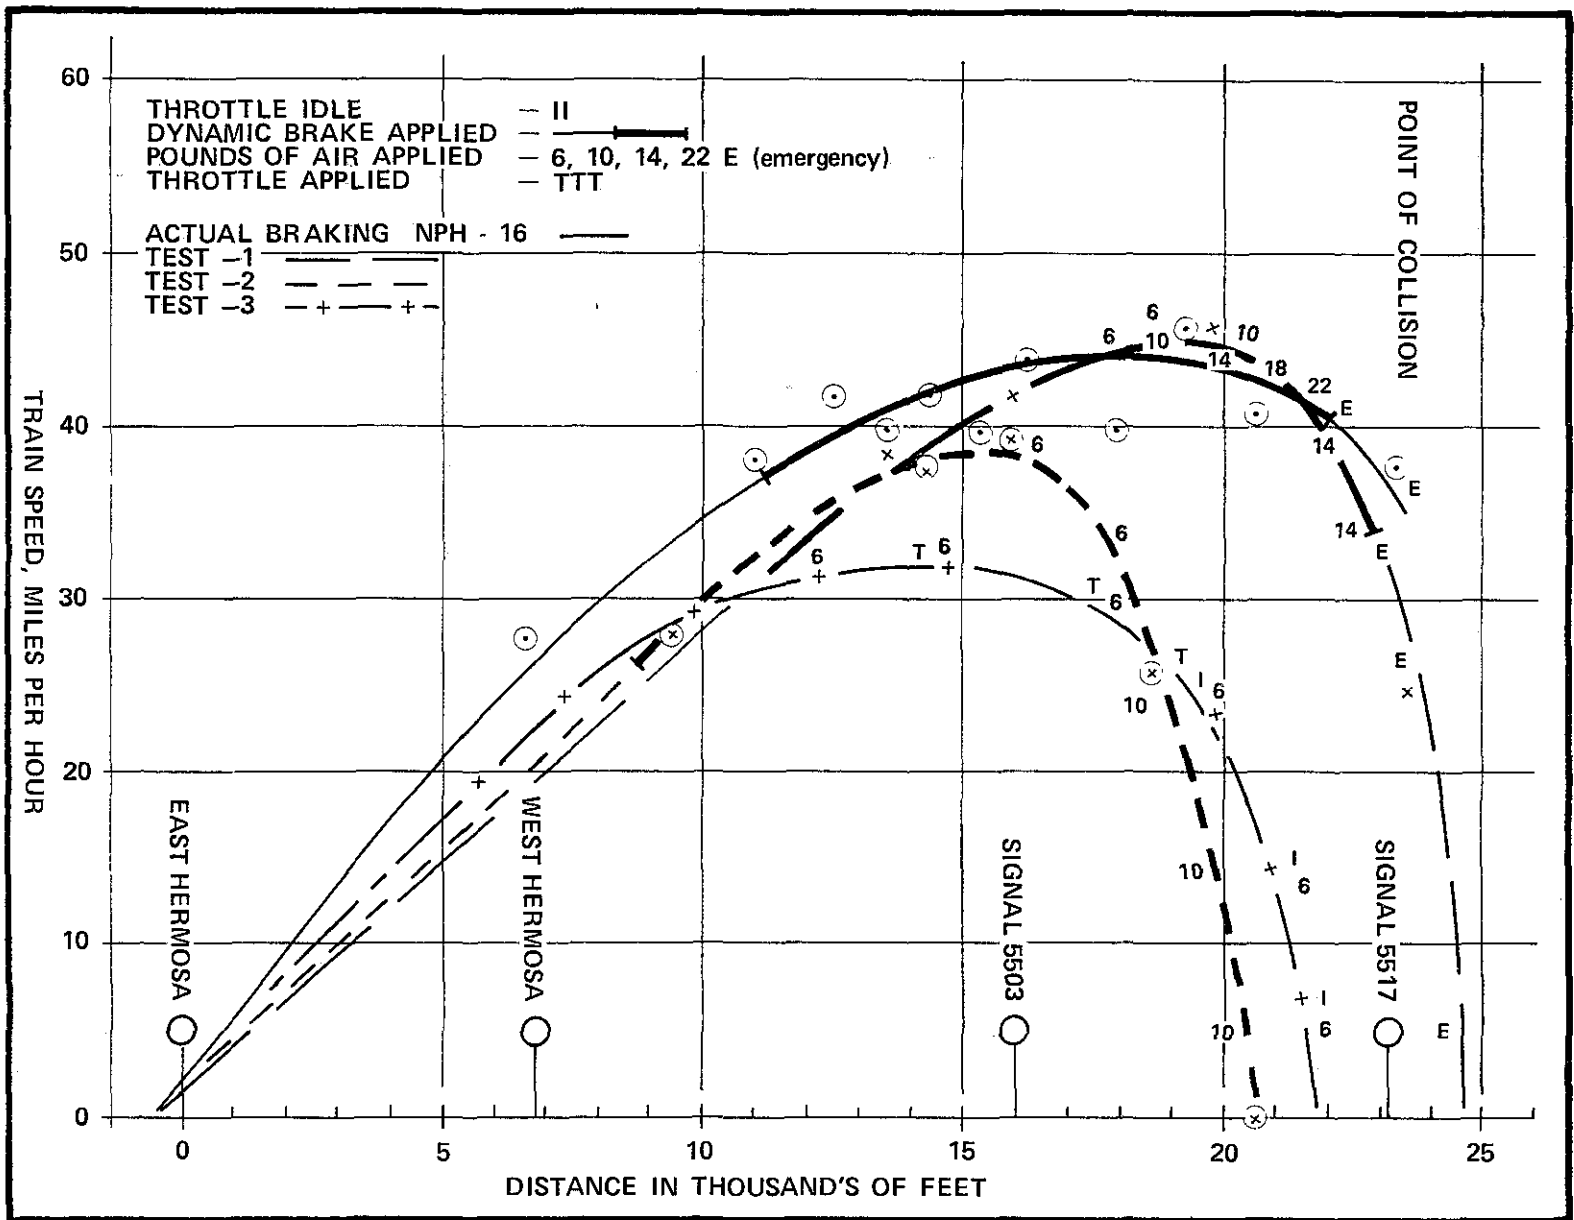
Figure 5.--Stopping distance tests of test trains.

A third test was made to determine compliance with UP Superintendent's Bulletin A-9 of March 12, 1980, which was an additional listing to the tables on page 148 of UP System Timetable No. 3. The table required that trains of between 60 to 80 tons per operative brake, using airbrakes only, must not exceed 30 mph between Hermosa and Red Buttes. Tons per operative brake for the NPH-16 were obtained by dividing the train's tonnage (5,450) by the number of cars (69) in the train. After the test train was started at East Hermosa, the engineer allowed the speed to increase to 30 mph; about 0.4 mile west of the signal at West Hermosa, a 6-pound brakepipe reduction was made. The train, with the brakes applied, passed signal No. 5503 with the throttle in 6th position; while moving at 32 mph, the

throttle was gradually reduced to idle, 3,960 feet west of signal No. 5503. The train stopped in 2,000 feet with the lead unit 1,214 feet east of signal No. 5517.
