INTERSTATE COMMERCE COMMISSION  
WASHINGTON

REPORT OF THE DIRECTOR  
BUREAU OF SAFETY

ACCIDENT ON THE  
UNION PACIFIC RAILROAD

INVESTIGATION NO. 2405

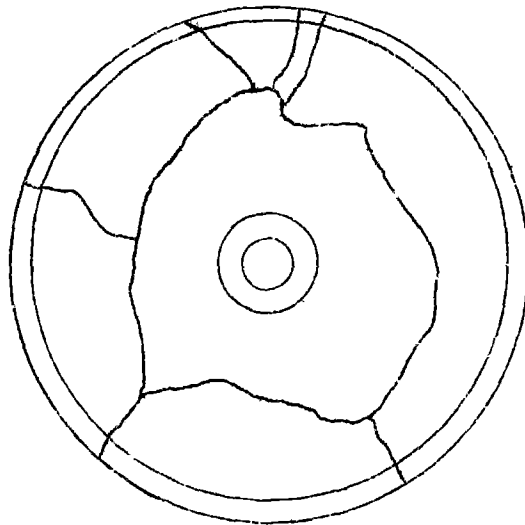
Sketch showing location of ruptures.

The metal appeared sound and of uniform structure. The structure of the metal at the middle of the tread was slightly altered as a result of brake-shoe friction and numerous light thermal checks appeared in this area. The break occurred circumferentially in the plate, starting on the flange side, as indicated by the direction of the rupture; the entire rim was broken from the hub portion and was fractured into five pieces; all fractures were clean. On a 4-inch triangular piece of rim there was a deep transverse cut about 2-3/4 inches in length on the tread and a deep semi-circular nick on the inner side of the flange; this nick fitted the contour of a 110-pound rail-head. A deep scar on the transverse section of the plate of the wheel indicated that this piece may have acted as a fulcrum between the broken rail and the heel block, and the wheels of the following cars. Measurements showed a maximum rim thickness of 1-3/32 inches and a minimum of 1 inch. The contour of the flange was normal and the maximum tread wear was 9/64 inch. The conclusion of the Research and Mechanical Standards Department was that the wheel was broken because of internal residual stresses in the plate; also, that the wheel approached A. A. R. condemning limits for wear.

Examination of the broken wheel disclosed that all five fractures were new and no evidence of any old defect was found.

The analysis of the metal in the wheel revealed that the chemical composition met the requirements of the specification for rolled steel wheels. Measurements of various points of the circumference of the wheel showed a maximum tread thickness of 1-3/32 inches and a minimum thickness of 1 inch. Contour of the flange was normal. There was no indication of recent overheating. After the occurrence of this accident the railroad changed the standard for tread thickness of rolled steel wheels from a minimum of 1 inch to a minimum of 1-1/4 inches for conventional equipment, and a minimum thickness of 1-3/8 inches for streamlined equipment.

The broken wheel approached A. A. R. condemning limits for wear. Apparently this accident was caused by stresses present in the plate of the wheel which overcame the band resistance of the rim and resulted in the rupture of the wheel.

Vice President Jabelman, in charge of research and standards of this railroad, advised the Commission's inspectors that, as a result of this accident, the Union Pacific has changed its standard for the thickness of the treads of rolled steel wheels from a minimum of 1 inch to a minimum of 1-1/4 inches for conventional equipment and a minimum of 1-3/8 inches for streamlined equipment.
