ACCIDENT REPORT NO. 80-6

UNION PACIFIC RAILROAD COMPANY

HOYA, NEVADA

DECEMBER 4, 1978

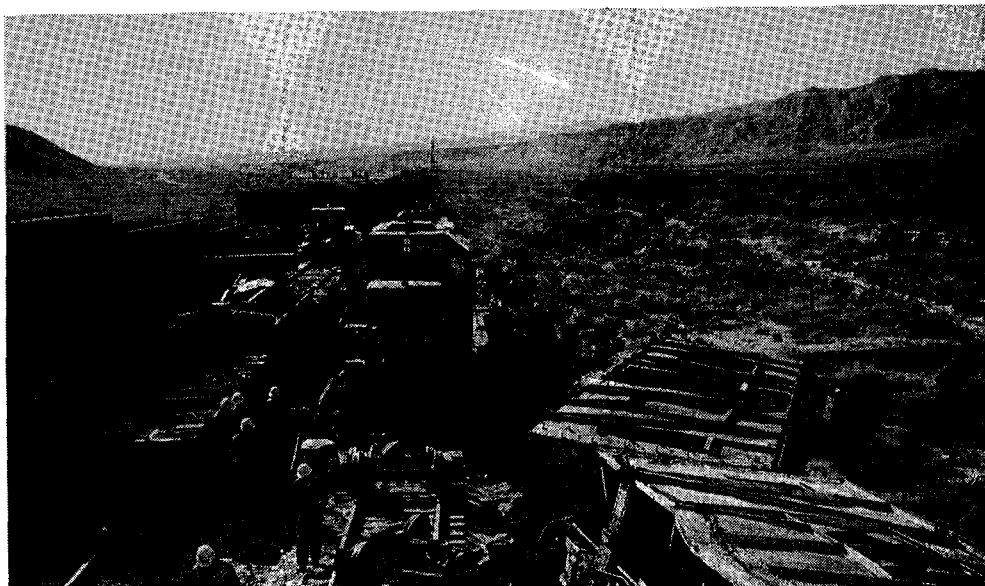
As the train collided with the track machinery, many of the machines were propelled to either side. Some of the machines piled up in front of the lead locomotive unit and burst into flames. The impact lifted the first two occupied maintenance-of-way cars off the track and overturned them. In the second maintenance-of-way car, a burning fuel oil stove overturned and spread fire and smoke throughout the car.

Fourteen track machines and two maintenance-of-way cars were destroyed by the collision and fire. The remaining maintenance-of-way cars and track machinery were not seriously damaged.

View of the accident site from the East

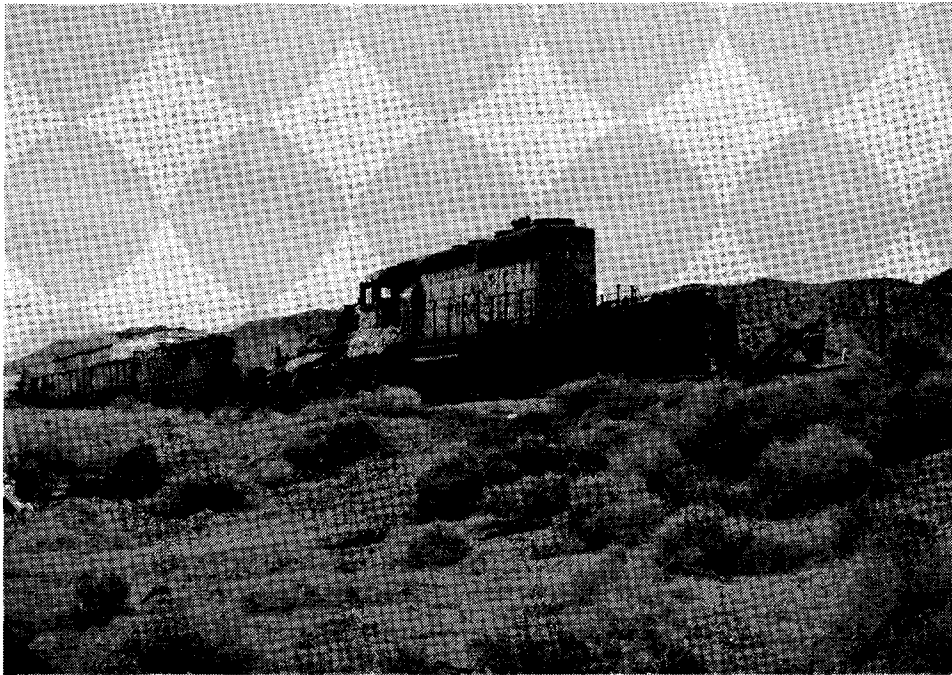
View of the accident site from the South
