**REPORT NO. 79-4
UNION PACIFIC RAILROAD
IDAHO FALLS, IDAHO
JUNE 21, 1978**

ACCIDENT REPORT NO. 79-4

UNION PACIFIC RAILROAD

JUNE 21, 1978

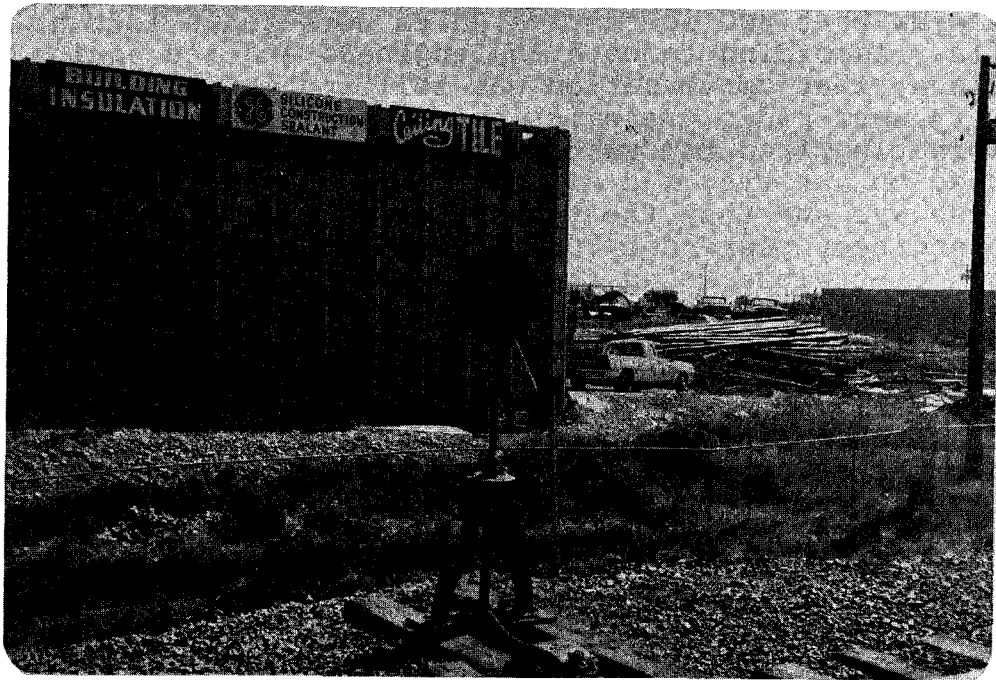
Entrance to the Del Monte spur is controlled by a hand-thrown switch with a high switch stand located on the north side of the main track. The position of the switch is indicated by a painted red disc 14 inches in diameter which is neither reflectorized nor lighted when the track is lined for the Del Monte spur.

Switch stand for Del Monte spur track. Red indication for track lined for siding.

4. The failure of the crew members of Extra 3185 East riding in the cab of the lead locomotive unit to notice, or call out, the red switch target prevented timely action from being taken before the train approached the open switch.

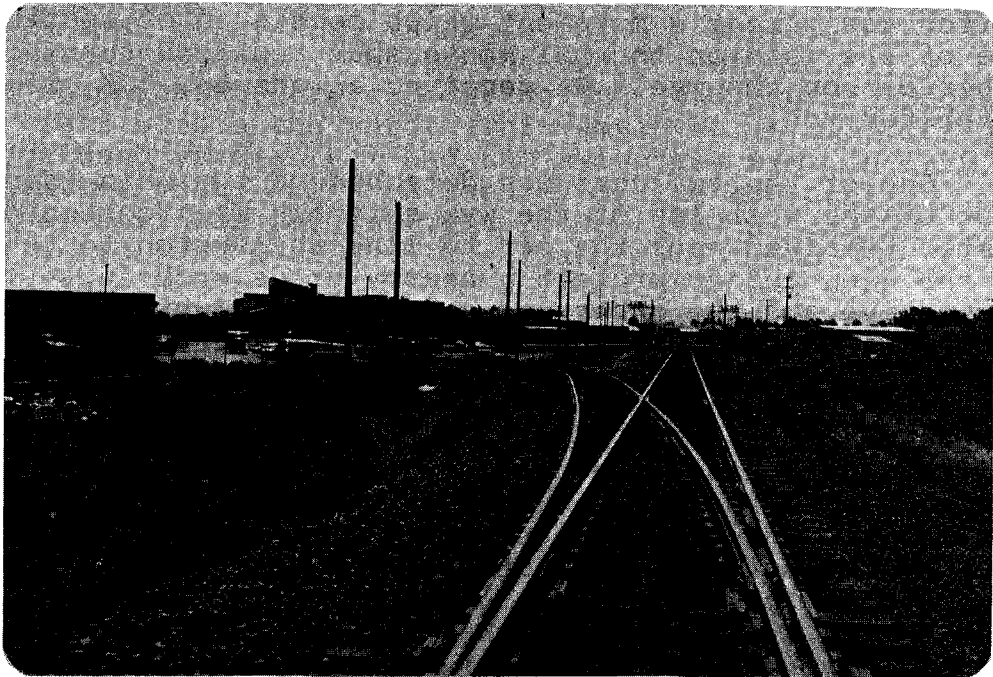
Eastbound, the main track is tangent for 7,047 feet approaching the point of accident, and the view to the switch of the Del Monte spur is unobstructed. The view of equipment on the spur is restricted by the curvature and descending grade of the spur, and by buildings and fences nearby.

View eastward from switch to Del Monte spur track (on left).
