REPORT OF THE DIRECTOR  
BUREAU OF SAFETY

ACCIDENT ON THE  
UNION PACIFIC RAILROAD

MENOKEN, KANS.

INVESTIGATION NO. 2057

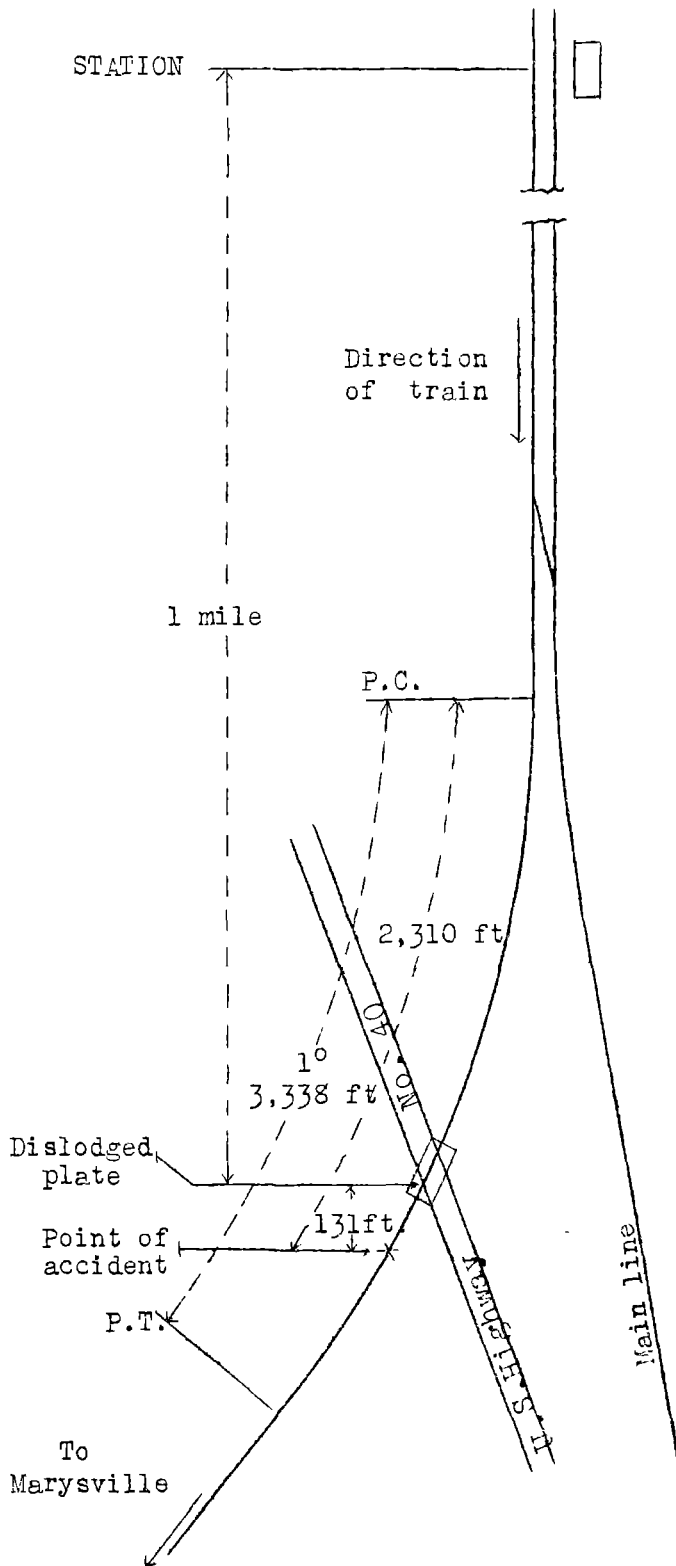
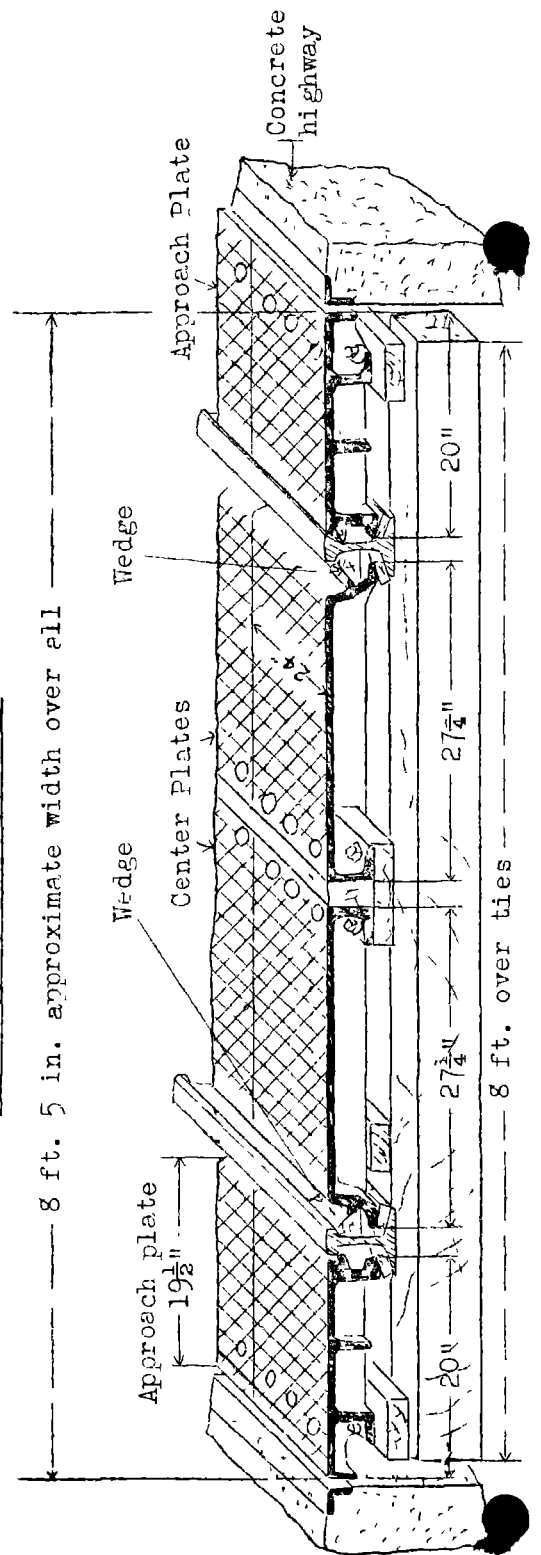
Section of Crossing Plates

U. S. Highway No. 40 crosses the tracks at an angle of 28° and the surface of the crossing is of the type known as the Universal Permanent Highway Crossing, manufactured by the Locomotive Finished Material Company of Atchison, Kans., and was installed in November, 1930, after the Kansas State Highway Commission had called the attention of the Union Pacific Railroad on September 18, 1930, to the rough condition of this crossing. Crossing plates of this type had been installed at a crossing of U. S. Highway No. 40, located about 2½ miles west of Menoken, on January 24, 1927; also at 15 additional crossings in 1929 and 4 more in 1930, the latter number including the crossing involved in this accident. This crossing surface consists of 4 rows of iron plates, with an overall width of 8 feet 5 inches and a length of 46 feet. The plates in the single row on the outside of each rail are known as approach plates, measuring 20 by 24 inches, and those between the rails are the center plates, measuring 24 by 24 inches and are 4 inches in depth. The plates are of a box-grill construction, each weighing approximately 200 pounds. Because of the automatic block-signal installation, a special

insulating strip of treated pine is used, running the full length of the crossing between the two rows of center plates. Under this strip there is a leveling strip 10 inches wide and  $1\frac{1}{2}$  inches thick, and on the gauge side of the rail there is an insulating strip which lies on the base of the rail and supports the outside edge of the middle section. An additional treated wood strip was installed under the center plates near the rail location for better support. Between the ball of the rail and the wedge lug on the outside of the middle plates are two creosoted tapered wedges, 12 inches in length, which are used as a means of tightening the plates in place on the insulating strips. The metal plates are then secured to the ties by 8-inch lag screws, there being at least one in each plate and two in every alternate plate. The lag screw holes in the center plates are located near the insulating strip in the center of the track; in the approach plates the screw holes are located near the ends of the ties. A casting flange on the approach plate fits under the ball of the rail. The ties under the crossing were creosoted, sound and in good condition, and the center plates were regular and even and the approach plates level except in the traffic lane, where the insulating or shimming strips were somewhat worn, permitting the plates to settle. At the time of this investigation a few of the lag screws were found to be slightly loose and the plates vibrated and rattled under traffic. This crossing is protected by a wig-wag signal and bell and is open to view for a long distance in either direction; there is little if any reduction in the speed of motor traffic when passing over it.

Examination of the parts of the center plate showed that the wedge lug and base had been broken prior to the accident, as the rough surfaces of the fractures had been rubbed comparatively smooth at some points, although it did not appear that the fractures existed for any great length of time before the accident; all the other pieces of the plate showed clean and more recent fractures. Examination was made of the crossing and many of the plates were removed for inspection. One of the approach plates in the traffic lane in direct line with the center plate involved was found to have several

cracks in the box grilling on the under side, but the cracks did not extend into the upper surface. Another approach plate had one deep crack in the center rib which did not extend into the upper surface. Five center plates were found to have the corners broken from the base which rests upon the wood insulating strip along the base of the rail. These breaks did not extend far enough along the base to destroy the value of the wedge lug and wedges but they decreased the supporting strength of the casting. This examination also showed that in order to lift out one of these center plates, after the wedge blocks and lag screws are removed, the plate must be lifted until the end of the plate clears the insulating strip; it is not possible to pry a plate out of position unless the wedge lug and base of the plate are broken off, for the base of the casting will not clear the under side of the ball of the rail.
