INTERSTATE COMMERCE COMMISSION
WASHINGTON

INVESTIGATION NO. 2618
THE UNION PACIFIC RAILROAD COMPANY
REPORT IN RE ACCIDENT
AT MOAPA, NEV., ON
AUGUST 20, 1942

Inv. No. 2618
 Union Pacific Railroad
 Moapa, Nev.
 August 20, 1942

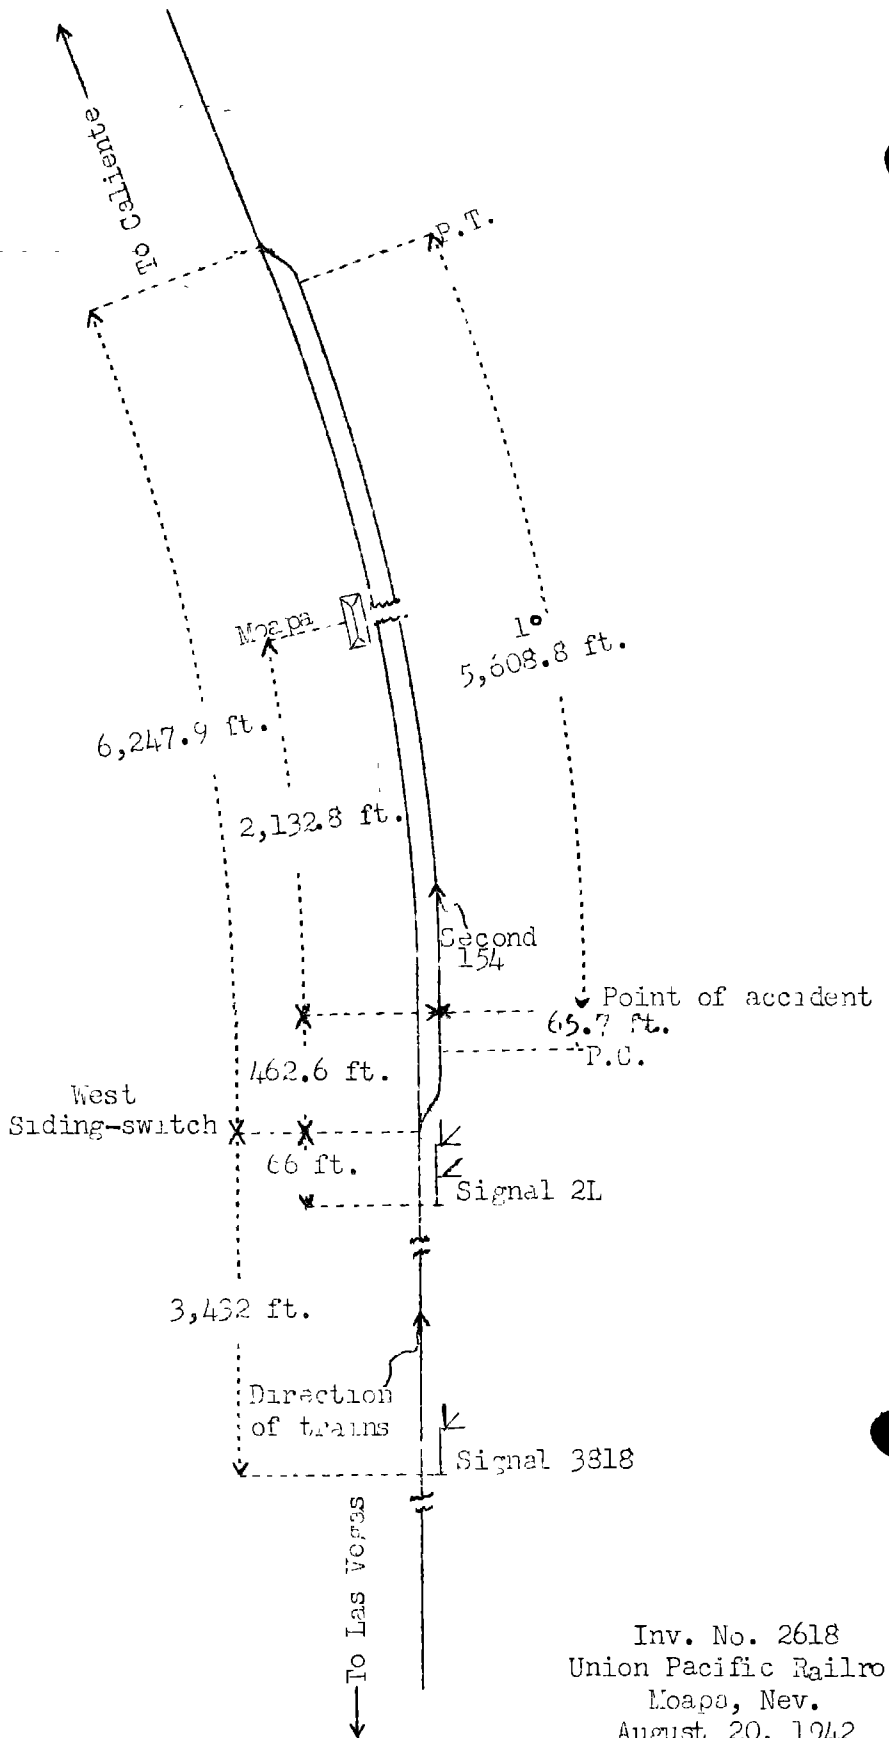
The automatic-block system is arranged on the overlap principle. Signals 3818 and 2L, which govern eastward movements, are located, respectively, 3,432 and 66.2 feet west of the west siding-switch. Signal 3818 is an automatic signal of the one-unit, three-indication, color-light type, and is approach lighted. The aspects and corresponding indications and names of this signal are as follows:

Under either remote-control or automatic operation the control circuits are so arranged that when the west siding-switch is lined for a train to enter the siding, signal 3818 will display approach and signal 2L will display red-over-yellow.

Immediately after the accident, inspection of the west siding-switch disclosed that it was lined for entry to the siding, and that the lock rod in the switch mechanism had moved sufficiently to open the circuit controlling signal 2L but not sufficiently to unlock the switch.

The operator at Moapa lined the route for Second 154 to enter the siding at the west siding-switch. This train entered the siding and cleared the insulated joint about 8:14 a. m. and stopped with the rear end standing 462 feet east of the west siding-switch. About 8:40 a. m. First 8 entered the west siding-switch and struck Second 154.
