INVESTIGATION NO. 3265
UNION PACIFIC RAILROAD COMPANY
REPORT IN RE ACCIDENT
AT MONTEBELLO, CALIF., ON
JULY 21, 1949

Accident at Montebello, Calif., on July 21, 1949, caused
by a motor-truck occupying a rail-highway grade-
crossing immediately in front of an approaching train.

Inv. No. 3265
 Union Pacific Railroad
 Montebello, Calif.
 July 21, 1949

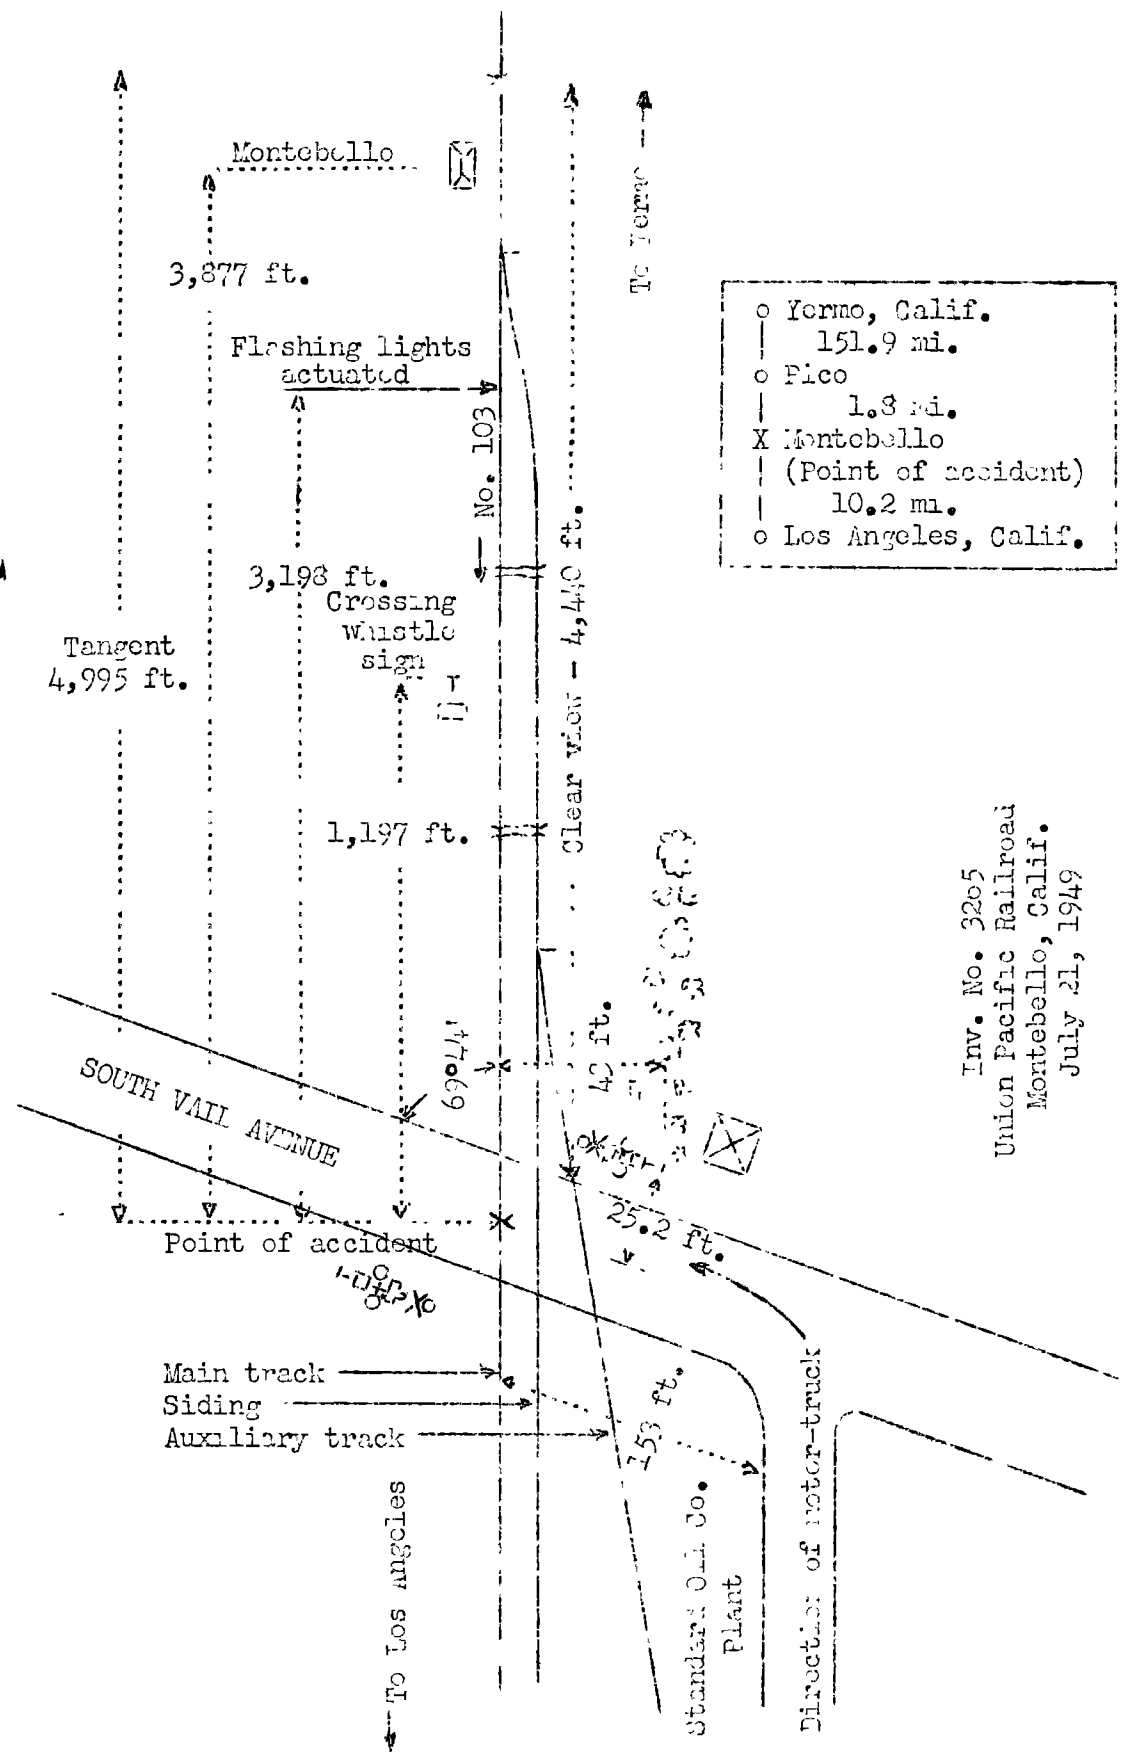
This accident occurred on that part of the California Division extending between Yermo and Los Angeles, Calif., 163.9 miles. In the vicinity of the point of accident this is a single-track line, over which trains are operated by signal indications. The accident occurred on the main track at a point 154.4 miles west of Yermo, and 3,877 feet west of the station at Montebello, where the railroad is crossed at grade by South Vail Avenue. At this point a siding parallels the main track on the south, and an auxiliary track is located south of the siding. The main track is tangent throughout a distance of 4,995 feet east of the crossing and a considerable distance westward. The grade for west-bound trains is 0.70 percent descending a distance of 2,610 feet and then is level 873 feet to the crossing. South Vail Avenue intersects the main track at an angle of 69°44', and is tangent a considerable distance on either side of the tracks. The crossing is 30 feet in width and is surfaced with asphalt-concrete to the level of the tops of the rails. Flangeways 2-1/2 inches in width are provided. The grade for north-bound vehicles is 5.4 percent ascending throughout a distance of approximately 140 feet immediately south of the center-line of the auxiliary track, 1.2 percent ascending 30 feet to the center-line of the main track, and 3 percent descending a considerable distance north of the main track. A distributing center of the Standard Oil Company is located in the southwest angle of the intersection. A driveway into this center diverges from South Vail Avenue at a point 153 feet south of the center-line of the main track.

A standard cross-buck railroad-crossing sign is located 43 feet south of the center-line of the main track and 25.2 feet east of the center-line of the highway, and bears the words "RAILROAD CROSSING" in reflectorized letters. This sign is mounted on a mast 11 feet 6 inches above the level of the highway. A sign bearing the reflectorized numeral "3" over the word "TRACKS," in reflectorized letters, is mounted immediately below the cross-buck sign. A horizontal bar 2 feet 6 inches in length is mounted on the mast 8 feet above the level of the highway. Two hooded red lights are attached back-to-back to each end of this bar. The lights for one direction are arranged to be illuminated alternately. The lights governing north-bound traffic are aligned slightly to the right to provide an indication to the driver of a vehicle entering South Vail Avenue from the Standard Oil

Company driveway. A sign bearing the words "STOP ON RED SIGNAL" is mounted on the mast below the lights. A warning bell also is mounted on the mast. A similar railroad-crossing sign is located in the northwest angle of the intersection and each flashing-light signal and the warning bell are arranged for automatic operation when a west-bound train occupies any portion of the main track throughout a distance of 3,198 feet immediately east of the crossing. A crossing-whistle sign for west-bound trains is located 1,197 feet east of the crossing.

The view of an approaching west-bound train from a north-bound vehicle on South Vail Avenue is obscured by shrubbery and several small structures until the vehicle reaches a point about 40 feet south of the main track. From this point the driver of the vehicle has an unobstructed view of the track east of the crossing throughout a distance of 4,440 feet. The driver of the motor-truck, who died about 10 hours after the accident occurred, said that after the truck entered South Vail Avenue he stopped it south of the crossing. He did not see a train approaching from either direction and drove the truck upon the crossing. When the truck reached the main track, the driving mechanism became defective. The driver thought that the momentum of the truck would carry it across the track before the train reached the crossing, but the rear end of the trailer was struck on the crossing.
