INTERSTATE COMMERCE COMMISSION  
WASHINGTON

REPORT OF THE DIRECTOR  
BUREAU OF SAFETY

ACCIDENT ON THE  
UNION PACIFIC RAILROAD

ORCHARD, COLO.

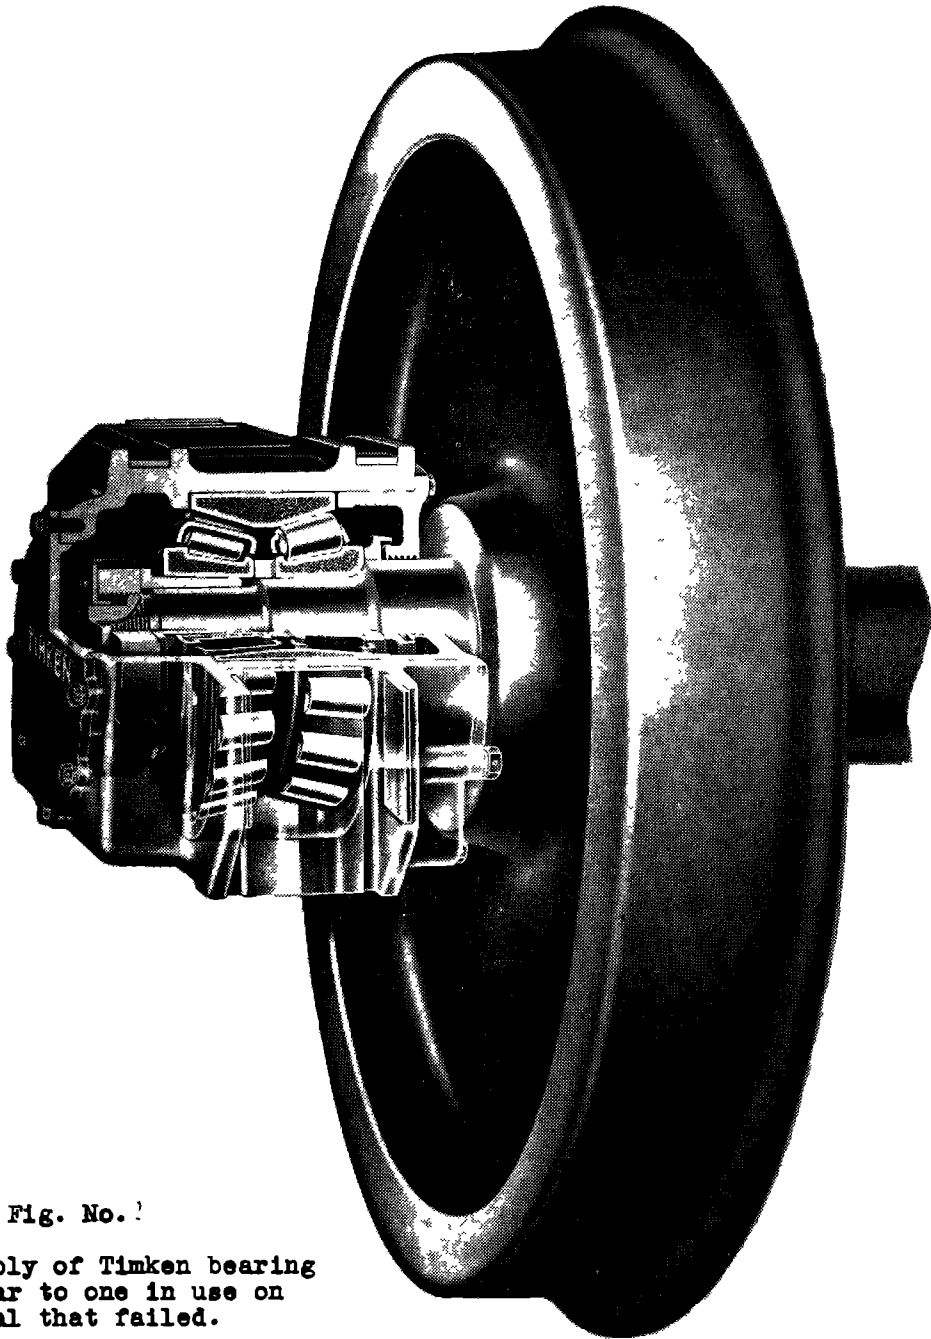
Fig. No. 1

Assembly of Timken bearing  
similar to one in use on  
journal that failed.

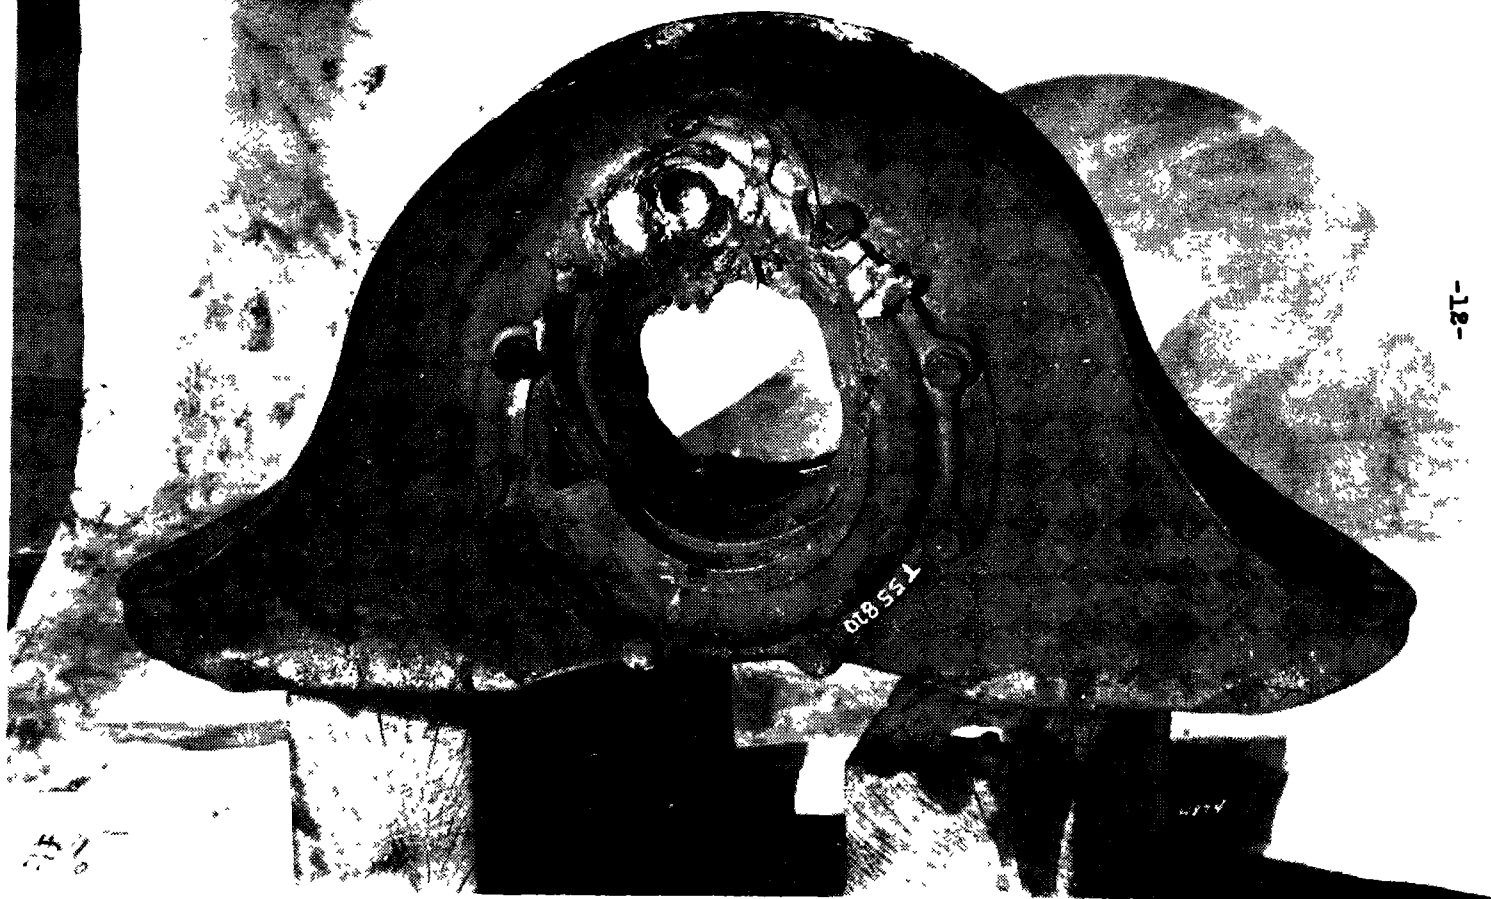
equipment and found that the enclosure plate was 1/8th of a turn out of its proper position. His record shows that this pair of wheels was turned at Denver on January 1, 1937, the boxes were assembled on January 3, and the wheels were installed in the lead position on the truck involved in the accident on January 15.

W. C. Sanders, General Manager of the Railway Division of the Timken Roller Bearing Co., stated that it is his opinion the cause of the accident was the failure of a roller in the bearing, due to a restricted circulation of oil in the box which resulted from an improperly applied rear enclosure plate. Numerous complaints have been received concerning the entrance of water through the axle fit of these plates and since water has a deteriorating effect on the bearing, it is important that rear enclosures be effective in excluding dampness from the box; for this reason this part of the box assembly has been redesigned with a view to eliminating the trouble. Careful tests of the new type of enclosure plate have been made for the purpose of determining the efficacy of the design in preventing the entrance of water and the loss of oil and these tests have shown such satisfactory results that it is the intention of the Timken Company to incorporate the new type of plate in all new installations on this type of equipment, and to replace the enclosures now in use on streamline trains of the Union Pacific railroad. Provision is made in the new design for making impossible the wrong application of the rear enclosure plate.

Fig. No. 2 -- View of back of damaged journal box.  
Pattern number appearing faintly on right  
lower edge of enclosure plate, which should  
be between the two bottom stud-bolts when  
plate is properly applied, show that plate was  
one-eighth turn out of proper alinement.

There can be little doubt but that the immediate cause of the overheating of the bearing was the failure of one or more of the rollers, but as to the cause of this there is some difference of opinion. Representatives of roller bearing company attribute the failure to lack of lubrication brought about by a misapplied rear enclosure plate; officials of the railroad company disagree with this theory and point to the fact that before failure occurred this bearing had run approximately 25,000 miles with the enclosure plate in the wrong position. Furthermore, other bearings, with misapplied enclosure plates have run the complete mileage between wheel turnings with no apparent damage to the bearing. Except for this showing of great mileage having been made with improperly applied enclosure plates, the theory of the bearing manufacturer seems reasonable. The roller

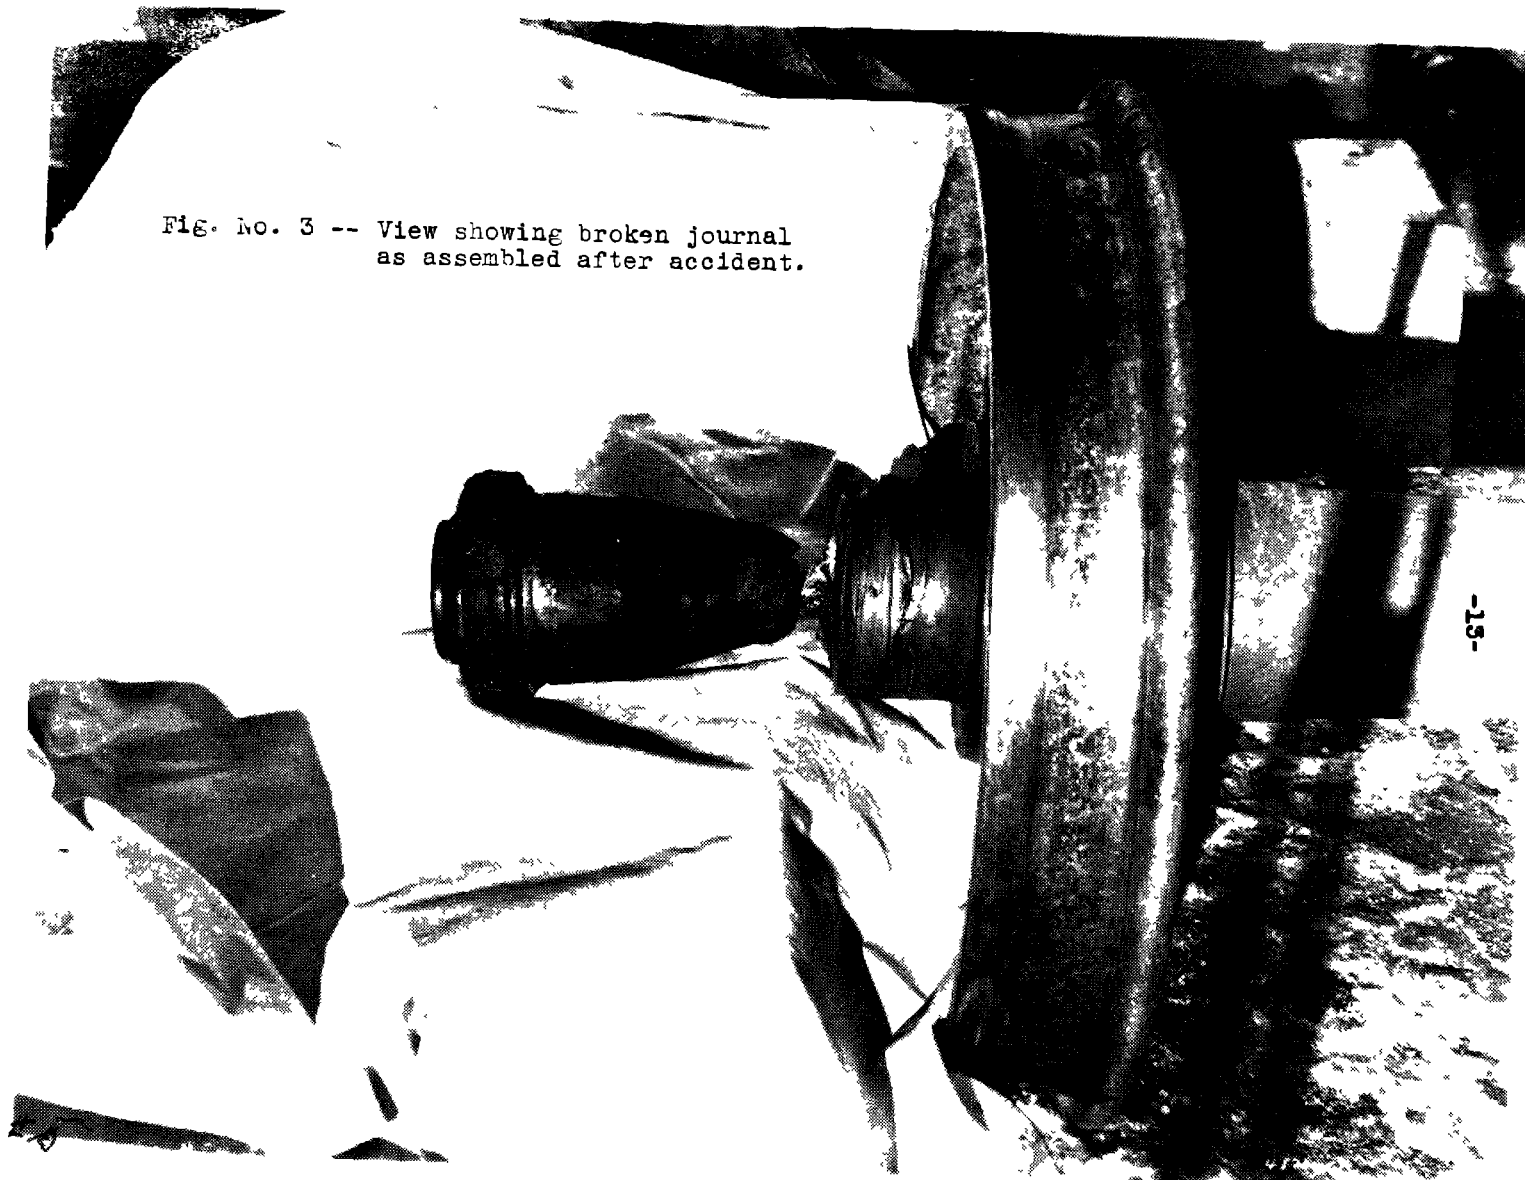
Fig. No. 3 -- View showing broken journal  
as assembled after accident.

The journal box which housed the failed bearing still contained the double cone or outer raceway and one of the inner raceways with most of its rollers, but these parts were welded to the outside upper portion of the box nearest the wheel. Just above the point where the welding of the bearing assembly had occurred, there was a deep gouge

mark, evidently made by the turning of the end of the journal against the side of the box after it had pulled out of the journal box. The upper half of the enclosure plate was missing but the lower half remained attached to the box; the lands in this portion were considerably worn.
