REPORT OF THE DIRECTOR
BUREAU OF SAFETY

ACCIDENT ON THE
UNION PACIFIC RAILROAD

RICHLAND, NEBR.

DECEMBER 20, 1939

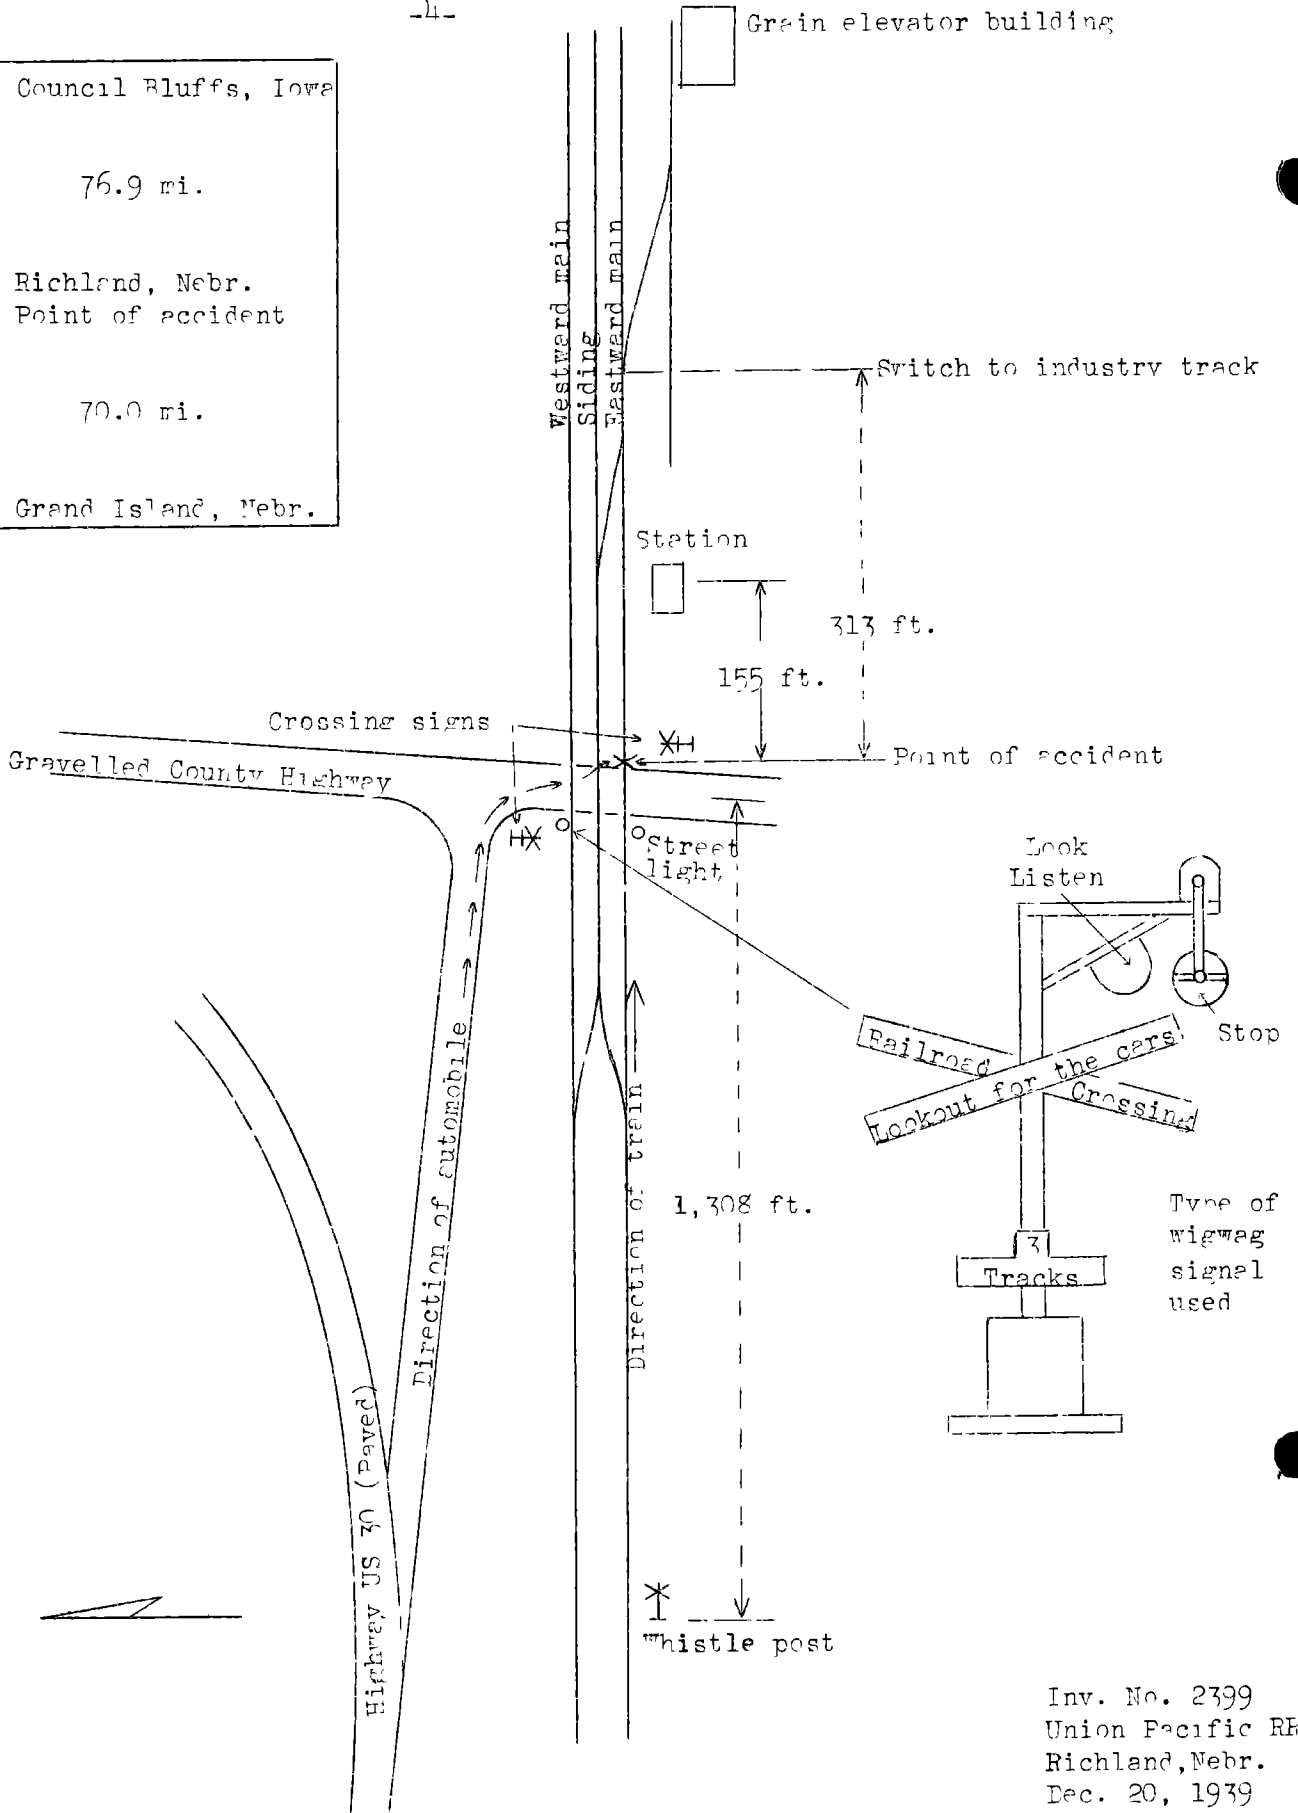
Inv. No. 2399
Union Pacific RR
Richland, Nebr.
Dec. 20, 1939

The automobile was a 1929 Chevrolet coupe and was driven by Martin D. Wilson, owner and sole occupant. It was driven eastward on the county road and made a right turn to the railroad tracks; in moving over the crossing it veered to the left or east side of the road, ran off the shoulder, became stalled between the rails of the eastward main track, and was struck by First 6.

The automobile was demolished and carried ahead of the pilot of the engine a distance of 313 feet, at which point it encountered the industry-track switch and caused such damage to the switch that the engine was diverted toward the industry track. The engine stopped on its left side, on the industry track, 726 feet east of the crossing. The tender, in reverse position, stopped 109 feet east of the engine on its left side and with its rear end fouling the eastward main track. The engine and the tender were badly damaged. The first car, and the third to seventh cars, inclusive, stopped practically at right angles across the siding and the main tracks, in upright position, except the fifth car which lay on its left side. The fourth car stopped between the tender and the first car. The second car was hurled over the engine, crashed through the northeast corner of a wooden grain-elevator building, situated south of the industry track, and stopped in upright position at an angle of 45 degrees to the industry track. All these cars were badly damaged. The eighth car and the front truck of the ninth car were derailed but remained in general line with the track. Parts of the front end of the automobile were entangled in the engine pilot, which was torn loose and stopped about 6 feet in front of the engine. The main frame of the automobile was under the fifth car of the train and about 40 feet west of the engine.

The wreckage of the automobile was carried on the pilot of the engine and, as the wreckage encountered a facing-point switch 313 feet east of the crossing, it so damaged the switch that the engine was diverted toward the turnout and became derailed.
