REPORT OF THE DIRECTOR
BUREAU OF SAFETY

ACCIDENT ON THE
UNION PACIFIC RAILROAD

RIGBY, IDAHO

JUNE 17, 1939
INVESTIGATION NO. 2364

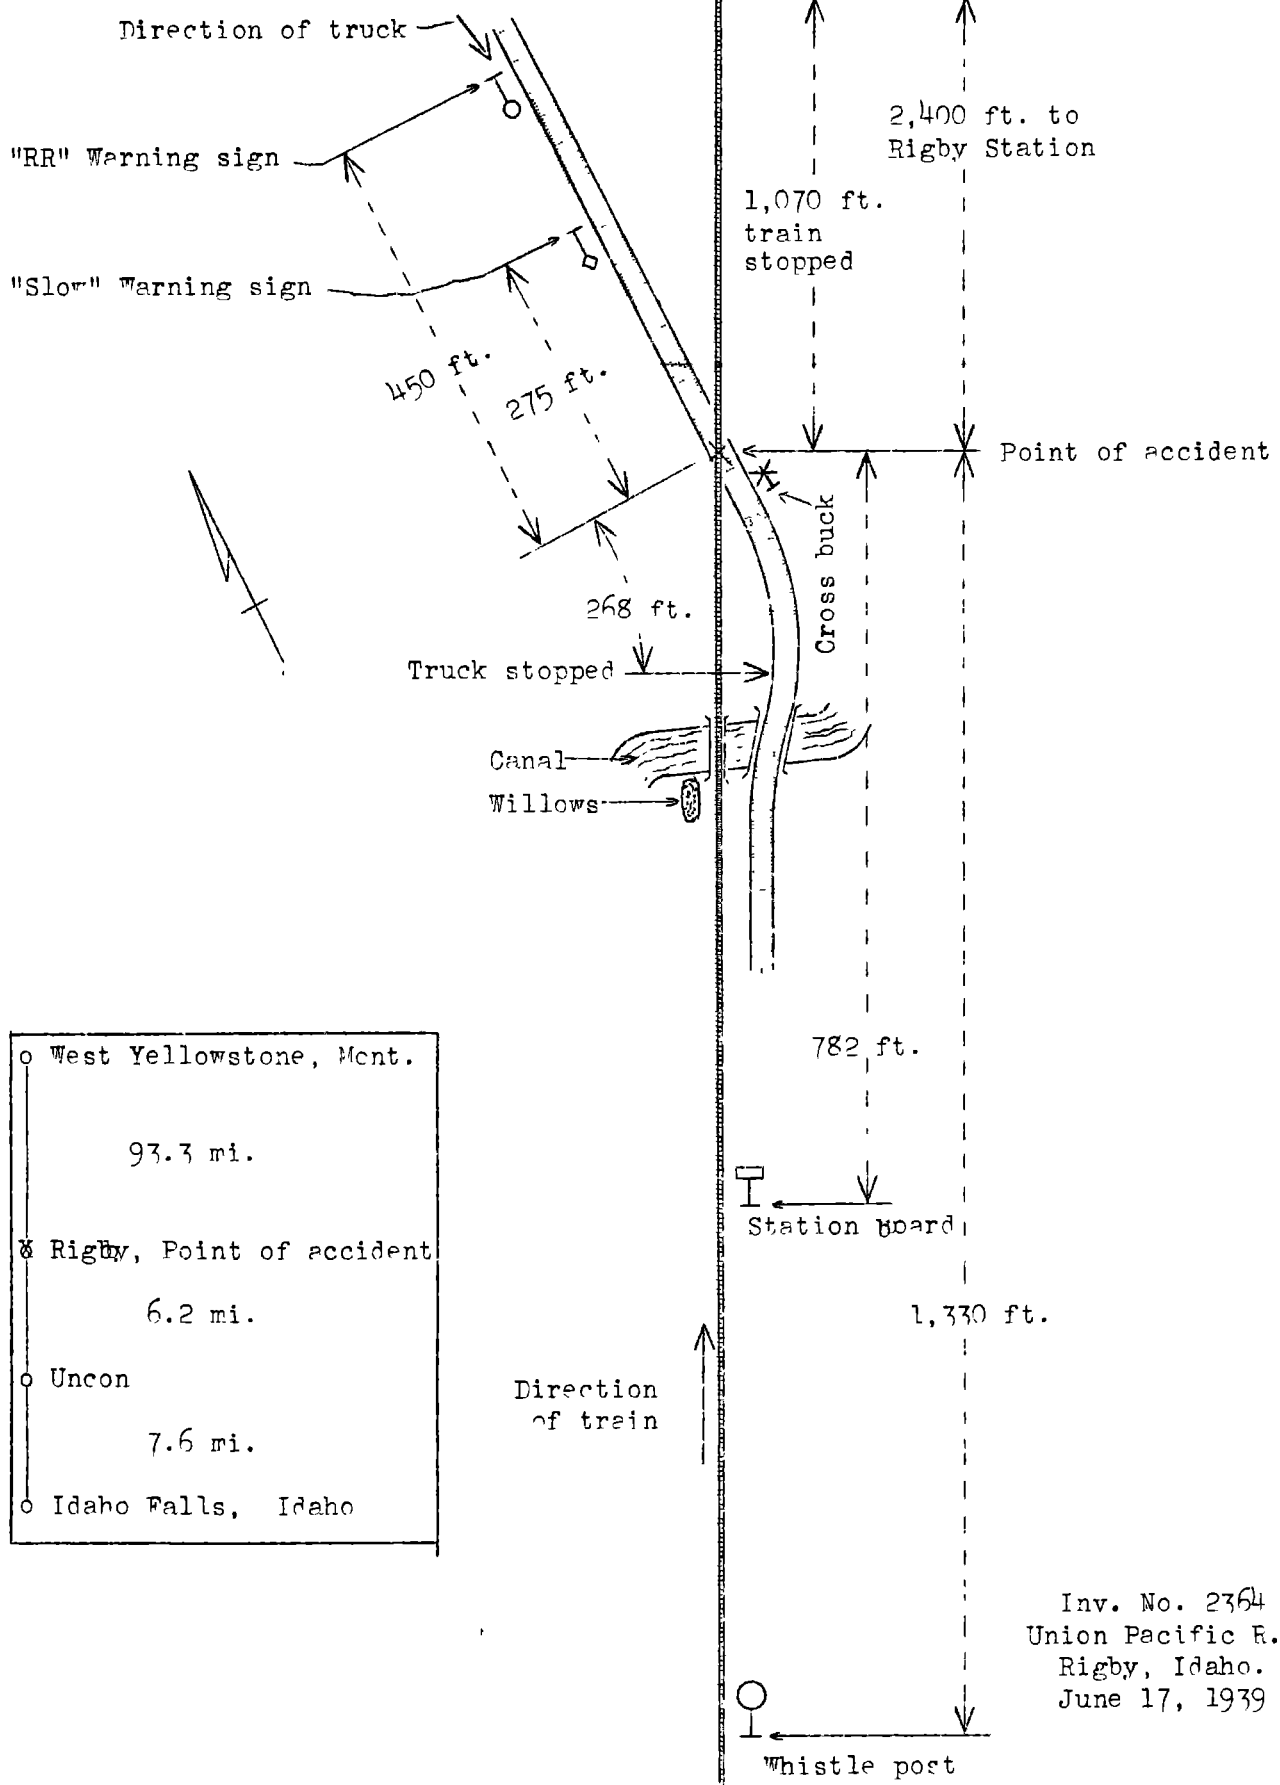
Inv. No. 2364
 Union Pacific R.R.
 Rigby, Idaho.
 June 17, 1939

The accident occurred at a point 2,400 feet southwest of the station at Rigby and 1,250 feet outside the city limits where U.S. Highway No. 191, known as "The Yellowstone Highway," crosses the line of the Union Pacific Railroad. The track at this point extends from southwest to northeast, but a train moving in a northeasterly direction is west-bound according to time-table direction. Approaching on the railroad from the southwest the track is tangent 12 miles to the point of accident and 5 miles beyond. The grade is level.

The highway, which extends north and south in the immediate vicinity of the point of accident, crosses the railroad at an angle of 30 degrees. Approaching from the north the highway is tangent a distance of 1,500 feet to the crossing and 50 feet beyond. The highway then curves to the right and parallels the railroad several miles. The grade is 1.62 percent ascending for southbound vehicles approaching the crossing. The highway is 20 feet in width, has 6-foot gravel shoulders on each side, and is oil mulched. The crossing is equipped with two 75-pound rails, 60 feet in length, which provide flangeways for the running rails. The space between these rails is well paved a distance of 40.6 feet.

The crossing is protected by a Union Pacific standard cross-buck highway-crossing warning sign, which is located on a mast 15 feet in height and bears the words "RAILROAD CROSSING." It is located in the southeast corner at a point 20 feet and 23.7 feet, respectively, from the center-lines of the railroad and the highway. Approaching from the north, there are two highway markers located on the right side of the highway; one, located

450 feet north of the railroad track, is circular and bears the letters "R R." and the other, located 275 feet north of the track, is diamond shaped and bears the word "SLOW."

The railroad track is laid on a fill 2 feet in depth and is in plain view of a driver approaching from the north. A clump of willow bushes 43 feet in length, 10 feet in width, and 8 feet in height is located 702 feet south of the point of accident and 11 feet west of the track. The view of a train from the southwest had by a driver of a south-bound vehicle when 50 feet from the crossing is restricted by these bushes to a distance of 1,070 feet; but a driver looking diagonally behind these bushes could have an unlimited view to the southwest. A station whistle-board and a crossing whistle-board are located 782 feet and 1,330 feet, respectively, southwest of the crossing.

The Commission's inspectors observed that a driver of a south-bound motor vehicle could plainly see a train approaching from the southwest a distance of 1,070 feet and a motorman of a gas-electric car approaching from the southwest could see a south-bound motor vehicle, 50 feet from the crossing, a distance of 1,300 feet.
