REPORT NO. 3540
UNION PACIFIC RAILROAD COMPANY
IN RE ACCIDENT
AT SPENCER, IDAHO, ON
SEPTEMBER 19, 1953

Accident at Spencer, Idaho, on September 19, 1953, caused
by a motor-truck occupying a rail-highway grade
crossing immediately in front of an approaching engine
with cars.

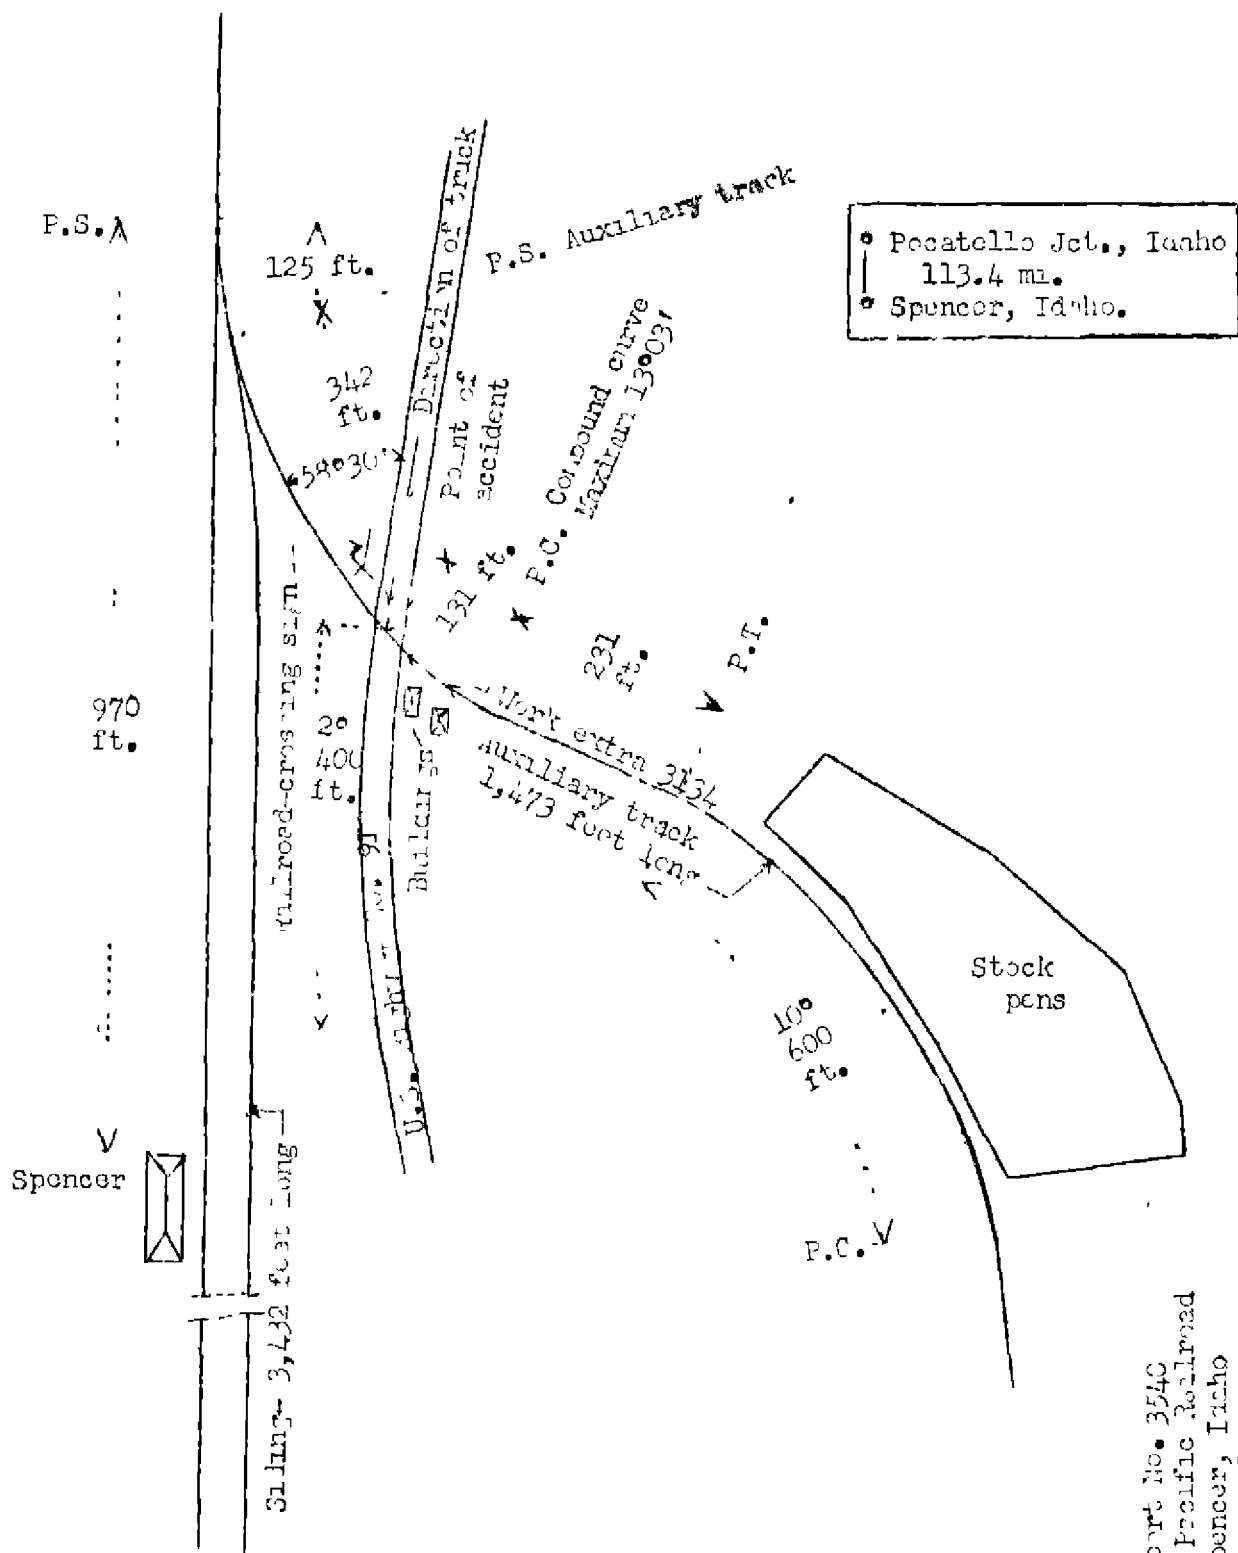
Report No. 354C
Union Pacific Railroad
Spencer, Idaho
September 19, 1953

This accident occurred on that part of the Idaho Division extending between Spencer and Pocatello Jct., Idaho, 113.4 miles. In the vicinity of the point of accident this is a single-track line, over which trains are operated by timetable, train orders and an automatic block-signal system. At Spencer, 113.4 miles west of Pocatello Jct., a siding 3,432 feet in length parallels the main track on the south. The railroad at this point extends approximately north and south. Timetable directions on the railroad are east and west, and are used in this report. The east siding-switch at Spencer is located 970 feet east of the station. An auxiliary track 1,473 feet in length extends in a generally southwesterly direction from the siding to stock pens and loading chutes located south of U. S. Highway No. 91. The switch of the auxiliary track is located in the siding at a point 125 feet west of the east siding-switch. It is trailing-point for east-bound movements. The accident occurred on the auxiliary track at a point 342 feet west of the switch, where this track is crossed at grade by U. S. Highway No. 91. The main track is tangent in the vicinity of the east siding-switch. From the west on the auxiliary track there are, in succession, a 10° curve to the left 600 feet in length, a tangent 231 feet and a compound curve to the right, having a maximum curvature of $13^{\circ}03'$, 131 feet to the point of accident and 342 feet eastward to the siding. The grade for east-bound movements on the auxiliary track is, successively, 2.0 percent descending from the end of the track to the crossing, a vertical curve over the crossing at the point where the accident occurred and then 1.0 percent ascending 300 feet to the siding.

U. S. Highway No. 91 intersects the auxiliary track at an angle of $58^{\circ}30'$. This highway is 20 feet wide and is surfaced with bituminous material. The crossing is surfaced with bituminous material to the level of the tops of the rails. The highway is tangent throughout a distance of 915 feet immediately east of the crossing and then there is a 2° curve to the left which extends westward from that point a distance of approximately 400 feet. The grade for west-bound vehicles approaching the crossing is, successively, 3.50 percent descending a distance of 700 feet, 1.0 percent ascending 200 feet and practically level over the crossing.

A standard cross-buck railroad-crossing sign is located to the right of the direction of west-bound highway traffic, 22 feet north of the center-line of the highway and 13 feet 6 inches south of the center-line of the auxiliary track. It bears the words "RAILROAD CROSSING" in black on a white background.
