REPORT NO. 3475
UNION PACIFIC RAILROAD COMPANY
IN RE ACCIDENT
AT WAMSUTTER, WYO., ON
JULY 6, 1952

Accident at Wamsutter, Wyo., on July 6, 1952, caused by a broken journal, and by derailed cars obstructing an adjacent main track in front of an approaching train.

Report No. 3475
 Union Pacific Railroad
 Wamsutter, Wyo.
 July 6, 1952

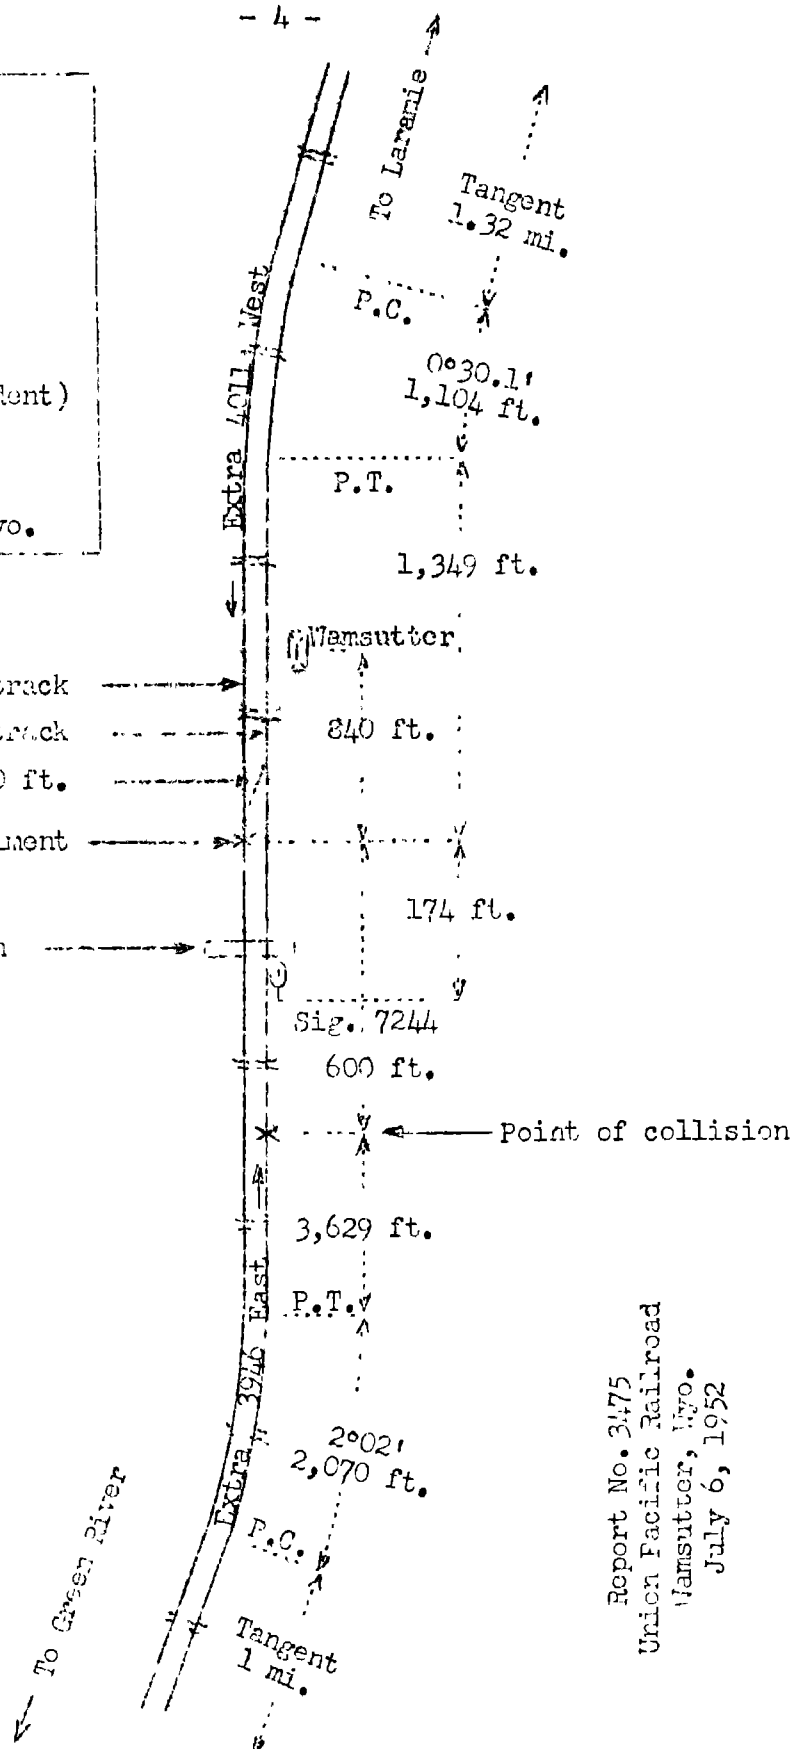
Westward main track
 Eastward main track
 Crossover - 240 ft.
 Point of derailment
 Coaling station
