INVESTIGATION NO. 3164  
UNION PACIFIC RAILROAD COMPANY  
REPORT IN RE ACCIDENT  
NEAR WATERLOO, NEBR., ON  
FEBRUARY 10, 1948

Inv. No. 3164  
 Union Pacific Railroad  
 Waterloo, Nebr.  
 February 10, 1948

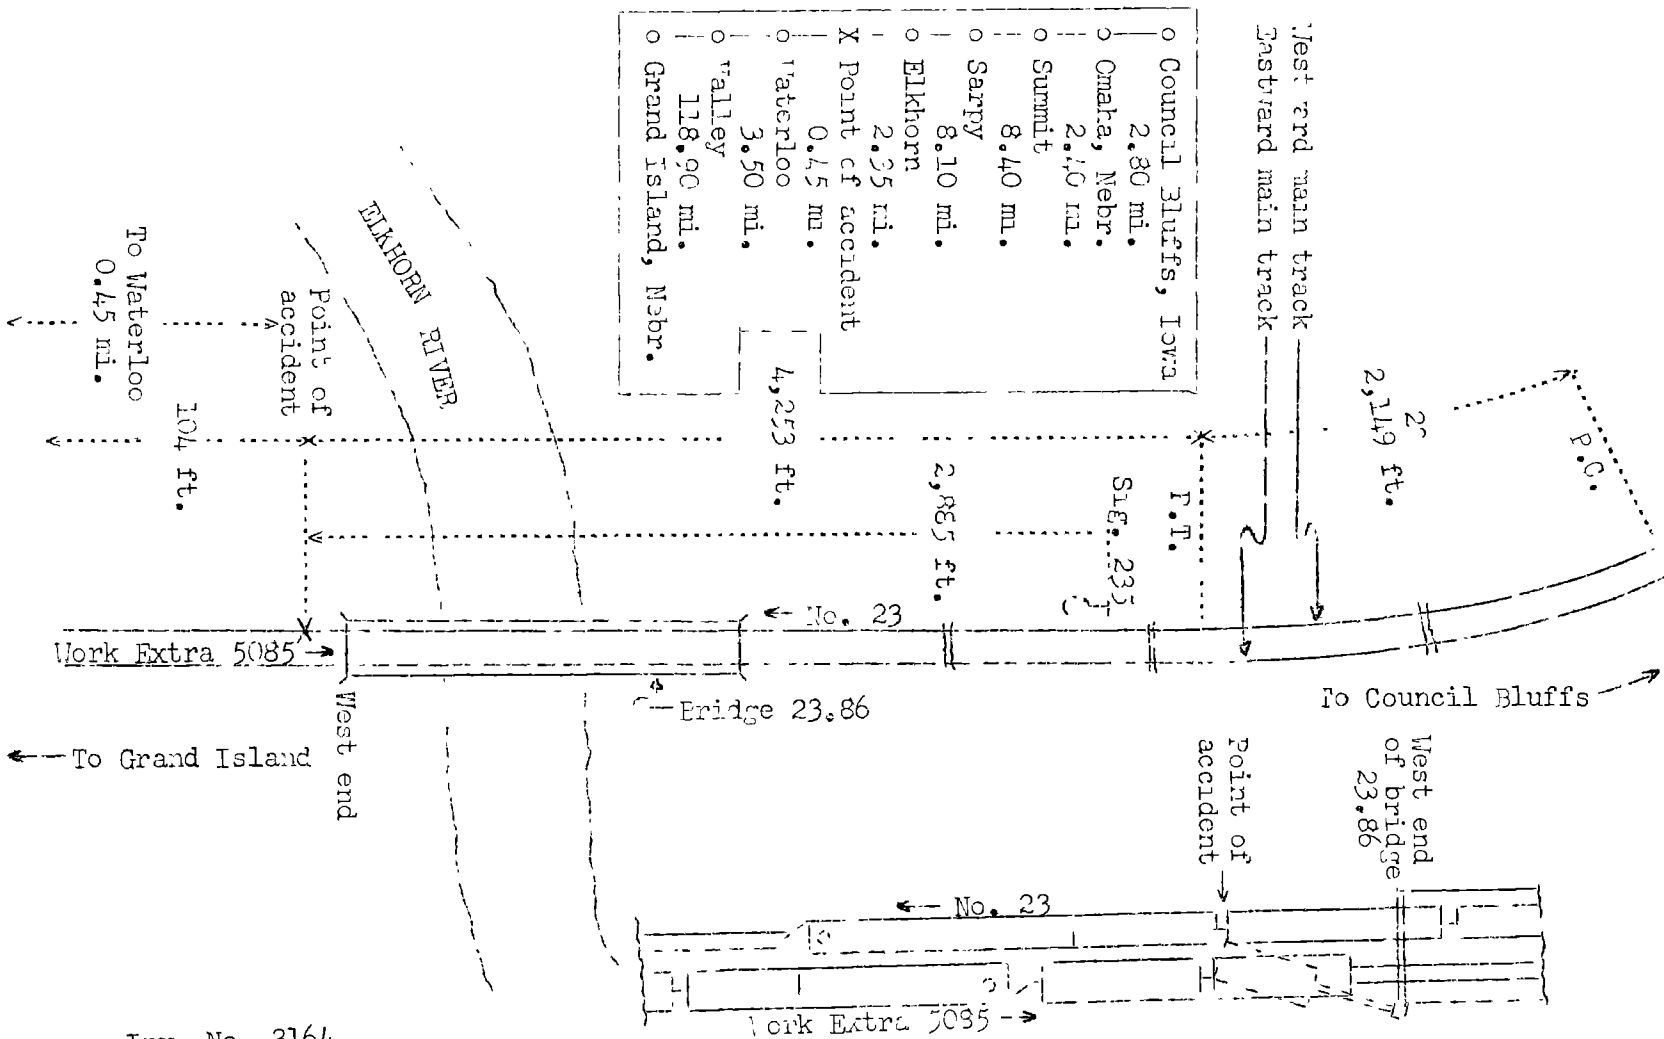
Sketch showing position of pile driver at time of the accident

The north side of the rotating portion of the pile driver was crushed inward throughout a distance of about 8 feet at the rear end. The frame of the rotating portion, the boiler and the leader of the pile driver were badly damaged. None of the equipment of either train was derailed. No. 23 stopped with the front of the engine 121 feet west of the point of accident. The left side of the engine was somewhat damaged.

The investigation disclosed that at the time of the accident Work Extra 5085 was engaged in driving piling at Bridge 23.86. During certain operations of the pile driver the rotating portion fouled the adjacent main track. Because of this condition, train-order instructions were issued requiring all trains to approach this bridge prepared to stop and, unless proceed signals were given with a yellow flag or a yellow light, all trains were required to stop before entering upon the bridge. A temporary slow-speed signal governing movement of west-bound trains on the westward main track was located on the north side of the track at a point 1.12 miles east of the bridge. This signal consisted of a yellow flag on a mast, and its indication required the speed of west-bound trains to be reduced to not exceeding 10 miles per hour at a point 1 mile westward. At the time of the accident Work Extra 5085 was standing at the west end of the bridge. The rotating portion of the pile driver was at an angle of about 18 degrees to the track, and it fouled the westward main track. The operator of the controlling mechanism was preparing to operate the pile driver to position to clear the westward main track when the rotating portion was struck by No. 23.
