**RAILROAD ACCIDENT INVESTIGATION**

**Report No 4039**

UNION PACIFIC RAILROAD COMPANY

RAWLINS, WYO

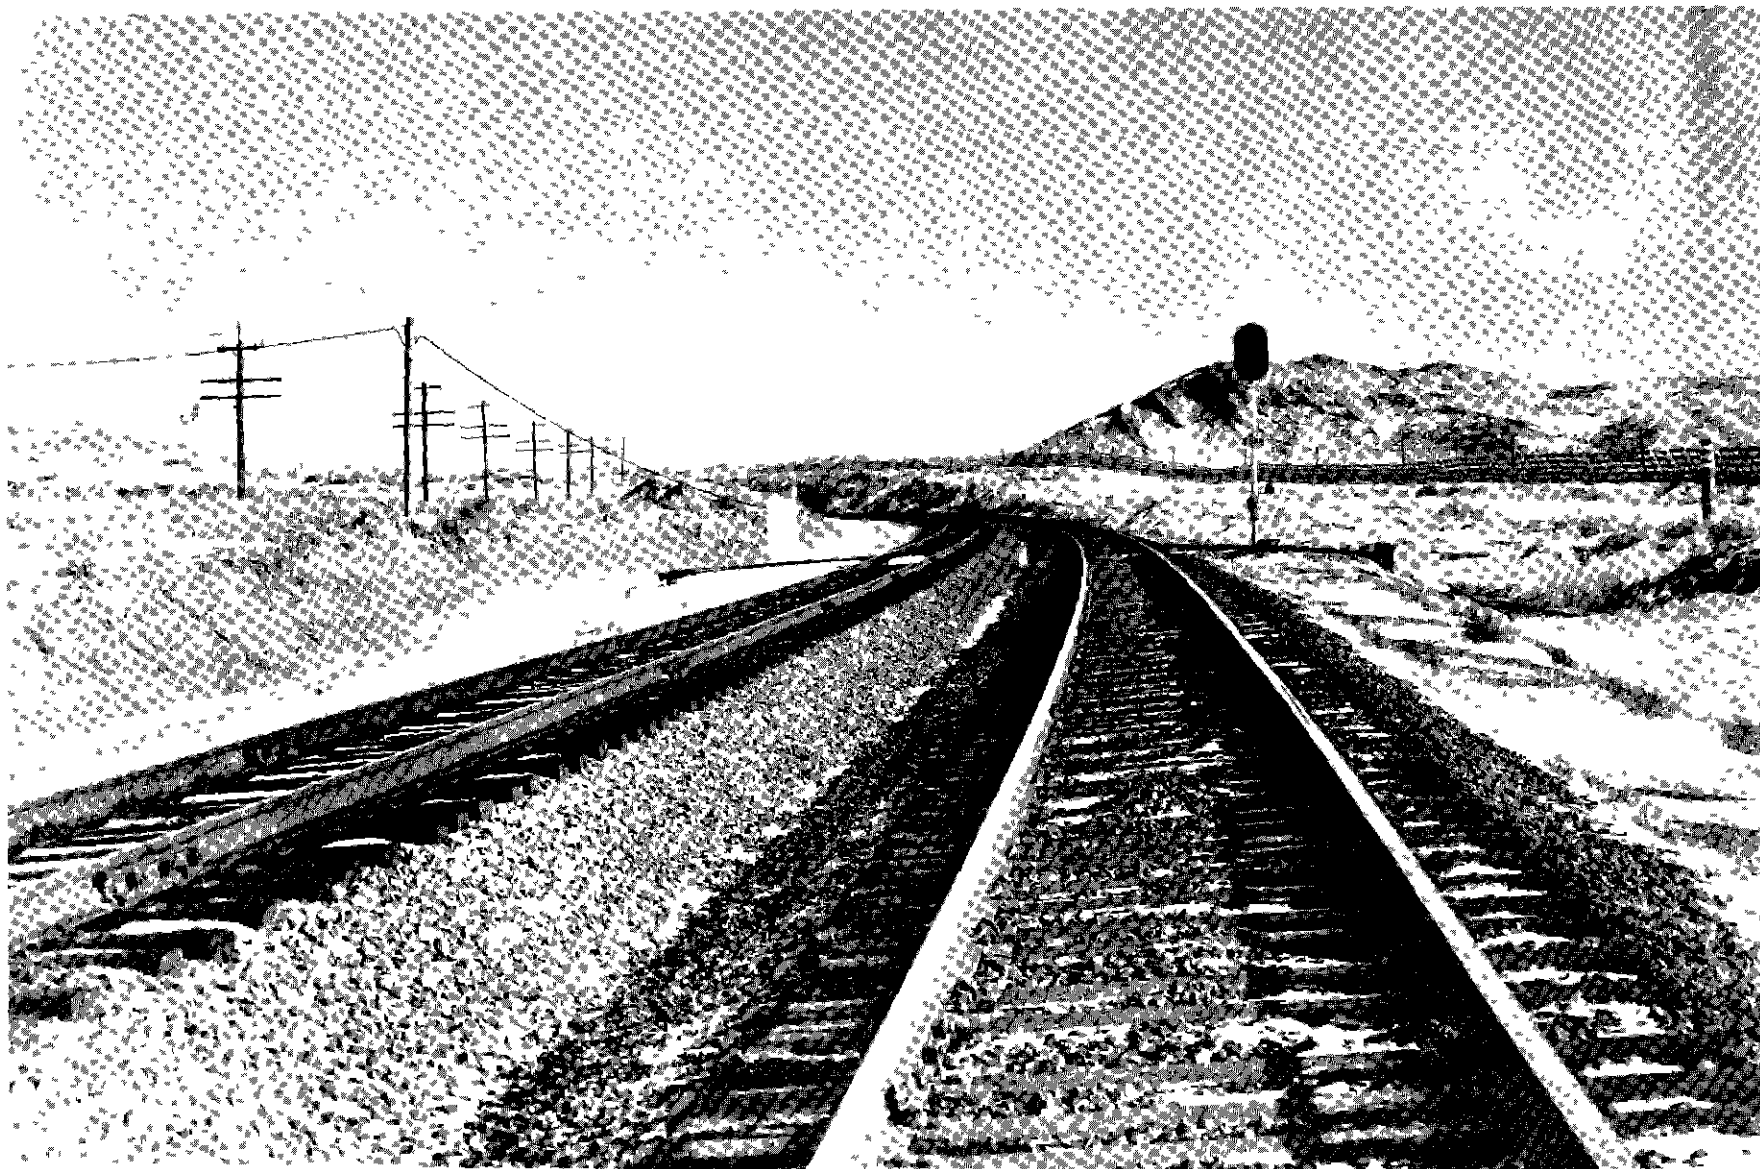
The initial point of collision was on the eastward main track 4.3 miles west of Rawlins. A second and third collision occurred on the eastward main track, 2,046 and 2,058 feet east of the first collision.

In the accident area, the main tracks are in a cut with walls about 33 feet high. Because of this cut and track curvature, the view between track cars at the second and third collision points and an approaching eastbound train is materially restricted. The view between a track car at the first collision point and an approaching eastbound train is partially restricted because of track curvature, cuts, and rolling terrain.

*Eastward main track and signal 6868 at right First collision occurred on eastward main track 175 feet east of signal 6868 Second and third collision occurred in cut and curve farther eastward*
