INVESTIGATION NO. 3260
UNION RAILROAD COMPANY
REPORT IN RE ACCIDENT
AT BESSEMER, PA., ON
JUNE 17, 1949

Date: June 17, 1949

Location: Bessemer, Pa.

Kind of accident: Head-end collision

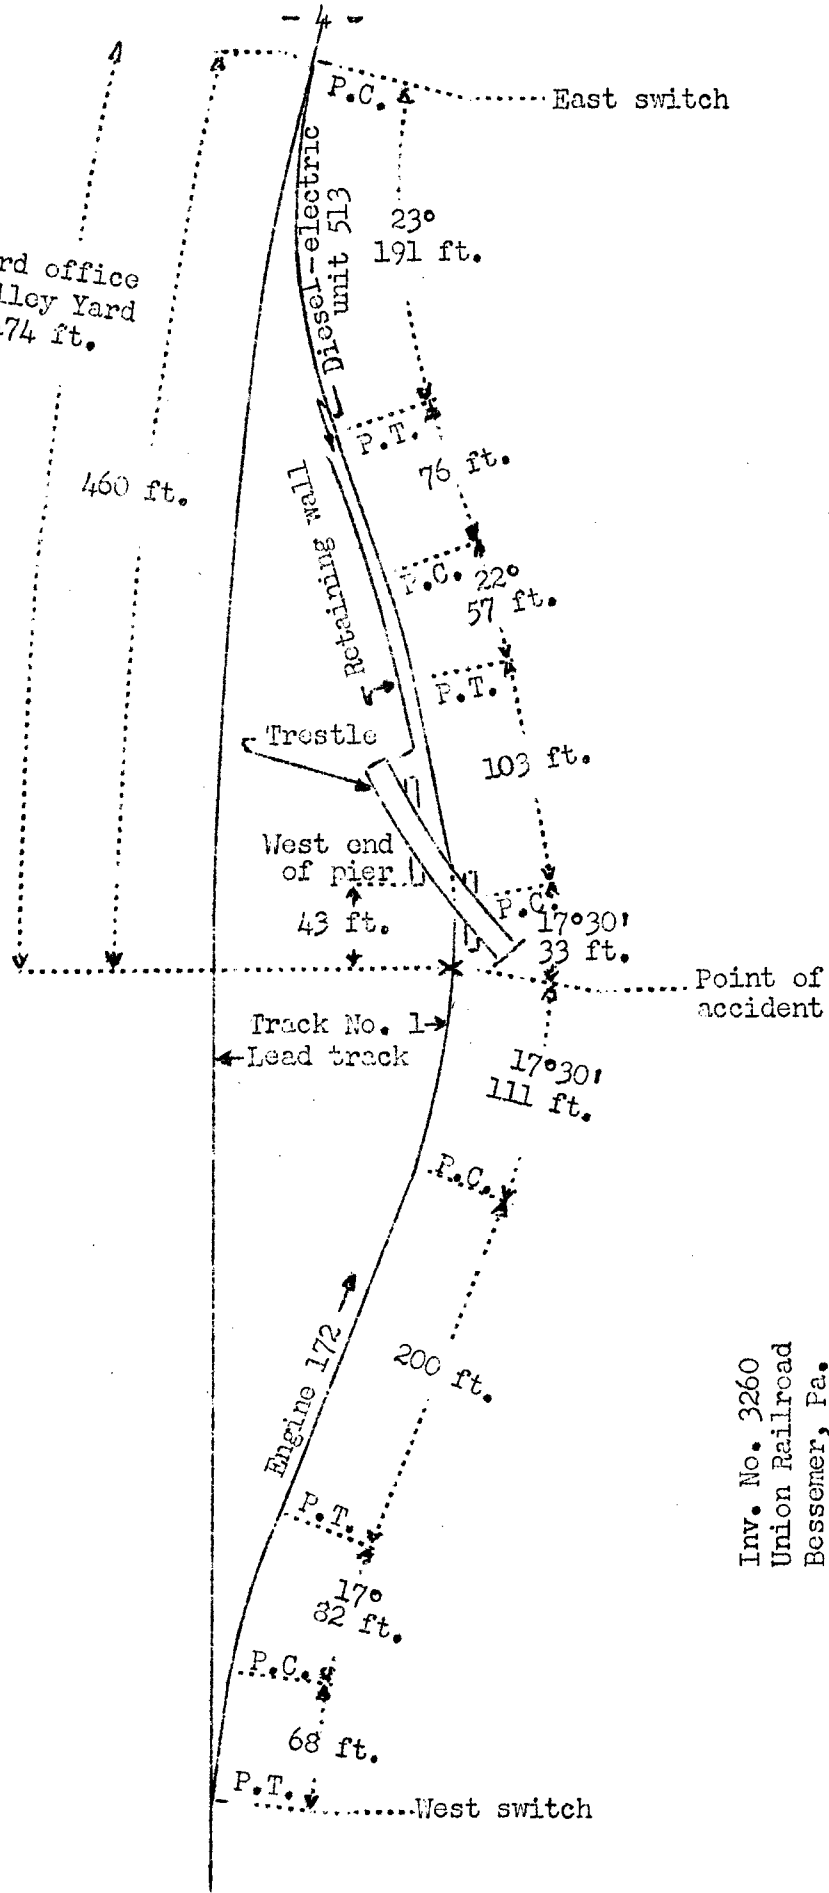
Inv. No. 3260
Union Railroad
Bessemer, Pa.
June 17, 1949

This accident occurred in the Valley Yard of the Union Railroad and the Carnegie-Illinois Steel Corporation at Bessemer. Train and engine movements in Valley Yard are under the jurisdiction of the Union Railroad, and are governed by the operating rules of this carrier. The track on which the accident occurred, hereinafter referred to as track No. 1, is 921 feet in length and at the point of accident is about 125 feet south of a lead track which extends westward from Valley Yard. Track No. 1 is connected at each end to the lead track. The east and the west switches of track No. 1 are located, respectively, 2,014 feet and 2,924 feet west of the yard office at Valley Yard. The accident occurred 460 feet west of the east switch. From the east there are, in succession, a 23° curve to the left 191 feet in length, a tangent 76 feet, a 22° curve to the right 57 feet, a tangent 103 feet, and a 17°30' curve to the right extending 33 feet to the point of accident and 111 feet westward. From the west there are, in succession, a tangent 68 feet in length, a 17° curve to the right 82 feet, a tangent 200 feet, and the curve on which the accident occurred. From the east the grade varies between 0.07 percent and 0.80 percent ascending westward a distance of 321 feet, then it is 0.51 percent descending 100 feet, and 1.96 percent ascending 39 feet to the point of accident. From the west the grade is 0.42 percent ascending eastward a distance of 100 feet, then it varies between 1.96 percent and 2.74 percent descending 361 feet to the point of accident.

The range of vision between opposing movements in the immediate vicinity of the point of accident is restricted by a pier, which supports an overhead trestle, and by a concrete retaining wall 24 feet high. The west end of the pier is 43 feet east of the point of accident. This pier, which is 25.5 feet in length, is parallel to track No. 1 and about 8 feet north of the center-line of the track. East of this pier, the concrete retaining wall parallels track No. 1 on the north at a distance varying between 8.19 feet and 11.27 feet from the center-line of the track. These structures restrict the view of an opposing movement from the north side of the cab of an engine approaching from either direction to a distance of about 200 feet. Because of track curvature, an opposing movement cannot be seen from the south side of the cab of an engine.
