-----  
REPORT NO. 1954

Railroad: Union Terminal Company  
Date: December 17, 1934  
Location: Dallas, Tex.  
Kind of accident: Rear-end collision  
Trains involved: Yard transfer and freight  
Casualties: 2 employees injured  
Cause: Engineman failed to operate under  
proper control within yard limits.

REPORT OF THE DIRECTOR OF THE BUREAU OF SAFETY CONCERNING AN  
ACCIDENT ON THE TRACKS OF THE UNION TERMINAL COMPANY AT  
DALLAS, TEX., ON DECEMBER 17, 1934.

February 26, 1935.

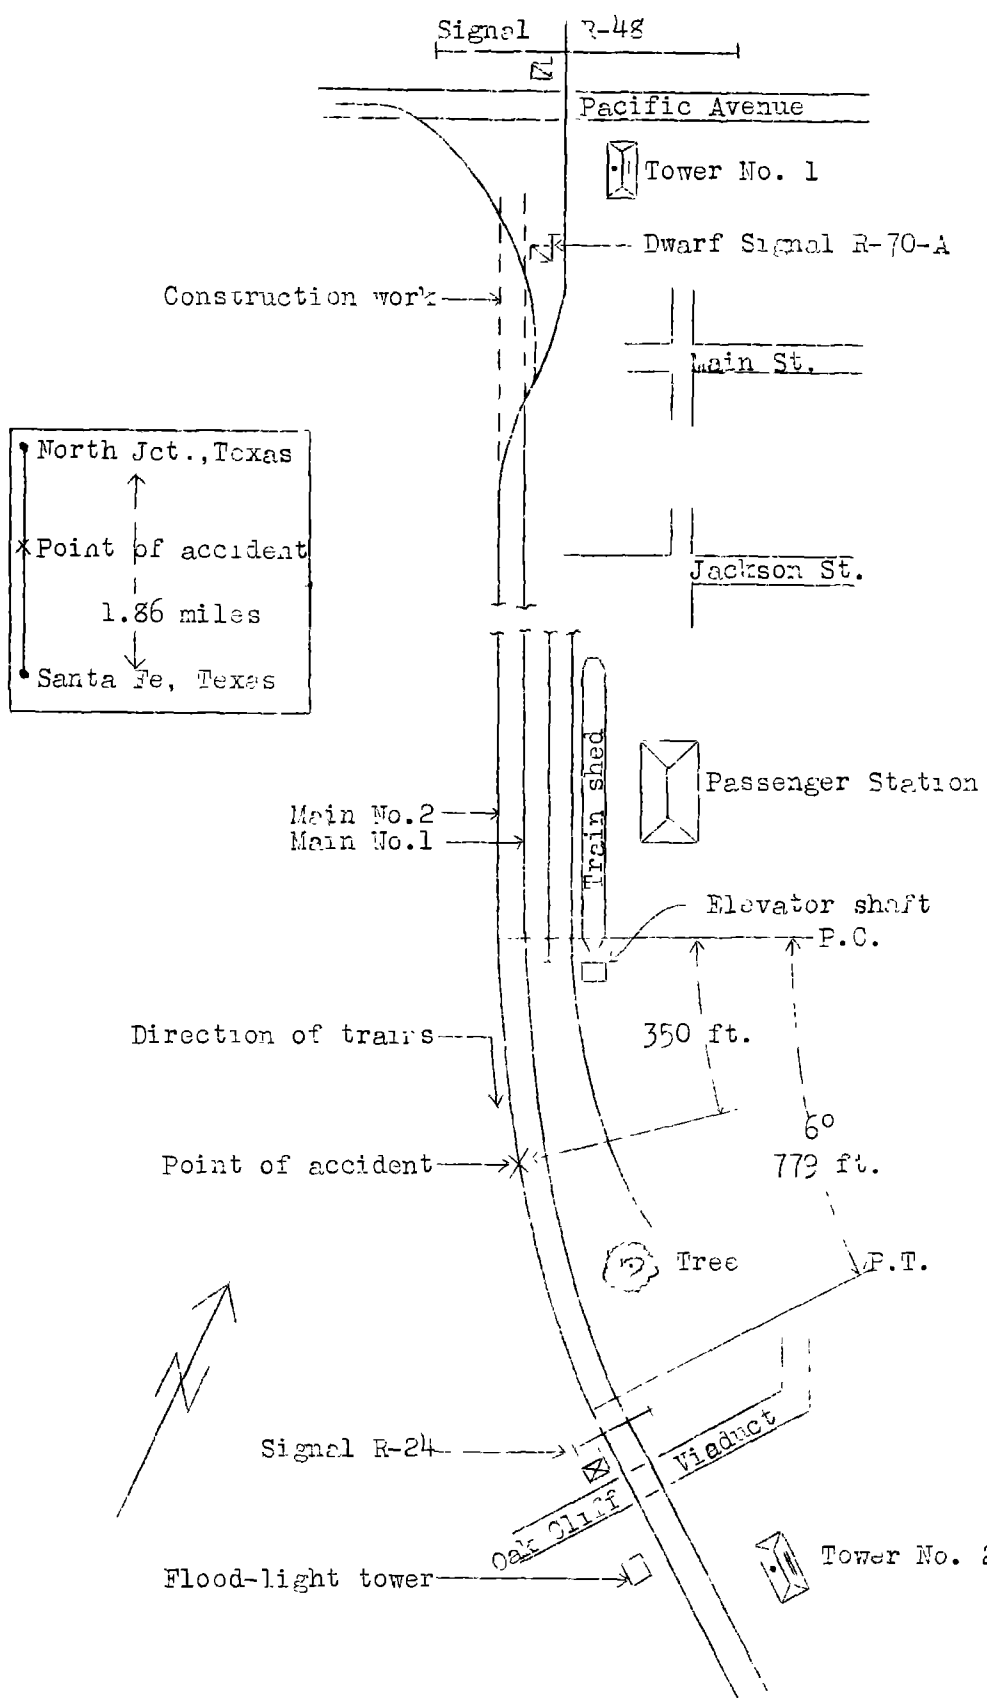
Inv. No. 1954  
 Union Terminal Co.,  
 Dallas, Texas  
 Dec. 17, 1934

Tower 1 is located east of the tracks and immediately south of Pacific Avenue, while Tower 2 is located 3,035 feet farther south, on the same side of the tracks. The signals involved are signals R-48 and dwarf signal R-70-A, located 2,376 and 1,933 feet, respectively, north of the point of accident, and signal R-24, located 469 feet south of the point of accident and 335 feet north of Tower 2. Signal R-48 is mounted on a signal bridge and both this signal and dwarf signal R-70-A are 2-position, upper-quadrant signals, displaying either stop or caution; signal R-24, mounted on a signal bridge, is a 3-position, upper-quadrant signal, displaying stop, caution or proceed indications. All signals except dwarf signals are semiautomatic; signal R-48

and dwarf signal R-70-A are operated from Tower 1, while signal R-24 is operated from Tower 2. Signal R-48 governs movements either into the station or as far as dwarf signal R-70-A, which in turn governs movements as far as signal R-24.
