INVESTIGATION NO. 2903
THE UNION TERMINAL COMPANY
REPORT IN RE ACCIDENT
AT DALLAS, TEX., ON
JUNE 21, 1945

Railroad: The Union Terminal Company
Date: June 21, 1945
Location: Dallas, Tex.
Kind of accident: Rear-end collision
Trains involved: M.K.T.T. yard : St.L.S.F.& T.
engine and cars : freight train
Train numbers: : Extra 1039 South
Engine numbers: 18 : 1039
Consist: 6 cars : 5 cars, caboose
Estimated speed: Standing : 8 m. p. h.
Operation: Signal indications
Track: Double; 5⁰54' curve; 0.33 percent
descending grade southward
Weather: Clear
Time: 6:03 p. m.
Casualties: 1 killed; 3 injured
Cause: Failure properly to control speed
of following train in accordance
with signal indication

August 8, 1945.

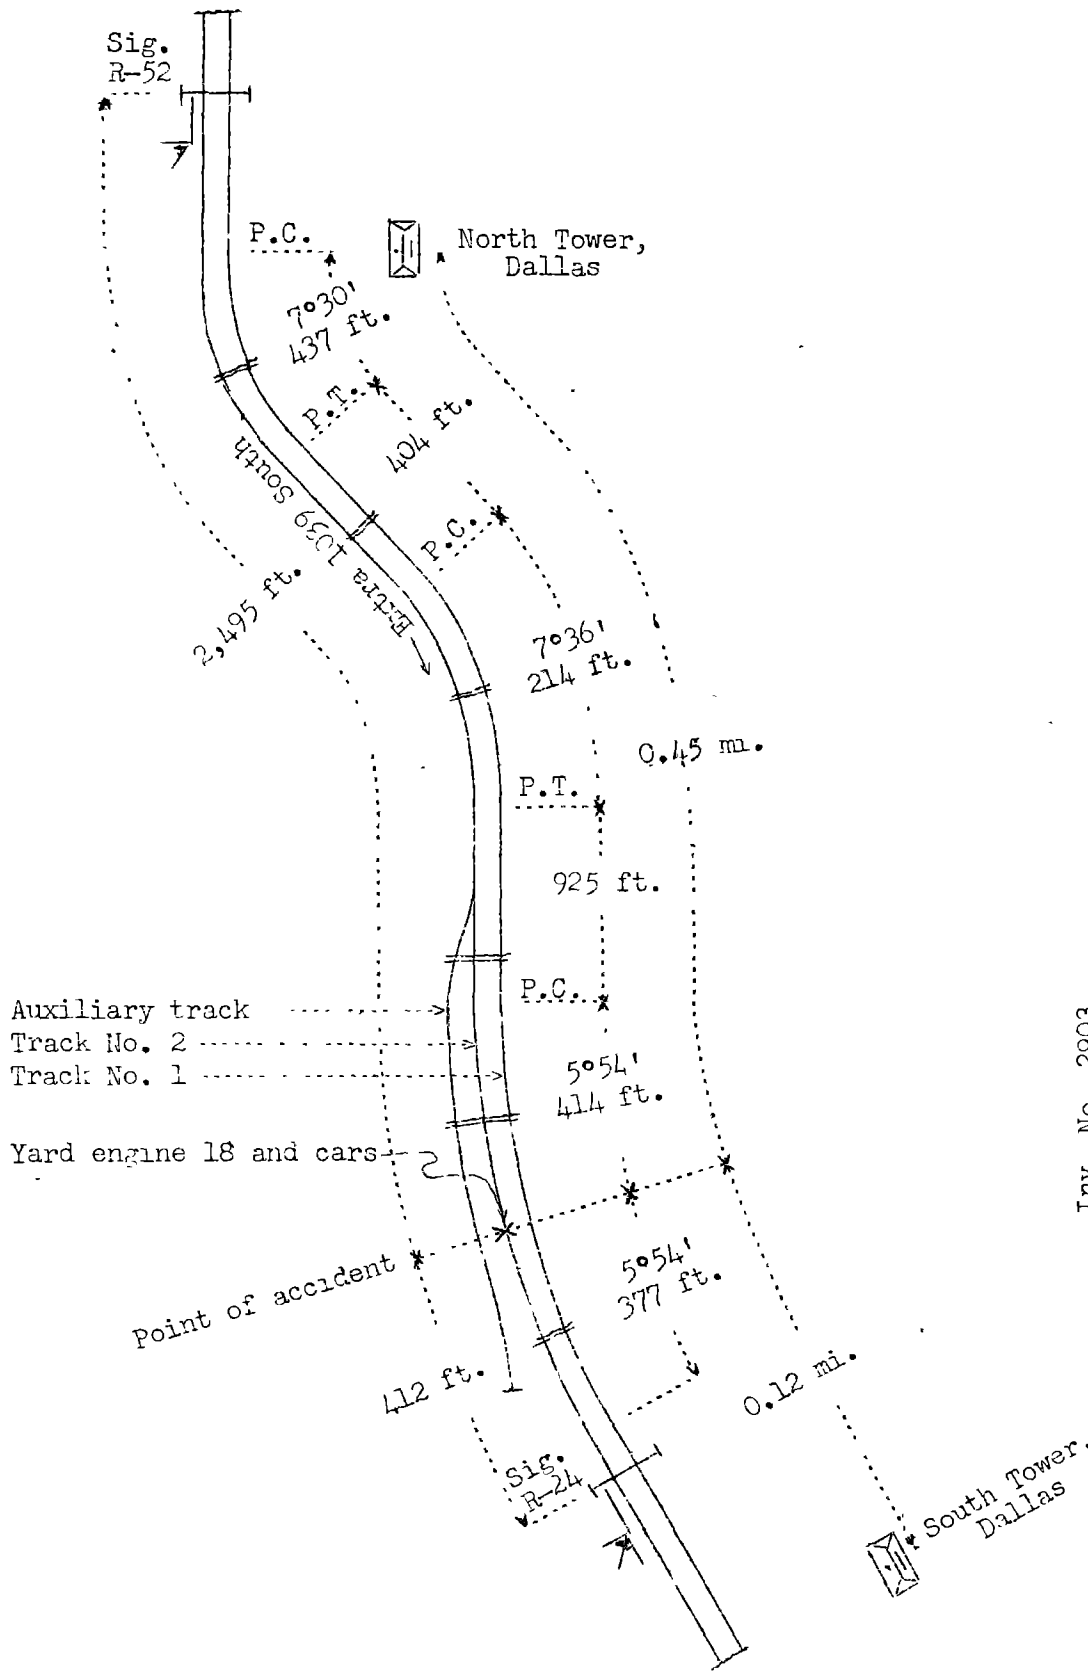
Inv. No. 2903
Union Terminal Company
Dallas, Tex.
June 21, 1945

South Tower,
Dallas
