RAILROAD ACCIDENT INVESTIGATION

Report No 3816

GIBSON CITY, ILL

AUGUST 11, 1958

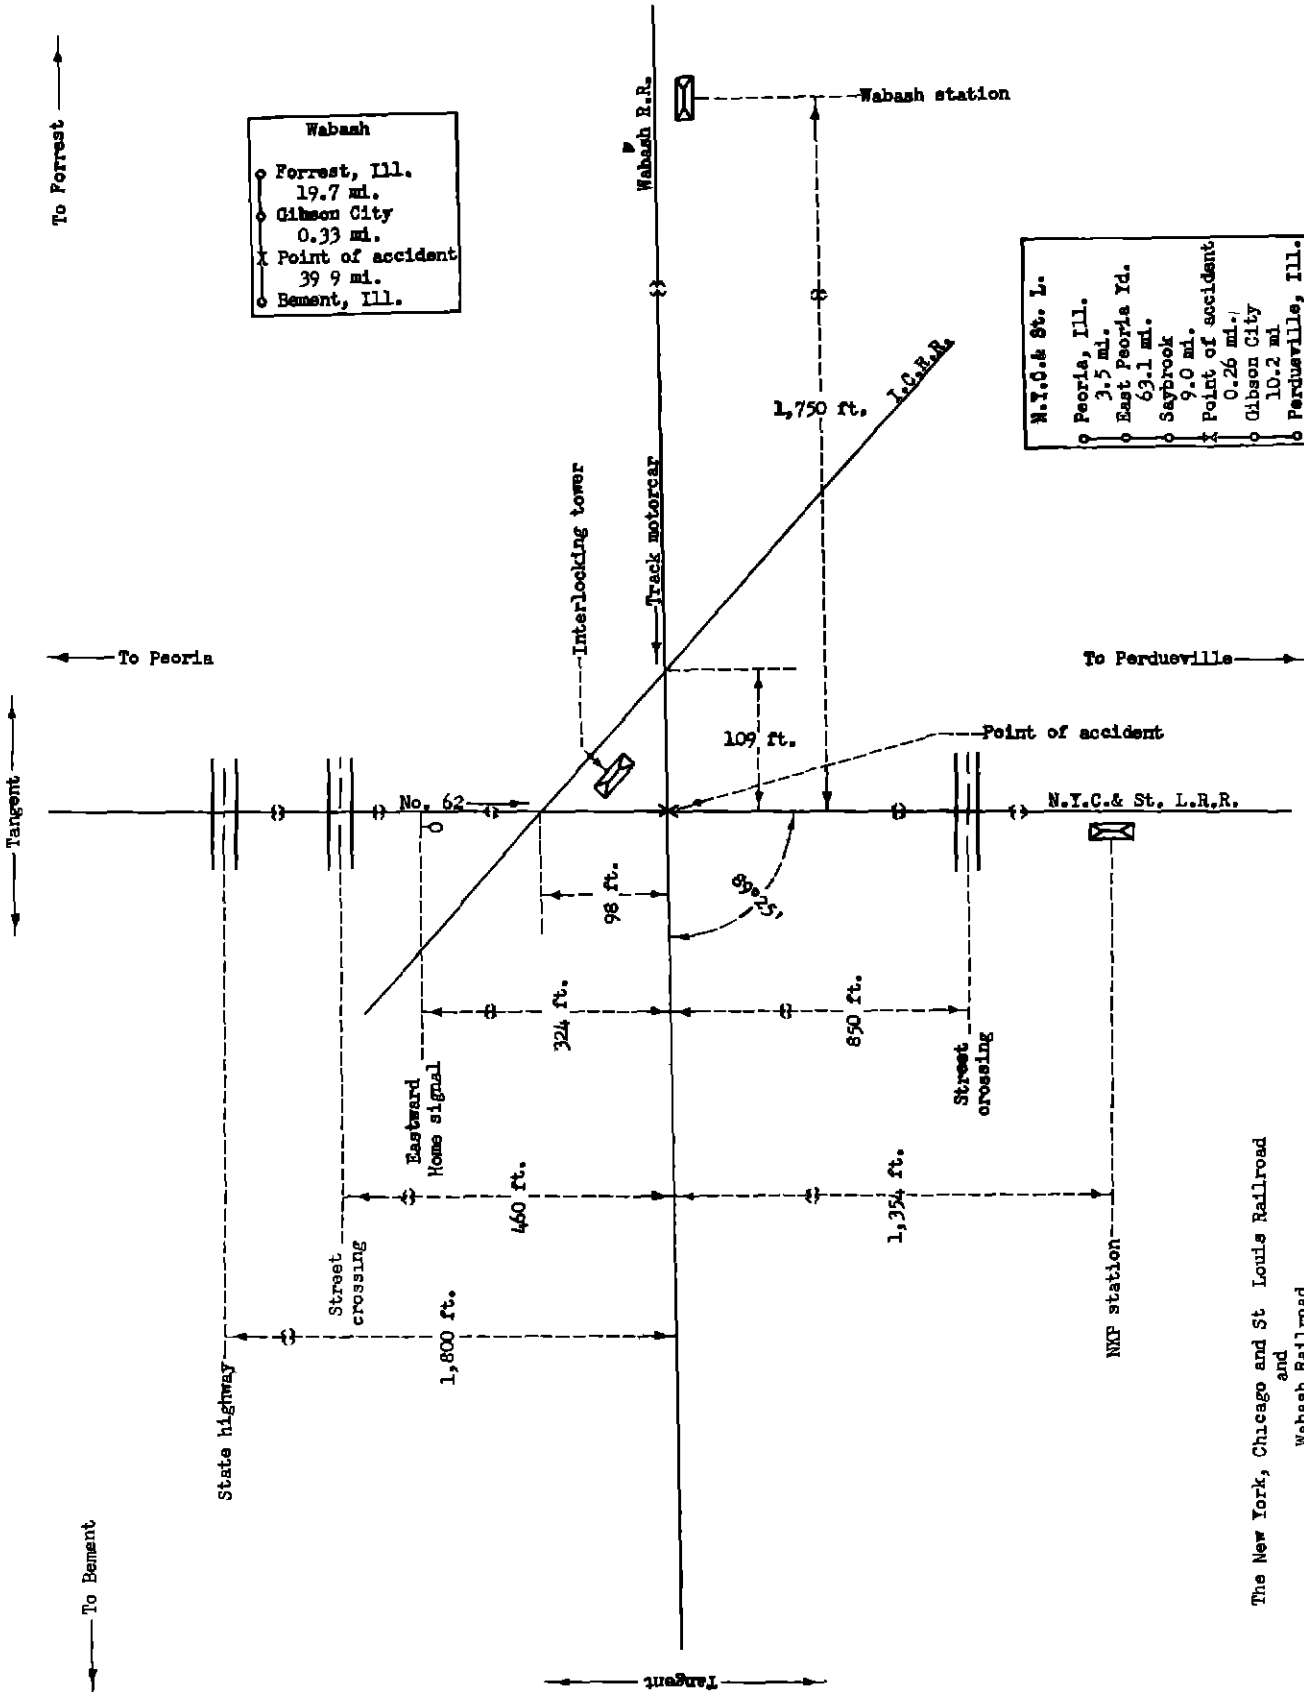
The New York, Chicago and St. Louis Railroad
and
Wabash Railroad
Gibson City, Ill.
August 11, 1958

Within the interlocking limits, a single-track line of the Illinois Central Railroad Company crosses the Wabash line at an angle of $42^{\circ}20'$ and the NKP line at an angle of $47^{\circ}40'$ at points, respectively, 109 feet north and 98 feet west of the crossing where the accident occurred. The interlocking tower is within the triangle formed by the lines of the three railroads. It is a two-story building about 26 feet in length and 14 feet in width, parallel to the Illinois Central Railroad, and about 11 feet from the main track of that railroad. The northeast corner of the building is 31.9 feet west of the Wabash main track, and the southeast corner is 16.2 feet north of the NKP main track. It is provided with an outside stairway on the south side, facing the NKP main track.

After the signal maintainer descended the outside stairway from the second floor of the interlocking tower and reboarded the track motorcar, his view of the NKP main track west of the point of accident was restricted by the interlocking tower to a distance of about 100 feet.
