## INTERSTATE COMMERCE COMMISSION

REPORT OF THE DIRECTOR OF THE BUREAU OF SAFETY IN RE  
INVESTIGATION OF AN ACCIDENT WHICH OCCURRED ON THE  
WABASH RAILWAY NEAR CHICAGO RIDGE, ILL., ON MAY 6, 1931.

June 13, 1931.

Inv No 1704  
Wabash Railway  
Chicago Ridge, Ill  
May 6, 1931

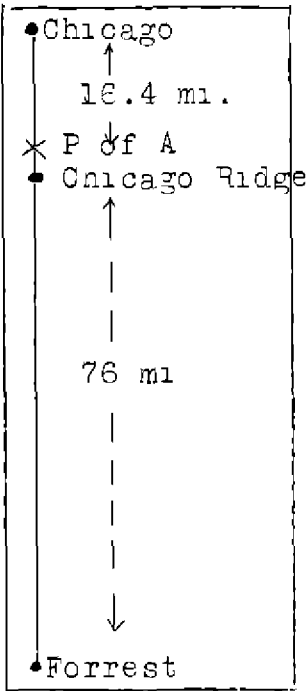
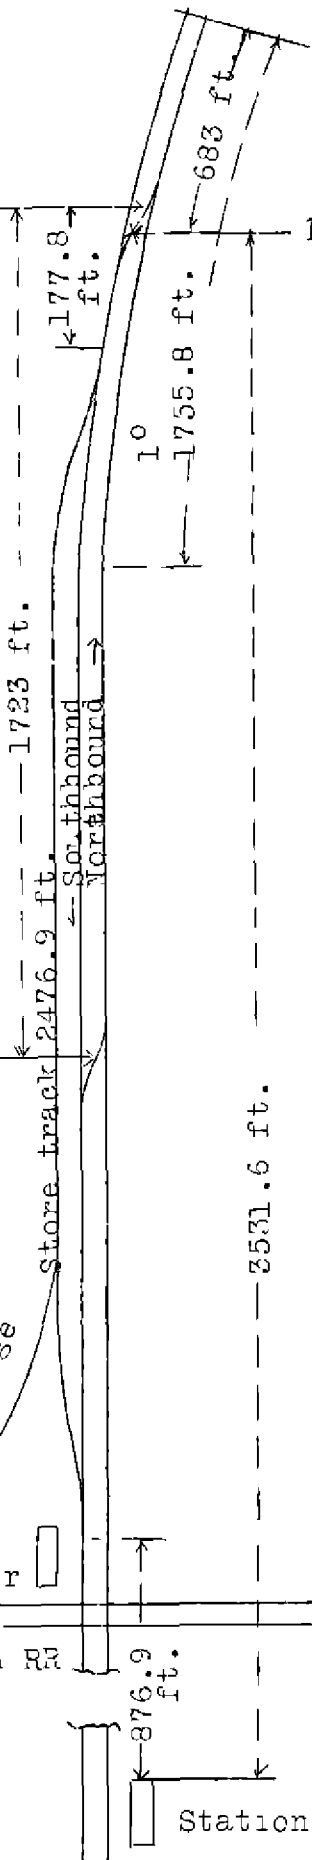
The crossover involved is known as the north crossover and is 204 feet in length, another trailing-point crossover, known as the middle crossover, is located 1,723 feet south thereof. Yard-limit boards are located 3,401 feet north and 8,754 feet south of the point of accident. Time-table instructions restrict the speed of dead freight trains to 25 miles per hour, while rule D-93 provides in part that extra trains must move within yard limits prepared to stop unless the main track is seen or known to be clear.
