INTERSTATE COMMERCE COMMISSION

REPORT OF THE DIRECTOR

WABASH RAILWAY

HUNTINGTON, IND.

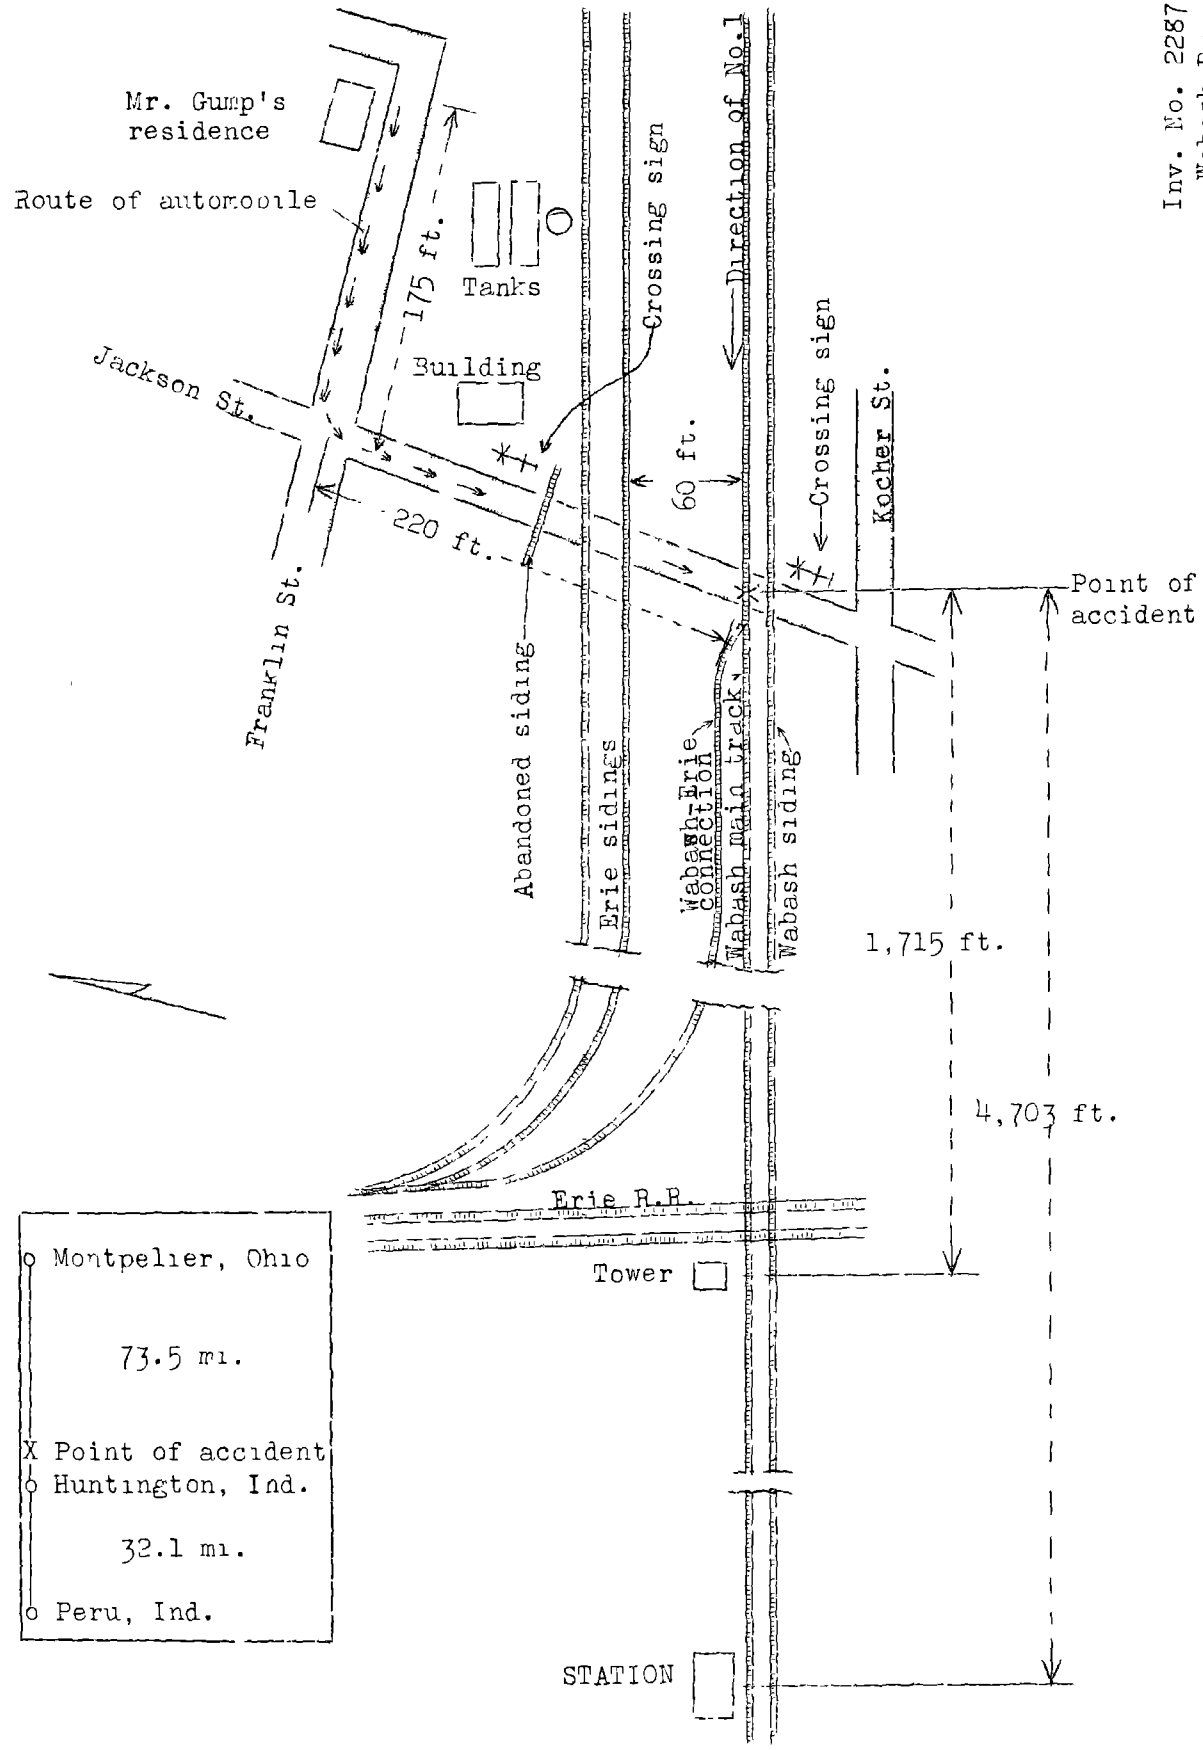
Inv. No. 2287
 Wabash Ry.
 Huntington, Ind.
 August 13, 1938

Jackson Street extends north and south and crosses five tracks at an angle of $70^{\circ} 43'$. Approaching from the north there is an abandoned track, a short distance beyond which are two auxiliary tracks of the Erie Railroad 13 feet apart; 60 feet south of the second of these is the main track of the Wabash Railway and 13 feet farther south a siding. The accident occurred on the main track. The street is constructed of stone screenings and is 16 feet in width except at the crossing where it is 12 feet wide; the tracks of the Wabash Railway are planked with 8-inch by 12-foot planks on each side of the rails, the filling between being of stone screening, the same material as used in the street. Franklin Street crosses Jackson Street at right angles at a point 220 feet north of the main track, and from this point southward to the crossing the street is tangent and is level to a point 130 feet from the main track where it ascends to the level of the tracks, the total rise being 2.14 feet; it is slightly undulating, however, between the tracks of the two railroads. This crossing is protected by two standard cross-bar signs bearing the words "RAILROAD CROSSING", and below each cross-bar is a horizontal bar bearing the word "DANGER". One sign is located north of the abandoned track and east of the street, 101 feet north of the center line of the main track; the other sign is located south of the siding and east of the street.

The view of an approaching west-bound train had by the driver of a south-bound vehicle is obstructed by a building and some storage tanks until reaching a point 120 feet from the main track where it is unobstructed for a distance of 760 feet; when 80 feet from the main track a clear view can be had for a distance of three-fourths mile and when 35 feet from the track the view is unobstructed. A row of telegraph poles is located 37 feet north of the main track.
