INTERSTATE COMMERCE COMMISSION

REPORT OF THE DIRECTOR OF THE BUREAU OF SAFETY CONCERNING AN
ACCIDENT ON THE WABASH RAILWAY AT JACKSONVILLE, ILL.,
ON DECEMBER 28, 1932

March 11, 1933.

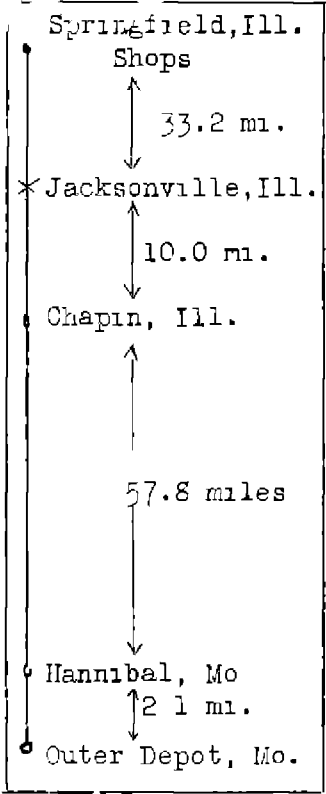
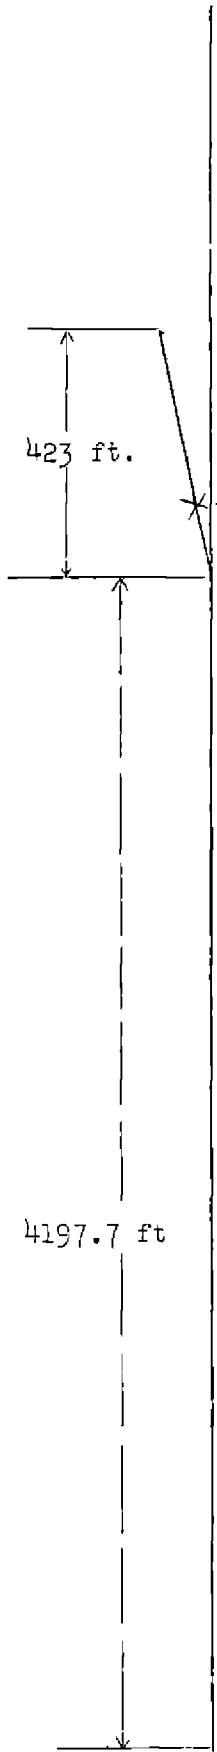
Inv No. 1802
Wabash Railway
Jacksonville, Ill.
December 28, 1932.

Point of accident
