REPORT OF THE DIRECTOR
BUREAU OF SAFETY

ACCIDENT ON THE
WABASH RAILWAY

LAFAYETTE, IND.

INVESTIGATION NO. 2214

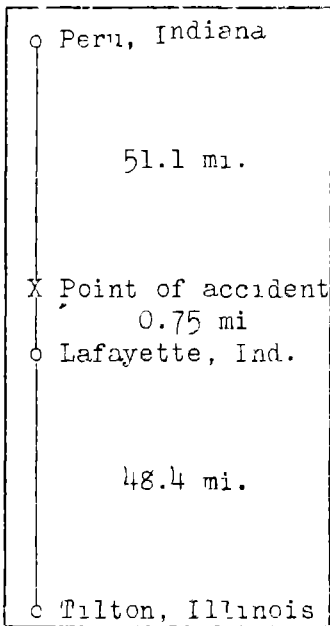
Inv. No. 2214
Wabash Railway
Lafayette, Ind.
Oct. 25, 1937

The accident occurred on South Track at a point 4,745 feet east of the end of double track. From the west the main track is tangent for over 5,000 feet to the point of accident and for a considerable distance beyond. From the end of double track eastward the south track closely parallels the main track for a distance of 1,100 feet and then for 1,300 feet is offset several feet to the south around the former location of a coal dock; from the east end of the offset it again closely parallels the main track for a distance of 2,345 feet to the point of accident and for a
