INVESTIGATION NO. 2931
WABASH RAILROAD COMPANY
REPORT IN RE ACCIDENT
AT MANHATTAN, ILL., ON
SEPTEMBER 15, 1945

Railroad: Wabash

Date: September 15, 1945

Kind of accident: Collision

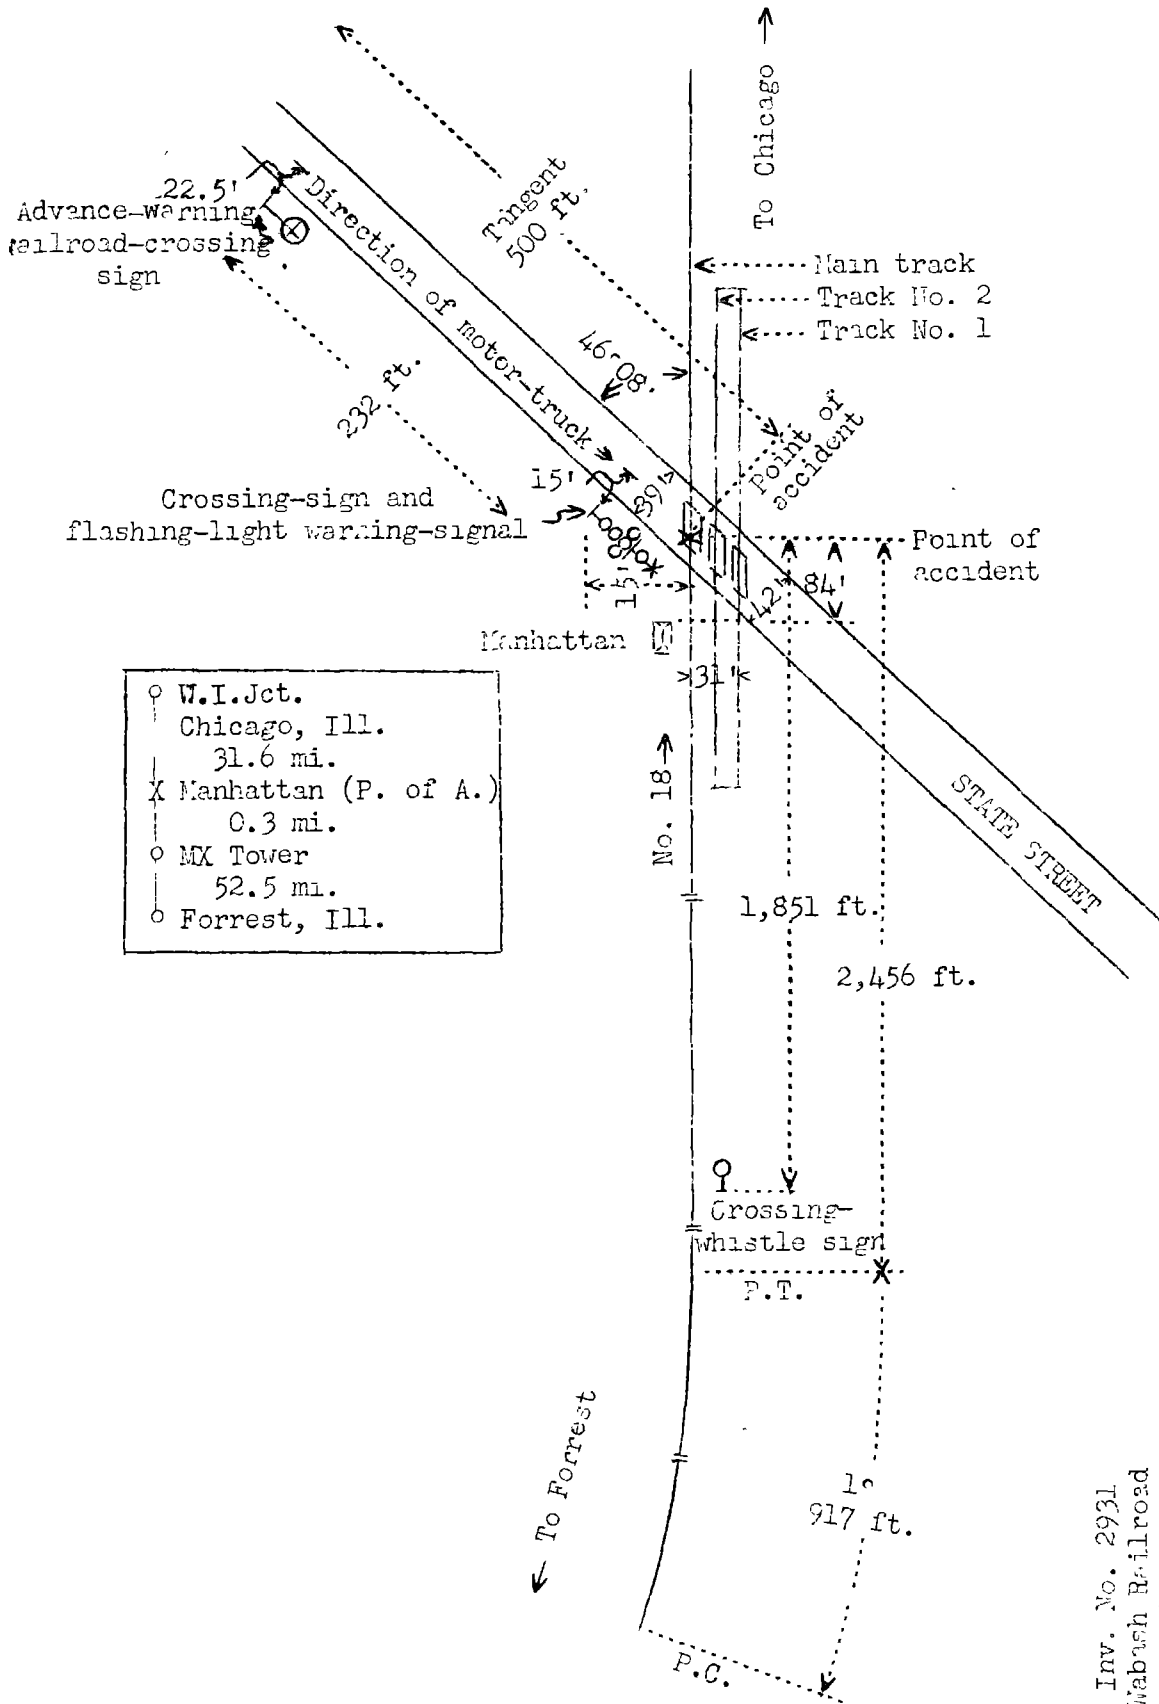
Inv. No. 2931
Wabash Railroad
Manhattan, Ill.
September 15, 1945

State Street intersects the railroad at an angle of 46°08'. From the west the street is tangent about 500 feet to the crossing and a considerable distance eastward. The grade is practically level. At the crossing two auxiliary tracks, hereinafter referred to from east to west as track No. 1 and track No. 2, parallel the main track on the east. West of the crossing, State Street is surfaced with concrete to a width of 18 feet. The crossing over the main track is 34 feet wide, and over tracks Nos. 1 and 2 it is 42 feet wide. The distance from the west rail of the main track to the east rail of track No. 1 is about 31 feet. The area between the rails of the main track and track No. 2 is surfaced with 1 plank inside each rail and asphaltum between the planks, and there is one plank outside each rail. The area between the rails of track No. 1 and 1 foot outside each rail is surfaced with scrap rails laid parallel to the rails of the track. The remainder of the surface of the crossing is paved with concrete.

An advance warning railroad-crossing sign is located 247 feet west of the main track and 22.5 feet south of the center-line of the street. This sign is a disc 2 feet in diameter, mounted on a mast 4 feet 6 inches above the level of the Street. It bears a horizontal line and a vertical line intersecting at right angles at its center, and bears the letters "R.R." in black and in colorless reflector buttons on a yellow background. A standard cross-buck railroad-crossing sign is located to the right of the direction of east-bound traffic, 15 feet south of the center-line of the street and 15 feet west of the center-line of the main track. This sign is mounted on a mast, 11.5 feet above the level of the street, and bears the words "RAILROAD CROSSING" in black letters and in colorless reflector buttons on a white background. Immediately below the cross-buck sign there are four hooded lamps attached to the mast in vertical position. The distance between the centers of the lenses is 1 foot 4 inches. A horizontal bar is mounted on the mast between the first and second vertical lamps, and a hooded lamp is attached to each end of this bar. The center of the lens of each lamp is 8 feet above the level of the street. When a north-bound train is occupying any portion of the main track within a distance of 2,929 feet south of the crossing, the word "STOP" in
