INVESTIGATION NO. 2892
WABASH RAILROAD COMPANY
REPORT IN RE ACCIDENT
AT WABASH, IND., ON
MAY 31, 1945

Accident at Wabash, Ind., on May 31, 1945, caused by a
train fouling the main track immediately in front
of a following train.

Inv. No. 2892
 Wabash Railroad
 Wabash, Ind.
 May 31, 1945

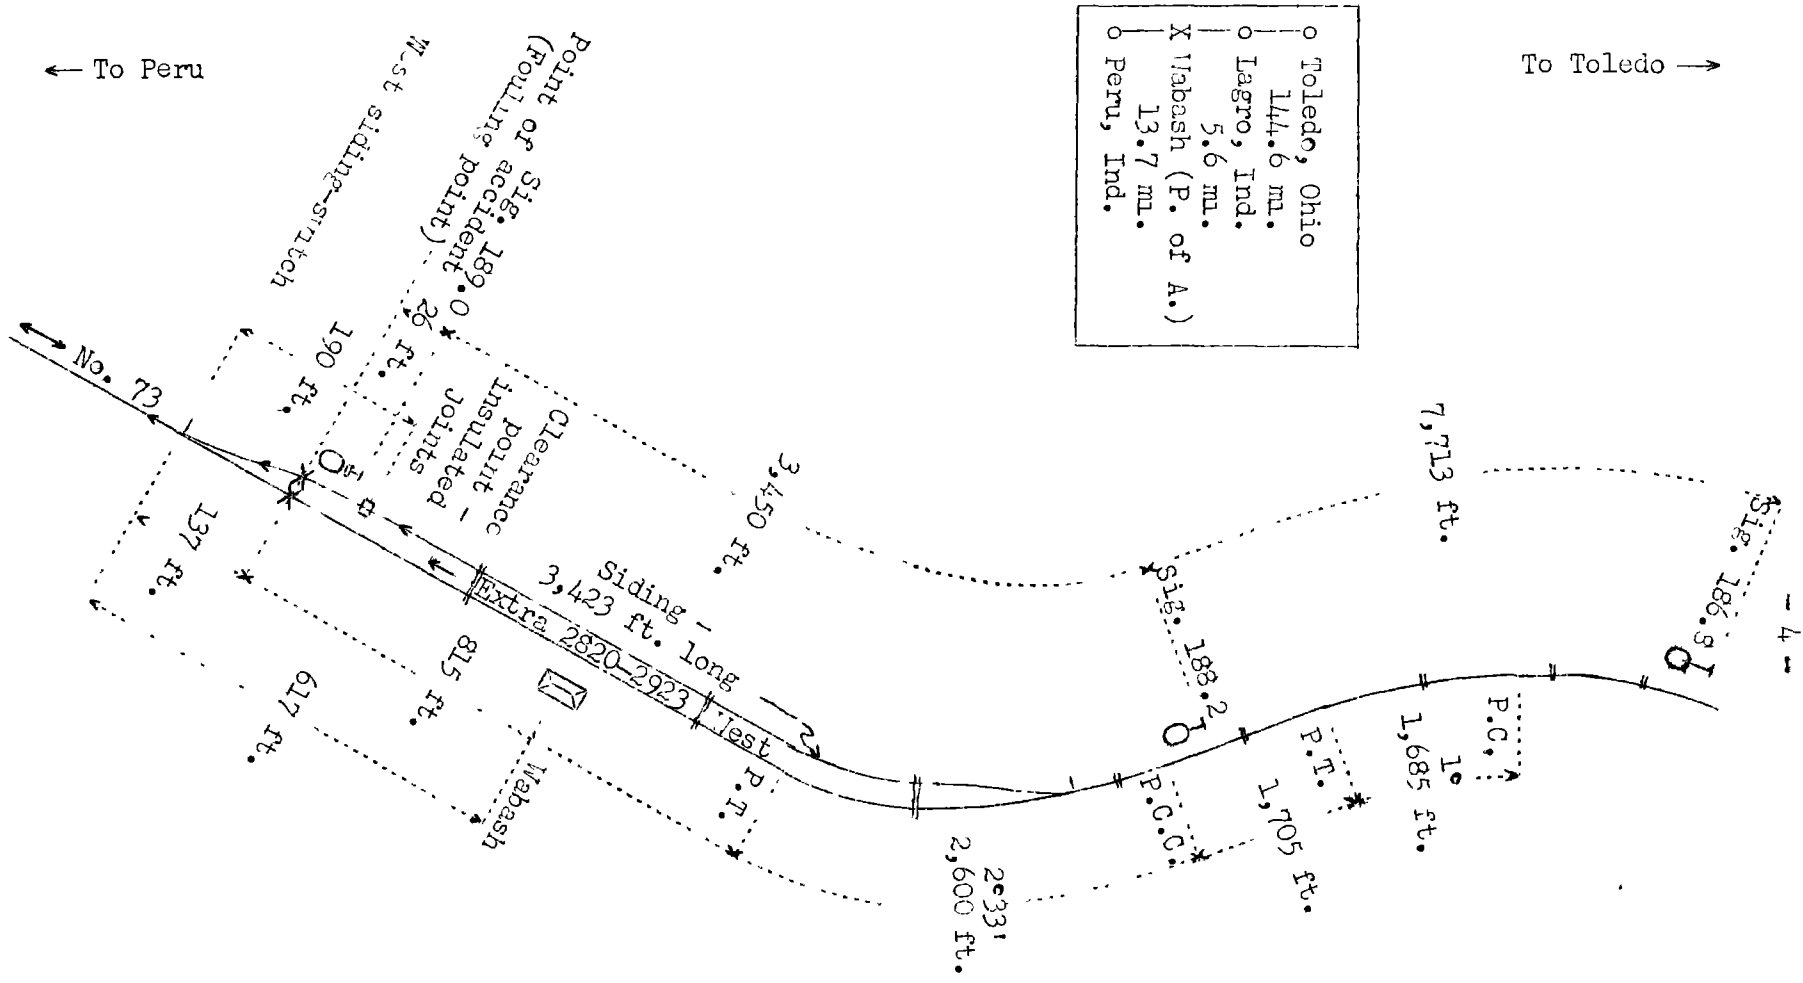
Automatic signals 186.8, 188.2 and 189.0 governing west-bound movements, are located, respectively, 11,189, 3,476 and 26 feet east of the point of accident. These signals are of the three-indication, color-light type. Signal 189.0 is continuously lighted when displaying a stop indication and approach lighted when displaying other indications. Signals 186.8 and 188.2 are approach lighted. The involved aspects and corresponding indications and names of these signals are as follows:

The track circuits of the fouling section of the turnout of the west siding-switch extend 190 feet east of the switch. The controlling circuits are so arranged that when the track between signal 189.0 and the next signal westward is occupied, or when main track switches between these signals are reversed, or when a train occupies the fouling section of the turnout of the west siding-switch, signals 189.0 and 188.2 display stop and signal 186.8 displays approach. Signal 189.0 is located north of the siding and about 20 feet north of the north rail of the main track.

No. 73, a west-bound third-class freight train, consisted of engine 2406, one rider car, seven cars and a caboose. This train entered the siding at Wabash about 1:45 p. m., 2 hours late, and performed switching service on the freight-house track, which connects with the siding at a point 330 feet east of the point of accident. Later, No. 73 proceeded westward on the siding en route to the next station, and entered the main track at the west siding-switch about 2:04 p. m., when the fireman saw a west-bound train approaching closely. Then the train stopped, and an attempt was made to back it into clear, and while it was moving backward at a speed of about 5 miles per hour the tender and the rider car were struck by Extra 2820-2923 West.

Extra 2820-2923 West, a west-bound freight train, consisting of engines 2820 and 2923, 96 cars and a caboose, passed Lagro, 5.6 miles east of Wabash and the last open office, at 1:58 p. m., passed signals 186.8 and 188.2, which displayed proceed, and while moving at an estimated speed of 15 miles per hour it passed signal 189.0, which displayed stop-and-proceed, and collided with No. 73 at the fouling point of the turnout 26 feet west of signal 189.0.

The engine of No. 73 was derailed and pushed westward about 300 feet, and stopped practically upright at a 45-degree angle to the track. The tender was torn loose and overturned at the west siding-switch. The rider car was demolished. Both engines of Extra 2820-2923 were derailed. Engine 2820 was badly damaged.

It is recommended that the Wabash Railroad Company install derails coordinated with electric switch-locking at clearance points on its sidings in automatic block-signal territory on the 1st District of the Montpelier Division.
