INTERSTATE COMMERCE COMMISSION,  
WASHINGTON

REPORT NO. 3501

WABASH RAILROAD COMPANY  
AND  
TERMINAL RAILROAD ASSOCIATION OF ST. LOUIS

AT MAY STREET, ST. LOUIS, MO., ON

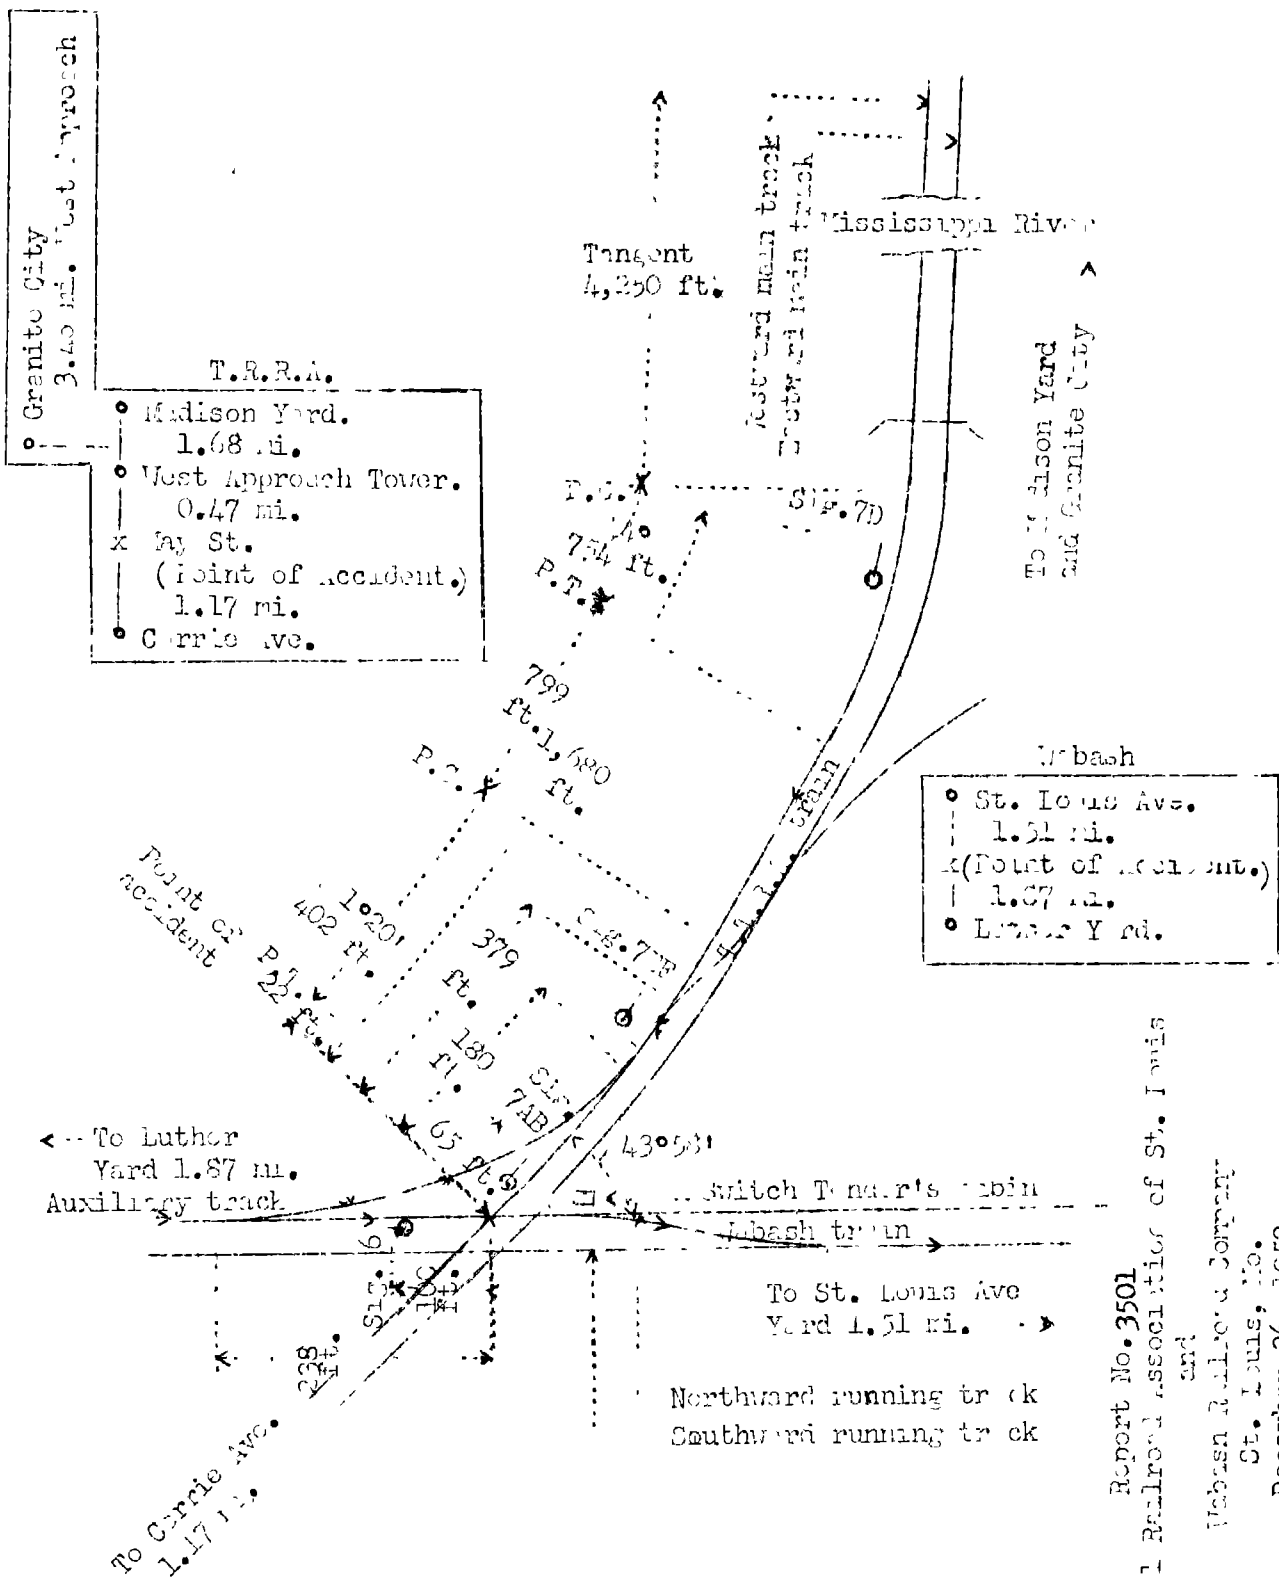
Report No. 3501  
 Terminal Railroad Association of St. Louis  
 and  
 Webbs Railroad Company  
 St. Louis, Mo.  
 December 26, 1952.

This accident occurred at the intersection of the Wabash Railroad and the Terminal Railroad Association of St. Louis, hereinafter referred to as the T.R.R.A., at May Street, St. Louis, Mo. The crossing is located on that part of the St. Louis Terminal Division of the Wabash extending between Luther Yard, St. Louis, and St. Louis Avenue Yard, St. Louis, 3.38 miles, and on that part of the T.R.R.A. extending between Granite City, Ill., and Carrie Avenue, St. Louis, 5.10 miles. The crossing is 1.87 miles south of Luther Yard and 3.93 miles west of Granite City. The tracks intersect at an angle of  $43^{\circ}58'$ . In the vicinity of the crossing the line of the Wabash consists of two running tracks, over which movements are made under the jurisdiction of a yard master. In the immediate vicinity of the crossing the tracks are tangent and practically level. In the vicinity of the crossing the T.R.R.A. is a double-track line, over which movements with the current of traffic are operated by timetable and an automatic block-signal system. East of May Street this line crosses the Mississippi River on Merchants Bridge, which is approximately 4,200 feet in length. The west abutment of the bridge is about 1,800 feet east of the crossing. From the east there are, in succession, a tangent 4,250 feet in length, a  $4^{\circ}$  curve to the right 754 feet, a tangent 799 feet, a  $1^{\circ}20'$  curve to the right 402 feet, and a tangent 22 feet to the crossing and 97 feet westward. From the east there is a vertical curve 1,279 feet, then the grade is, successively, 0.01 percent descending 621 feet, 1.51 percent descending 1,695 feet, 2.036 percent descending 500 feet, 1.08 percent descending 300 feet, and level 239 feet to the crossing. The northward running track of the Wabash and the westward main track of the T.R.R.A. are connected by an auxiliary track which extends between a switch in the Wabash track 238 feet north of the crossing and a switch in the T.R.R.A. track 180 feet east of the crossing. South of the crossing, a trailing-point crossover connects the two running tracks of the Wabash. The switches are all of the hand-throw type.
