INTERSTATE COMMERCE COMMISSION

Ex Parte No. 184

ACCIDENT AT UNION STATION, WASHINGTON, D. C.

Accident at Union Station, Washington, D. C., on January 15, 1953, caused by a train moving out of control as a result of the brakes on the rear 13 cars being inoperative from the locomotive because of a closed angle cock at the rear of the third car.

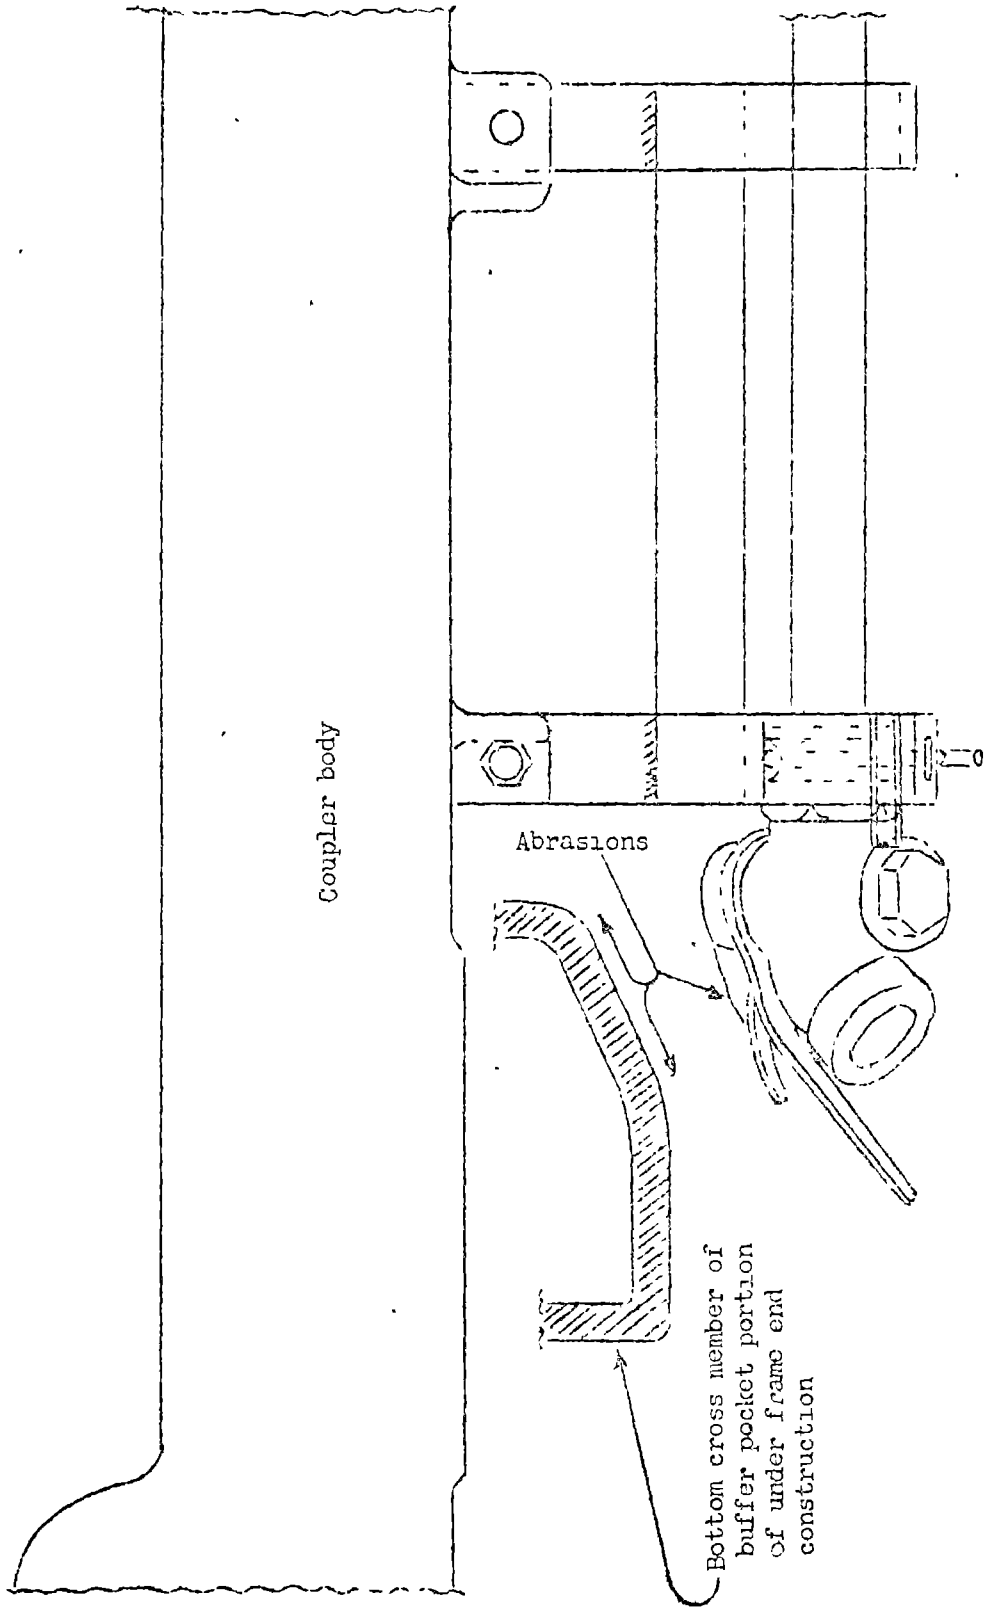
Sketch showing location of angle cock

Coupler body

Abrasions

Bottom cross member of
buffer pocket portion
of under frame end
construction

An abrasion mark was found on the top of the handle just above the thumb release of the double-locking angle cock on the undamaged end of the second car. Abrasion marks were also found on the bottom side of the bottom cross member, showing that the handle of the angle cock had been coming in contact with the cross member. Examination of the rear end of the third car disclosed abrasion marks on the bottom cross member similar to and in approximately the same location as those on the second car. Examination of the angle cock which had been removed from the rear end of the third car after the accident disclosed an abrasion on the top of the handle similar to that found on the angle cock of the second car. There were also abrasion marks showing that the coupler heads of the second and third cars had been coming in contact with the top cross members of the buffer pockets.

The abrasion marks on the handle of the angle cock and the bottom cross member at the rear of car 8665 show that the handle had repeatedly come in contact with the cross member. As the angle cock was so located that contact could be made while the coupler body and the angle cock were moving vertically and either longitudinally or laterally, it is apparent that as a result of these contacts the handle was unlatched and moved toward closed position a sufficient distance to close the angle cock. Tests were made on a car of similar construction by manually manipulating the coupler with a bar, and the handle of the angle cock was moved toward closed position as a result of contact between the handle and the cross member.

1. The angle cocks on New Haven car 8635 and other cars of similar construction are so located that the handles of the angle cocks are permitted to come in contact with the bottom cross member of the buffer pocket portion of the underframe end construction.
2. Between the time the brakes of No. 173 were released after the train stopped at Baltimore and the time the engineer attempted to apply the brakes as the train approached Washington the angle cock at the rear of car 8635, the third car of train No. 173, became closed, obviously as a result of contact between the handle and the bottom cross member, and after this occurred the brakes of the rear 13 cars of the train could not be applied from the locomotive.
3. The engineer was not aware of the condition of the air-brake system until he attempted to reduce the speed of the train by the use of the air brakes.

We recommend that all passenger train cars equipped with thirdlock or similar type couplers operated over any railroad subject to the Interstate Commerce Act be inspected immediately, and that such cars on which any angle cock is so located that the handle can come into contact with any other portion or appurtenance of the car be withheld from service until such condition is corrected.
