NATIONAL TRANSPORTATION SAFETY BOARD

DERAILMENT OF
WESTERN PACIFIC RAILROAD COMPANY
FREIGHT TRAIN EXTRA UP 3734 WEST
(SEALAND 6)
HAYWARD, CALIFORNIA
APRIL 9, 1980

NTSB-RAR-80-10

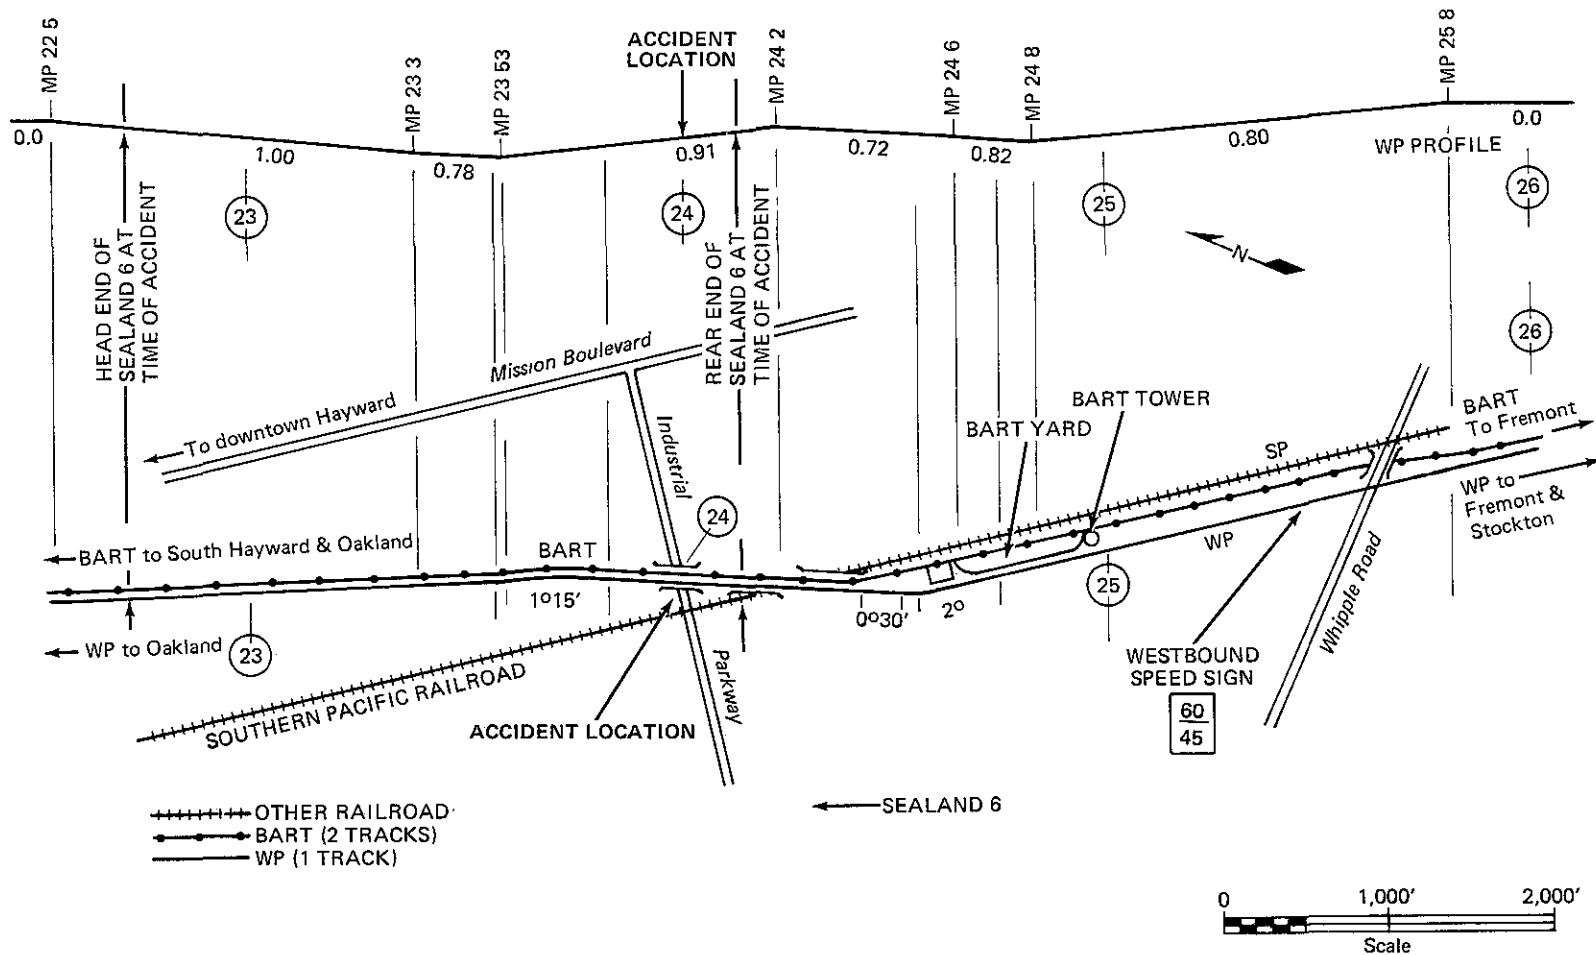
At Milepost 24.2 the head-end started down a 0.91 percent grade 0.7 mile long. The head-end engineer said he continued to run in full throttle but at this point made an automatic brake application to keep from accelerating beyond 60 mph. At the bottom of the grade, the engineer released the brake application and the head end started to ascend a 1-mile grade varying from 0.78 to 1.00 percent. Shortly afterward, the helper locomotive started down the 0.91 percent grade. When the helper reached Milepost 24 and the Industrial Parkway overpass, the forward two-thirds of the Sealand 6 was on the ascending grade and the rear one-third was on the descending grade. (See figure 1.) Indicated speed at the rear helper unit had reached 63 mph whereas, according to the engineer, the indicated speed of the lead unit at the head-end had dropped to 52 mph. The train experienced a severe run-in of slack at both ends, followed by the lead-end of the caboose ahead of the helper locomotive raising up from the track and derailing to the left. Separated from the car ahead and the locomotive behind, the caboose left the track structure at or near the south end 1/ of the overpass and came to rest on Industrial Parkway west of the overpass. The train brakes went into emergency simultaneously with or immediately after the caboose derailed.

Figure 1.--Diagram and profile of accident location and approach from Milepost 25.8.

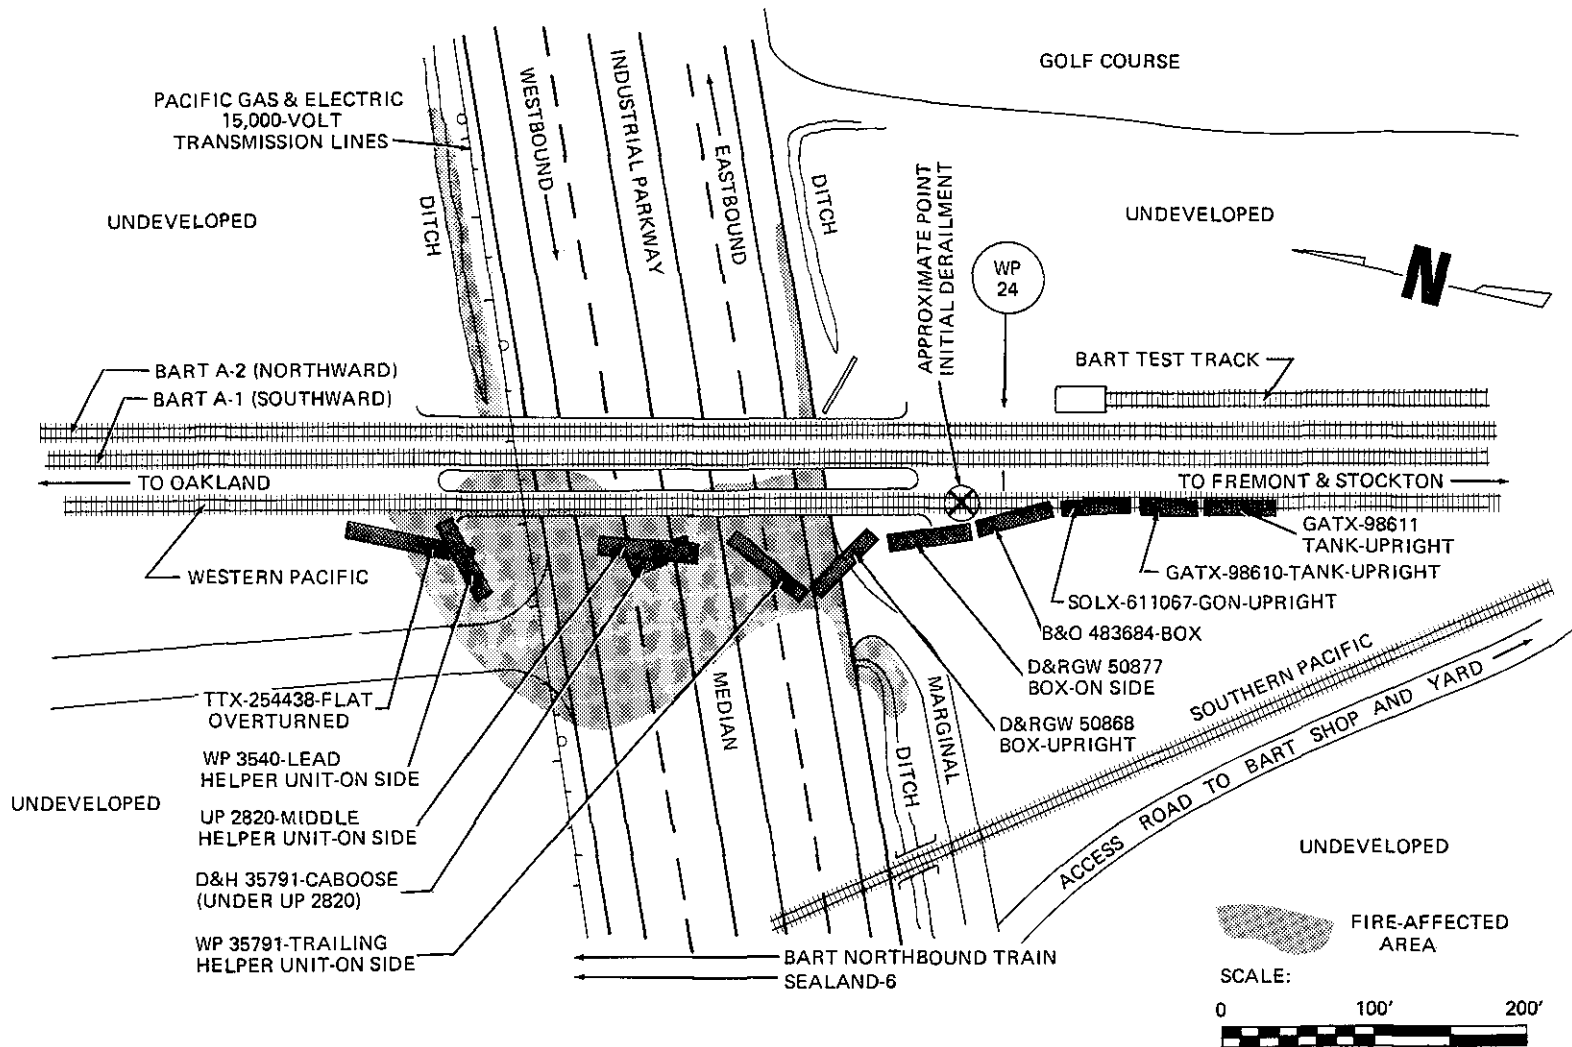
The rear truck of the car ahead of the caboose derailed to the left and the car was struck by the lead unit of the locomotive. Both vehicles left the track structure at or near the north end of the 230-foot overpass and came to rest on the west embankment north of Industrial Parkway. The second and third helper locomotive units derailed to the west and fell 30 feet from the overpass onto the highway. The second unit fell on the caboose. The third unit came to rest on the

eastbound traffic lane. (See figure 2.) The fuel tanks of all three units were ruptured in the derailment and escaping fuel was ignited immediately by the arcing of 15,000-volt Pacific Gas and Electric (PG & E) powerlines that had been severed in the derailment. (See figure 2.)

Figure 2.--Plan view of accident site and wreckage distribution.

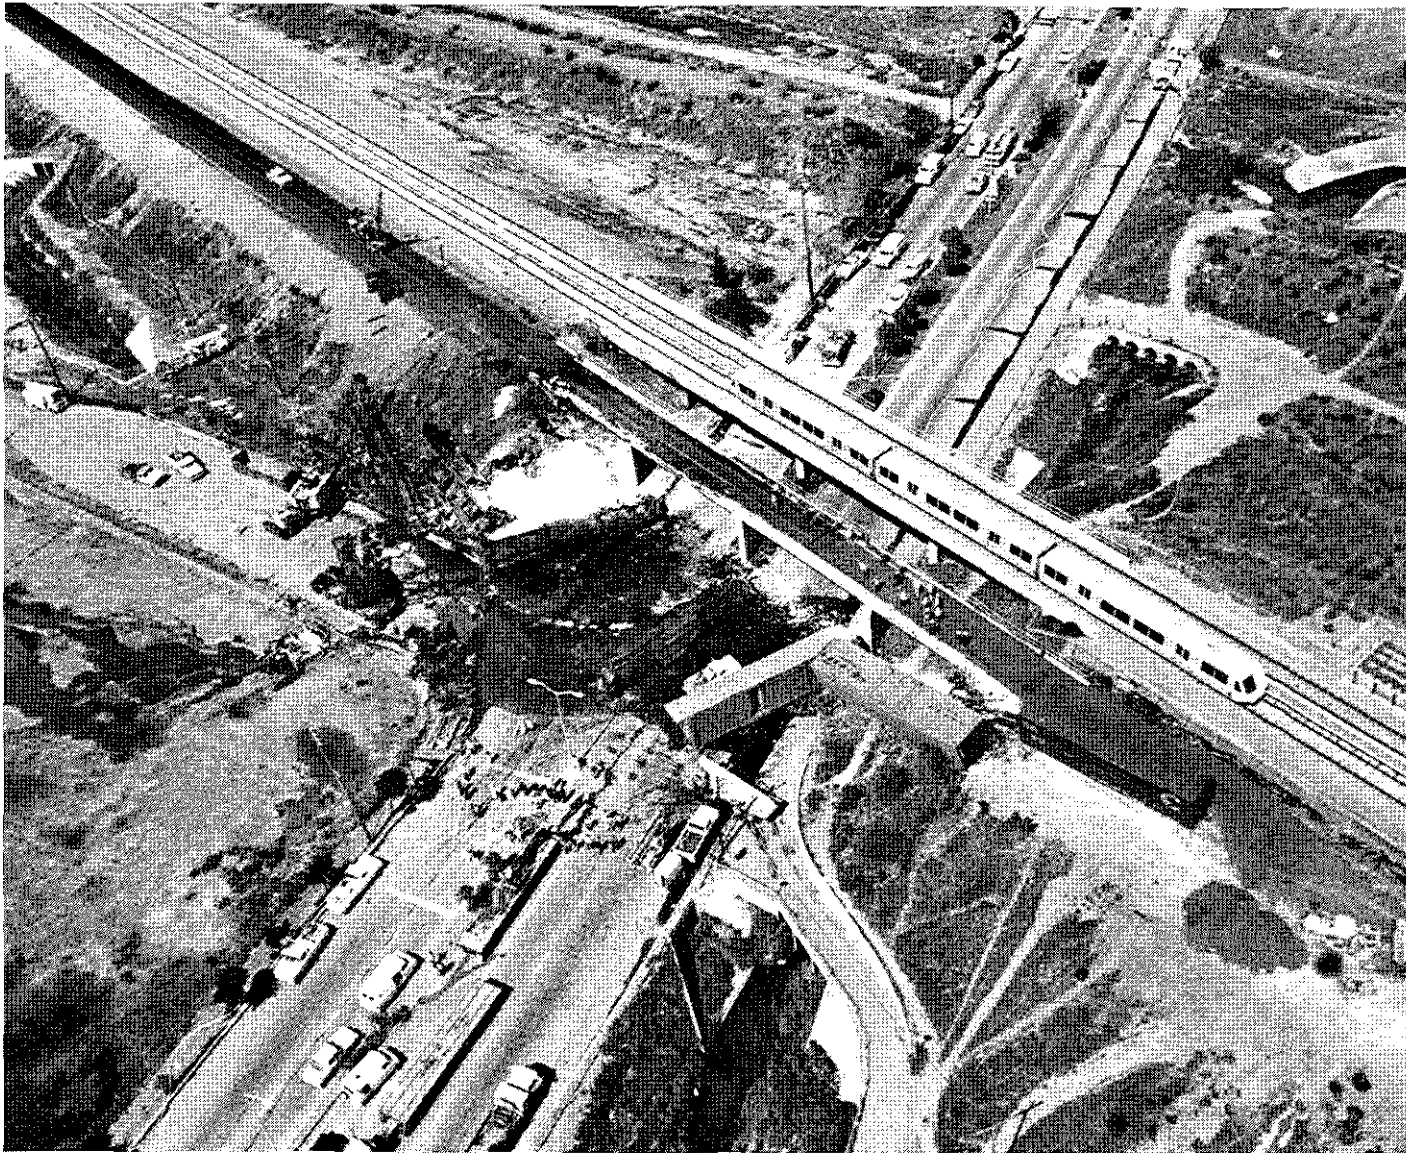
The 230-foot overpass over Industrial Parkway is a prestressed concrete ballast deck bridge with concrete backwalls and a center pier. The track is about 30 feet above the highway and approaches the bridge on long fills. The track was maintained according to FRA Class 4 standards and was in good condition. The rail was jointed 119-pound in 78-foot lengths laid in double-shoulder tie plates on 7-inch by 9-inch by 9-foot treated crossties. There were no guard rails. The right-of-way is shared with the double-track line of the Bay Area Rapid Transit District (BART) between Fremont and Oakland. At Industrial Parkway, the WP and BART tracks are about 20 feet apart, with each railway having its own bridge. (See figure 3.)

Figure 3.--Aerial view of the accident location viewed to the northeast.
The BART train is southbound en route from Oakland to Fremont.

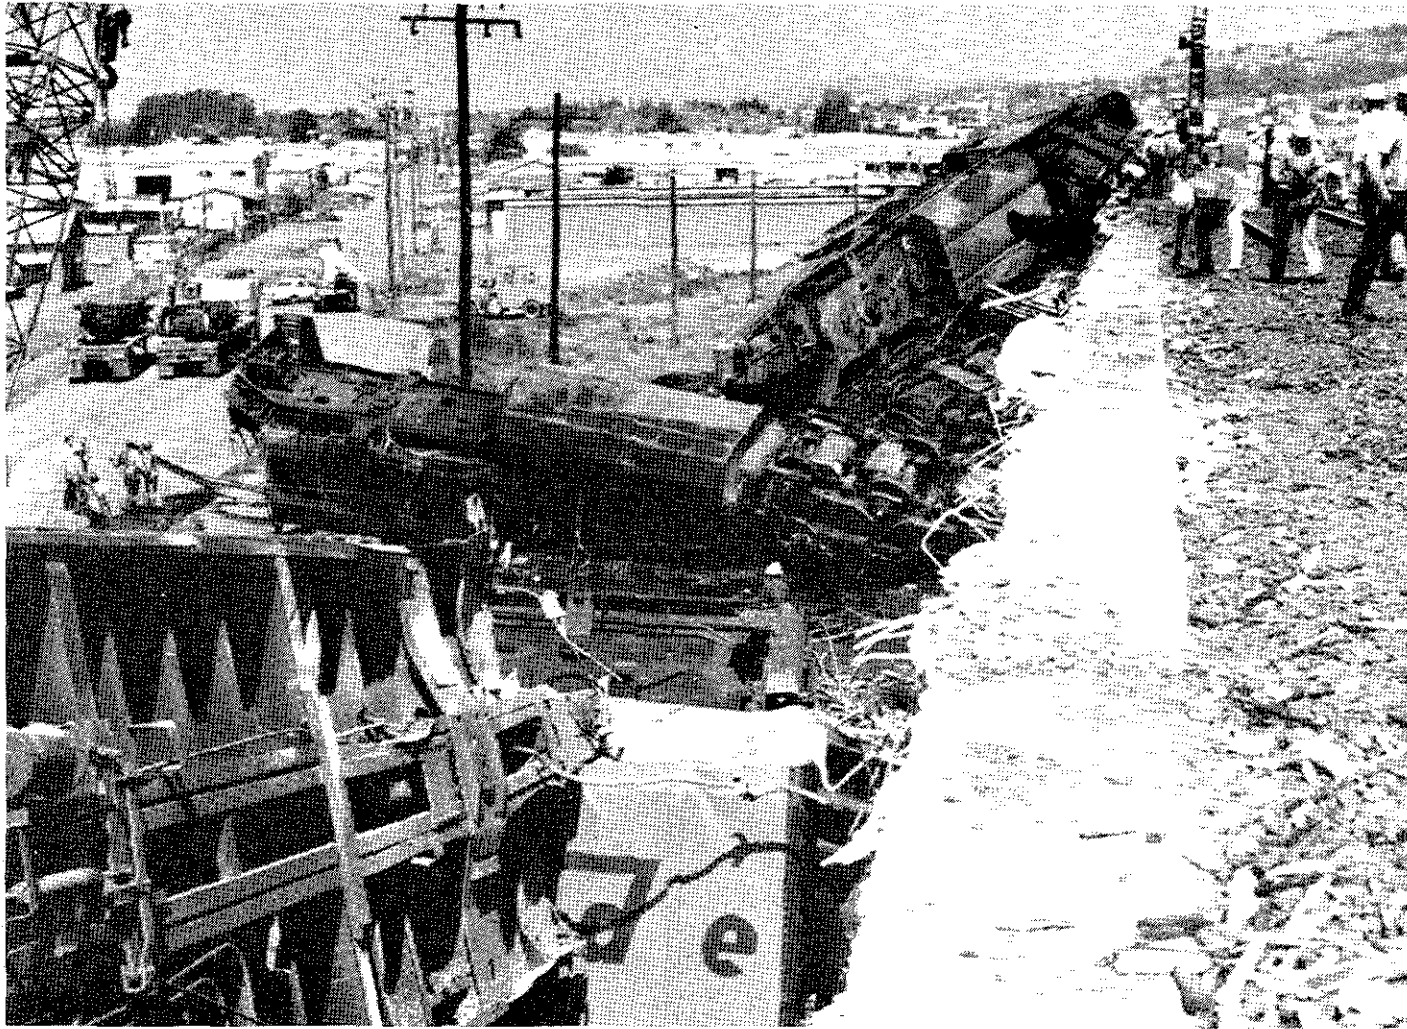
Figure 4.--Derailed locomotive units and cars viewed from Bridge 23.93.
The lead RBW-9 unit is at the far end of the bridge as it came to rest after derailing.
