ACCIDENT ON THE
WESTERN PACIFIC RAILROAD

FRANKLIN, CALIF.

NOVEMBER 8, 1936

INVESTIGATION NO. 2110

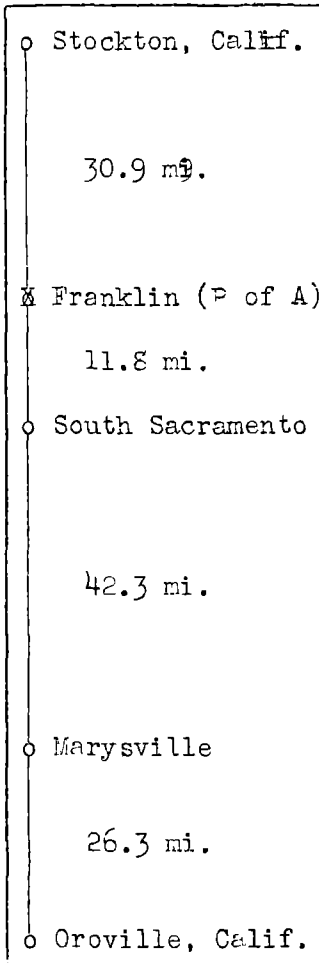
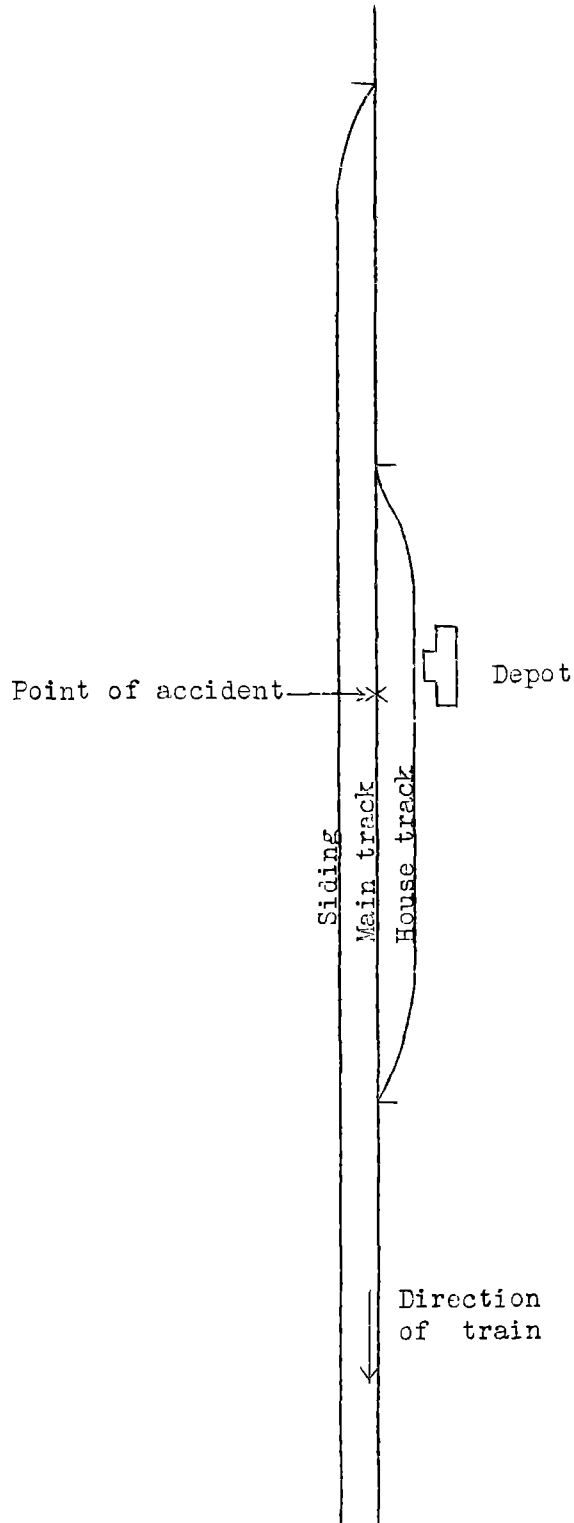
Inv. No. 2110
Western Pacific R.R.,
Franklin, Calif.
Nov. 8, 1936

The fortieth car in the train, U.P. 21791, a steel gondola loaded with pig iron, was the first car to become derailed, this being caused by a truck side-frame breaking at the bottom on the forward end, left side, this being the B-end of the car; the next two cars, also steel gondolas, loaded with pig iron, and the forward truck of the forty-third car, a flat car, loaded with car wheels, were also derailed.

Inspection of the defective truck side-frame by the Commission's inspectors disclosed that there were several old flaws or breaks in the metal at the bottom on both sides of the spring seat, and there were numerous sand holes. Most of these defects, however, were concealed on the inside of the truck side-frame casting, and could not be discerned in ordinary inspection.

The investigation developed that steel gondola car U.P. 21791, loaded with pig iron, the fortieth car in westbound freight Train No. 61, was the first car to become derailed; this was caused by a defect at the bottom of the truck side-frame on the left side and forward end of the car. The side frame failed as the train was passing Franklin station at a speed of about 35 or 40 miles per hour, resulting in the derailment of four cars. The car involved was not overloaded and it was inspected in the train by a car inspector at Oroville and also by the crew at several points en route. The air brakes were tested and worked properly. Neither speed nor track conditions had any apparent bearing on the accident, and there was no indication of dragging equipment. Examination of the failed truck side-frame disclosed that there were several old flaws or breaks in the metal at the bottom of the truck on both sides of the spring seat and there were also numerous sand holes in the casting; these defects, however, were concealed on the inside of the truck and were not discernible by ordinary inspection.

This accident was caused by the failure of a truck side-frame.
