INVESTIGATION NO. 2983  
THE WESTERN PACIFIC RAILROAD COMPANY  
REPORT IN RE ACCIDENT  
AT PILOT, NEV., ON  
APRIL 5, 1946

Accident at Pilot, Nev., on April 5, 1946, caused by  
failure properly to control the speed of a train  
entering a siding.

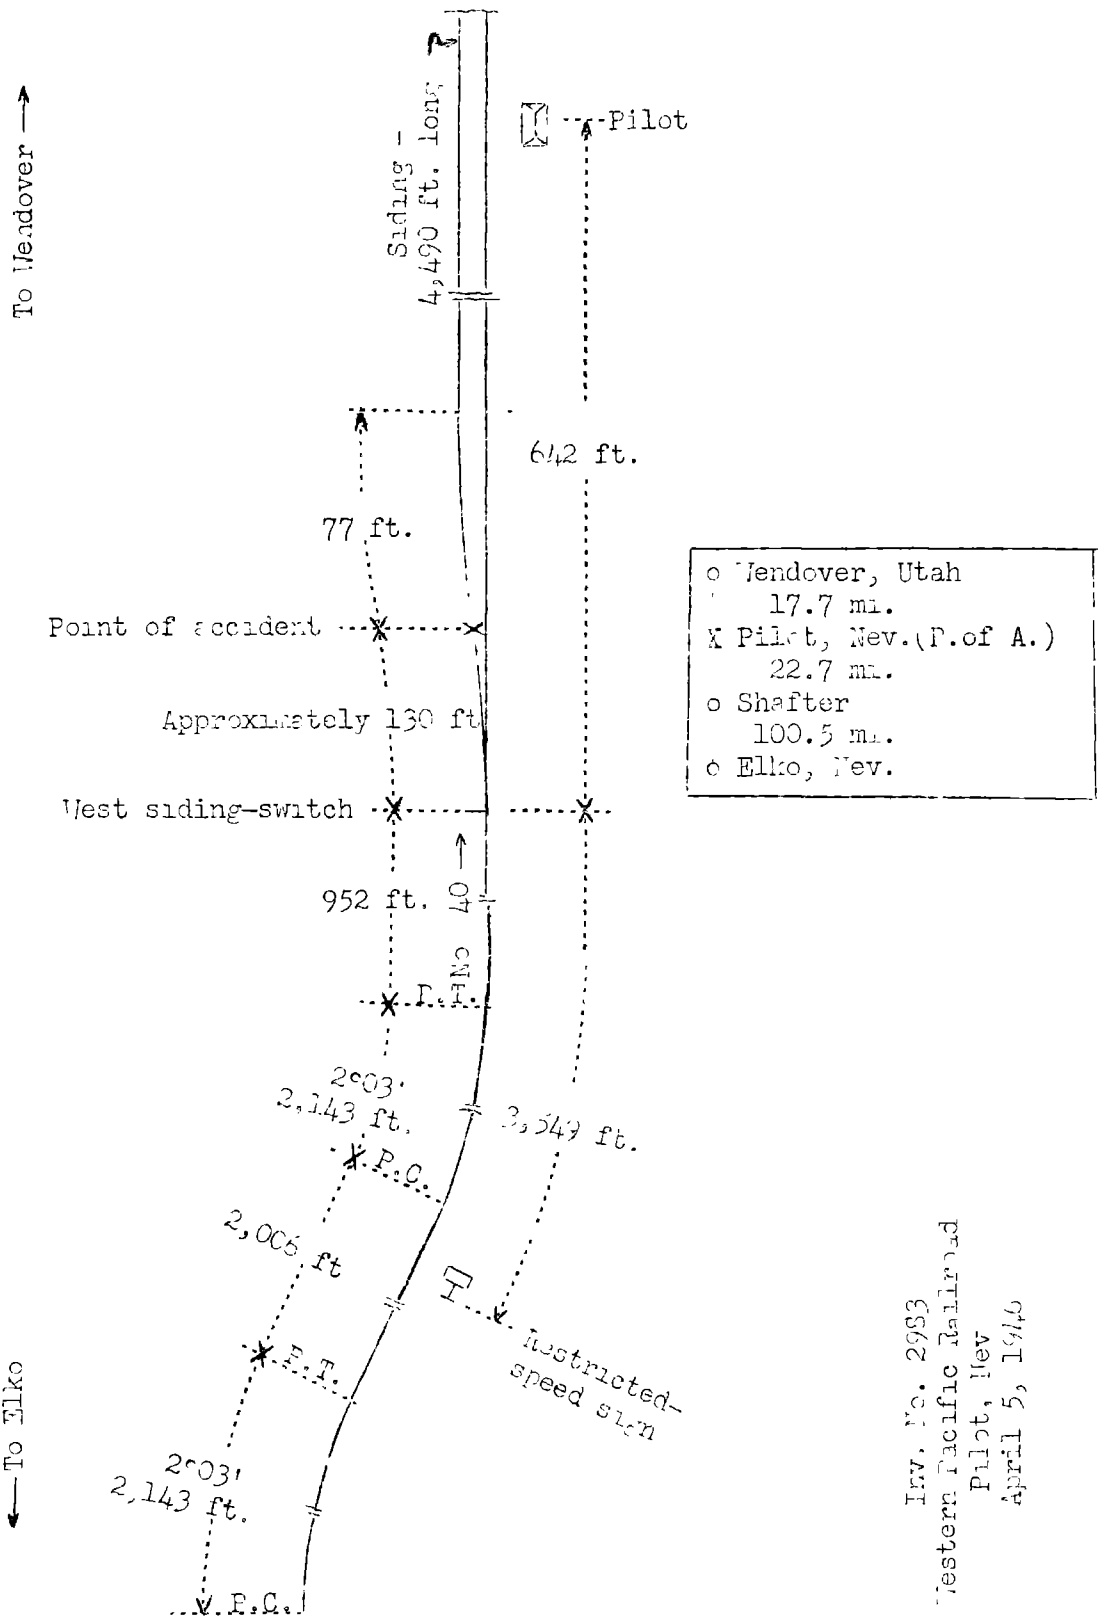
Inv. No. 2953  
Western Pacific Railroad  
Pilot, Nev  
April 5, 1946

of Pilot, at 2:38 p. m., 15 minutes late, passed the restricted-speed sign, located 3,549 feet west of the west siding-switch at Pilot, and while moving at an estimated speed of 45 miles per hour it entered the west siding-switch and the engine and the first ten cars were derailed.

The engine stopped on its left side about 30 feet north of the siding and practically parallel to it, with the front end about 376 feet east of the point of derailment. The tender was torn loose from the engine and stopped on its left side at the rear of the engine, and at an angle of 30 degrees to the siding. The first two cars stopped at the rear of the tender, across the siding and at right angles to it. The third to fifth cars, inclusive, stopped on top of the first two cars, and at right angles to the track. The sixth to eighth cars, inclusive, stopped in various positions across the siding. The ninth and tenth cars stopped practically upright and in line with the turnout. The engine and the first to ninth cars, inclusive, were badly damaged, and the tenth car was slightly damaged.

The maximum safe speed through the turnout involved was about 30 miles per hour, and the theoretical overturning speed was about 60 miles per hour. The evidence indicates that the engine was moving at less than the theoretical overturning speed but considerably in excess of the maximum safe speed when it entered the turnout.
