REPORT NO. 3757  
THE WESTERN PACIFIC RAILROAD COMPANY  
IN RE ACCIDENT  
NEAR BERRY CREEK, CALIF., ON  
MAY 18, 1957

REPORT NO. 3757

Accident near Berry Creek, Calif., on May 18, 1957, caused  
by a landslide.

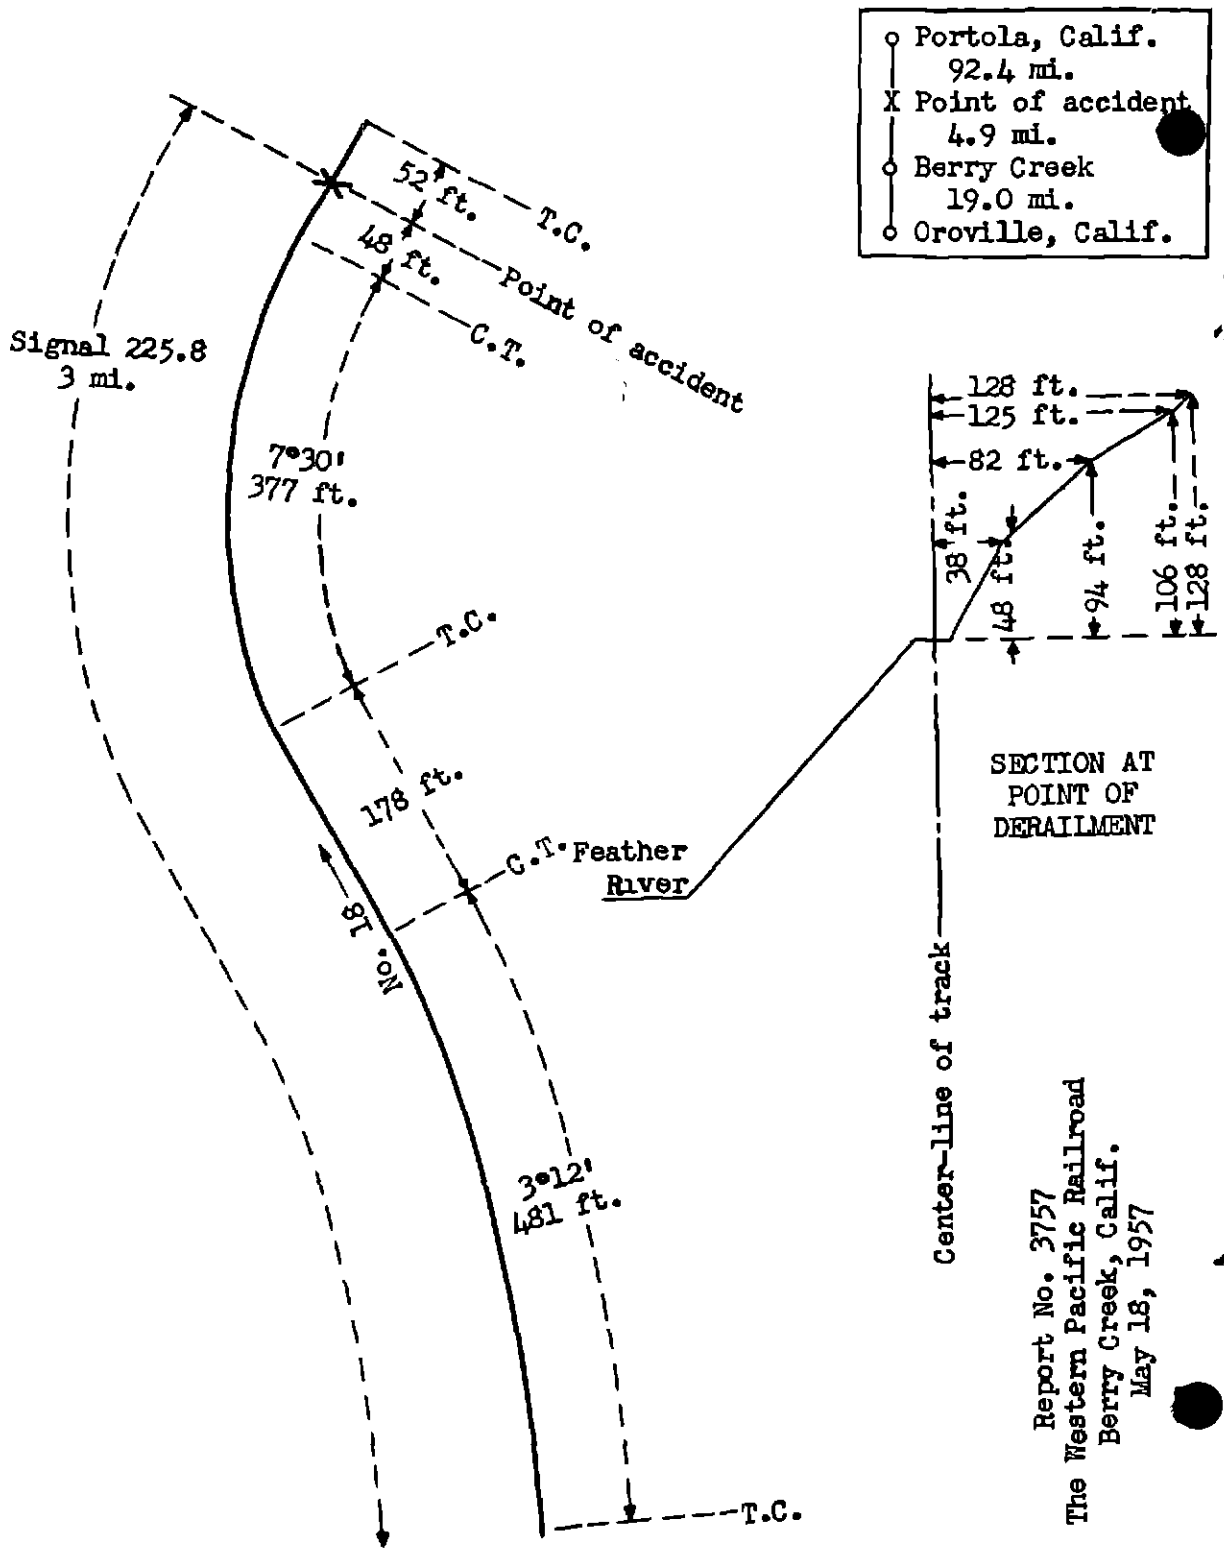
Report No. 3757  
The Western Pacific Railroad  
Berry Creek, Calif.  
May 18, 1957

The locomotive and the first two cars were derailed. Separations occurred between the first and second diesel-electric units and between the second and third units. The first unit was derailed to the north and stopped on its left side at a point approximately 150 feet east of the point of derailment and 120 feet horizontally distant from the track. The second unit stopped upright at the rear end of the first unit. The third unit stopped with the front end 17 feet north of the track and the rear end on the track structure. The derailed cars stopped in line with the track. The diesel-electric units and the first car were considerably damaged, and the second car was slightly damaged.
