INTERSTATE COMMERCE COMMISSION

REPORT OF THE DIRECTOR OF THE BUREAU OF SAFETY CONCERNING AN
ACCIDENT ON THE WHEELING & LAKE ERIE RAILWAY AT CLEVELAND,
OHIO, ON JULY 12, 1933.

September 1, 1933.

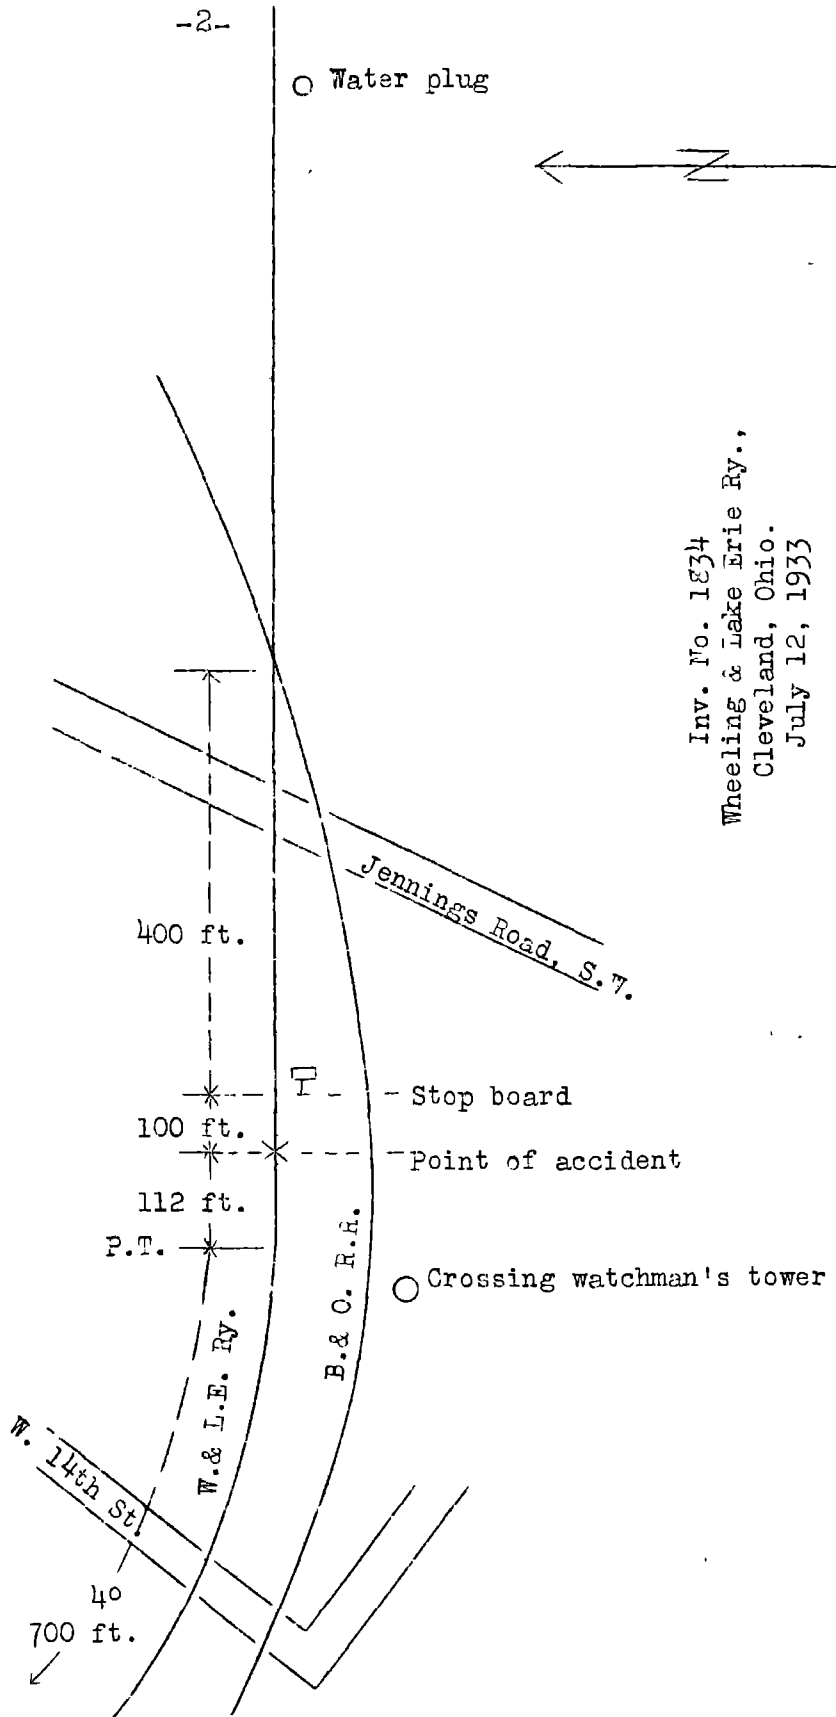
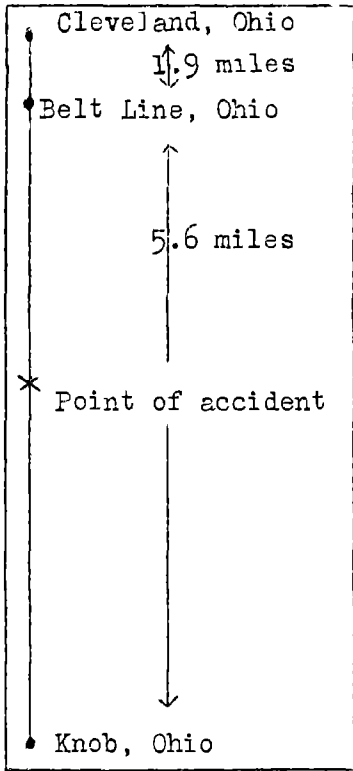
Inv. No. 1834
 Wheeling & Lake Erie Ry.,
 Cleveland, Ohio.
 July 12, 1933

Owing to an embankment and shrubbery on the north side of the track around the curve involved the view of the rear end of the W&LE yard drag at the point of accident was restricted to a distance of about 500 feet from the cab of the approaching CCC&StL engine involved.
