REPORT OF THE DIRECTOR OF THE BUREAU OF SAFETY CONCERNING AN
ACCIDENT ON THE YAZOO & MISSISSIPPI VALLEY RAILROAD,
ILLINOIS CENTRAL SYSTEM, AT STEVEN, LA., ON MAY 18, 1935.

June 29, 1935.

Inv. No. 1985
Yazoo & Mississippi Valley
Steven, La.
May 18, 1935

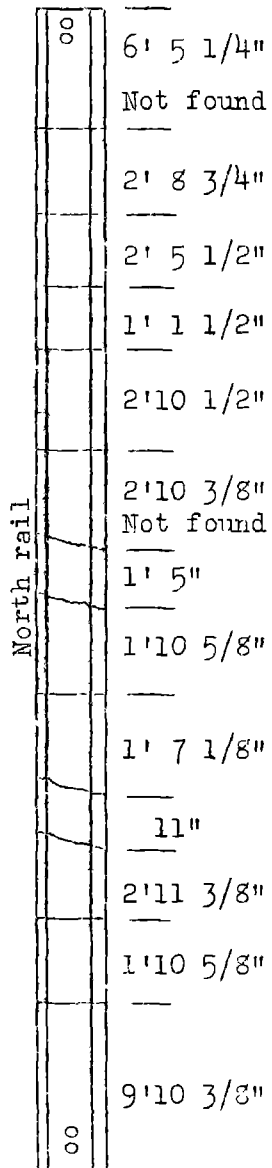
Point of accident
