INTERSTATE COMMERCE COMMISSION

REPORT OF THE DIRECTOR OF THE BUREAU OF SAFETY IN RE
INVESTIGATION OF AN ACCIDENT WHICH OCCURRED ON THE
ALABAMA GREAT SOUTHERN RAILROAD, SOUTHERN RAILWAY
SYSTEM, AT NEW ENGLAND, GA , ON OCTOBER 29, 1929

February 17, 1930

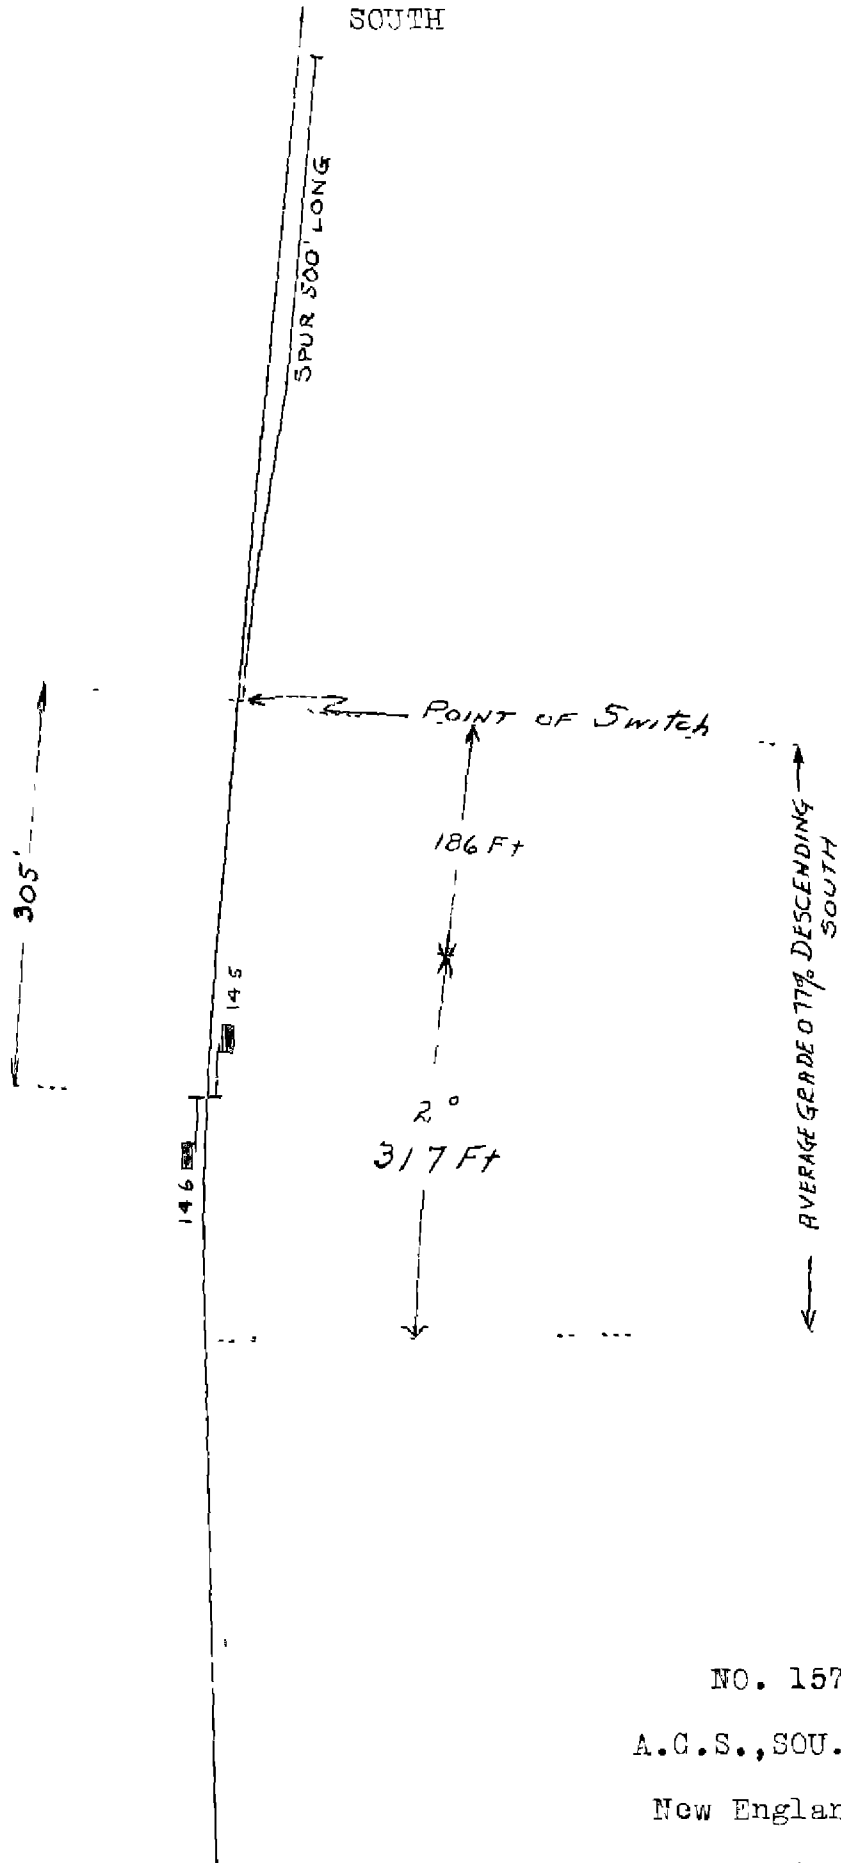
NO. 1579

The low switchstand, located on the west side of the main track, was not equipped with either targets or a switch lamp, the turnout is a No. 10, with 15 ft. switch points. The insulated bridle bar is of the solid type, 5/8 inch thick and 2½ inches wide, with riveted lugs and 1 inch bolts, the tie or No. 2 bar is fastened likewise, and a solid-type connecting rod is used. The switch works in conjunction with the automatic block-signal and train-control system, and the signals are operated if the switch points are open ¼ inch or more, the signals are of the three-position, upper-quadrant type, displaying light indications of red, yellow, and green, for stop, caution, and proceed, respectively. Automatic signal 14.5, the last southbound signal, is located 305 feet north of the switch. The automatic train-control system is of the intermittent

The first mark of derailment was on the gauge side of the base of the east main track rail, 9 feet from the point of switch, this mark extended a distance of 4 feet and then appeared on the ties, continuing to the frog, beyond which point the track was torn out. The first mark on the west rail was at the angle bar on the outside, 14 feet from the point, marks continued on the base of the rail for a distance of 8 feet before passing off on to the ties and then extending up to the frog.

This accident was caused by the defective condition of a switch.

The investigation developed that the automatic block-signal and train-control system functioned as intended, that the No. 1 bridle rod of the switch had broken in some unknown manner, and that this condition permitted the switch points to open, causing the automatic signals to assume the stop position. Engineman Daniels did not see the open switch points from his position in the engine cab, it appearing to him that they were properly lined for the main track. Engineman Daniels, however, should have known that there was a break somewhere in the track circuit by reason of the signals displaying stop indications, since he knew there was no train in the block; this was the only facing-point switch between the points named in the train order, and the switch was not equipped with either a target or a lamp. In the interest of safety and in view of the existing conditions, Engineman Daniels should have been operating his train at a much lower rate of speed than is actually believed to have been the case when approaching the switch, and had he done so, even though the switch points were open or cocked, in all probability no serious consequences would have resulted.
