INTERSTATE COMMERCE COMMISSION

REPORT OF THE CHIEF OF THE BUREAU OF SAFETY IN RE INVESTIGATION OF AN ACCIDENT WHICH OCCURRED ON THE ATCHISON, TOPEKA & SANTA FE RAILWAY AT EAST FORT MADISON, ILL., ON MAY 29, 1922

JULY 18, 1922

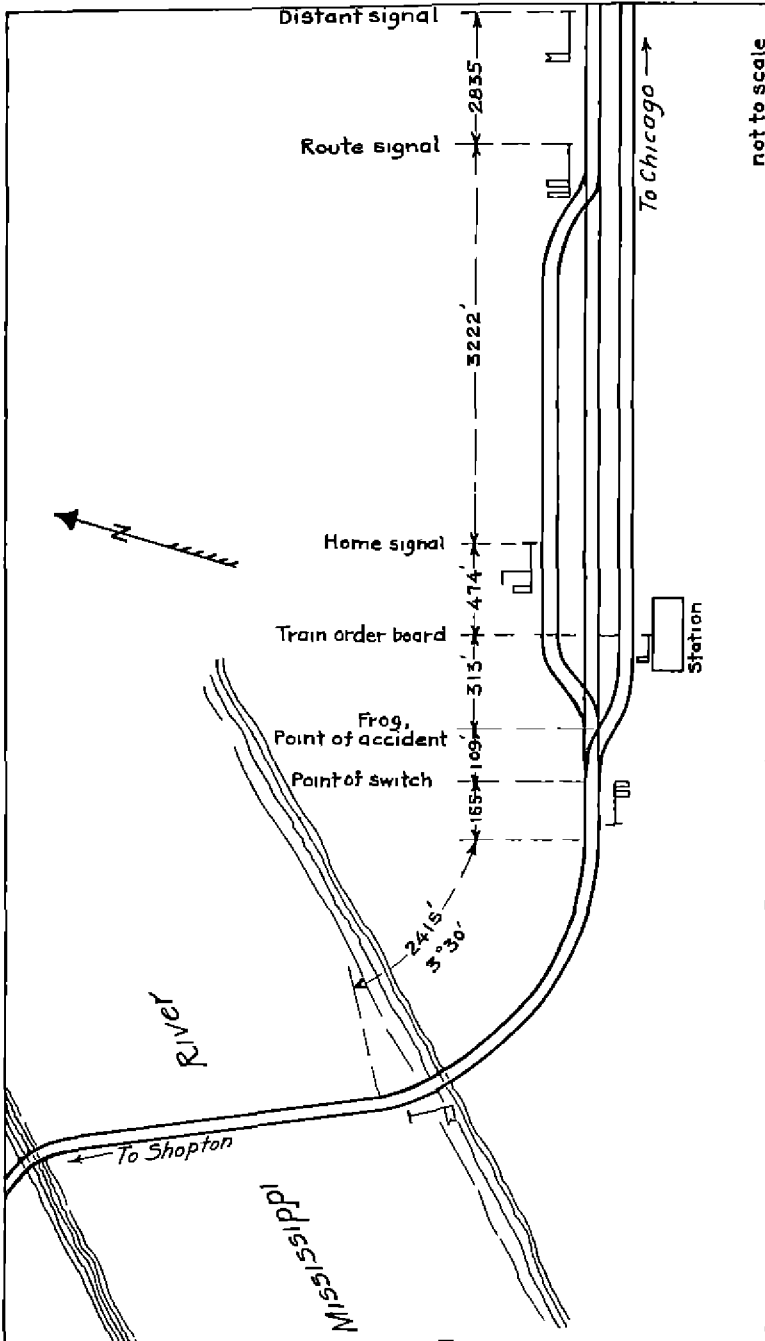
Diagram showing relative location of tracks and signals in vicinity of point of accident

The accident occurred about 15 feet west of the frog of the switch leading from single to double track at the eastern end of the bridge. The movements of westbound trains approaching this point are governed by a one-arm, lower-quadrant, two-position distant signal, displaying yellow or green for caution and proceed, respectively, a two-arm route signal of the lower-quadrant, two-position type, the top arm governing main-line movements and displaying red or green for stop and proceed, respectively, a one-arm, lower-quadrant, two-position home signal displaying red or green for stop and proceed, respectively, and a train-order board, these signals being located 6,844, 4,009, 787, and 313 feet, respectively, east of the point of accident. The eastbound home and distant signals are located approximately 200 and 2,500 feet, respectively, west of the point of accident.

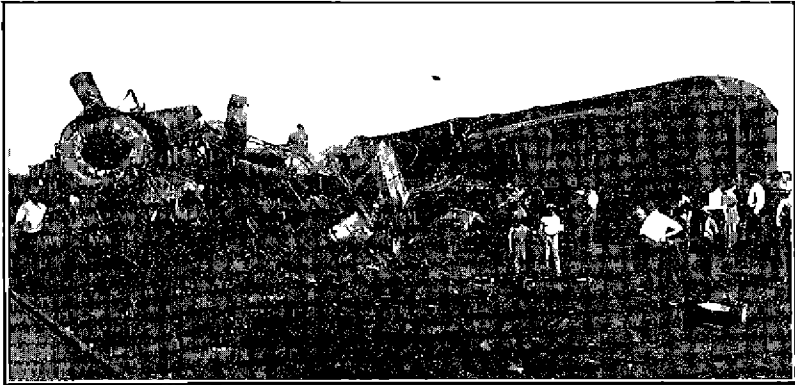
Engine 3403 came to rest on its right side, while engine 531 was also derailed to the right and came to rest inclined at an angle of about 45 degrees, both engines were quite badly damaged. The first car of each train was also derailed, and half of the left side of the baggage car of train No. 1 was torn away. The employees killed were the engineman of train No. 1 and the fireman of train fourth No. 2.

FIG 1—View looking west engine 531 on left

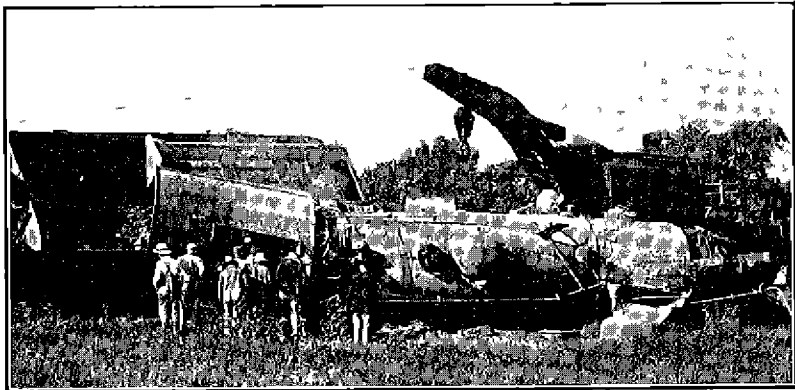
FIG 2—Engine 3403

General Foreman Cullom found the brake valve of engine 3403 in the emergency position and the reverse gear two or three notches back of center. The driving-wheel brake shoes were burned blue. He examined the track for a distance of several hundred feet but did not find any evidence of sand having been used.
