INTERSTATE COMMERCE COMMISSION

REPORT OF THE DIRECTOR OF THE BUREAU OF SAFETY IN RE INVESTIGATION OF AN ACCIDENT WHICH OCCURRED ON THE ATCHISON, TOPEKA & SANTA FE RAILWAY NEAR YAMPAI, ARIZ, ON MARCH 13, 1928¹

MARCH 25, 1929

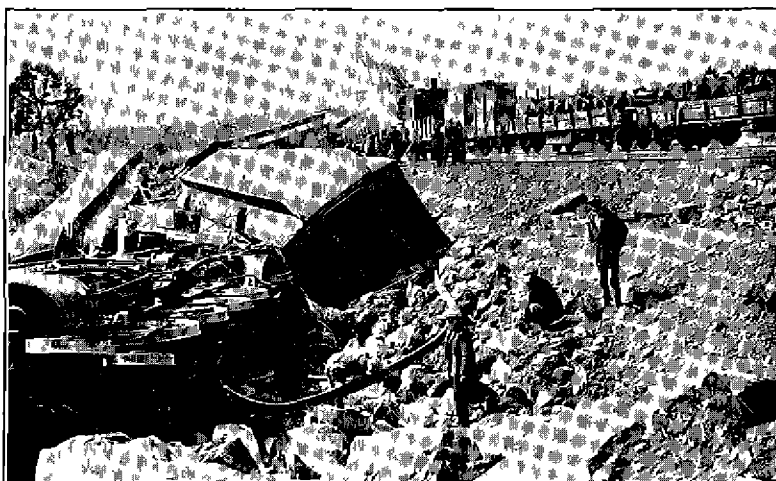
Engine 3744, together with its tender, the first six cars, and the forward truck of the seventh car were derailed to the south, the engine was badly damaged and the first car was practically demolished, while the remaining derailed cars were more or less damaged. The employees killed were the engineman and the fireman.

FIGURE 1A—View of derailed train

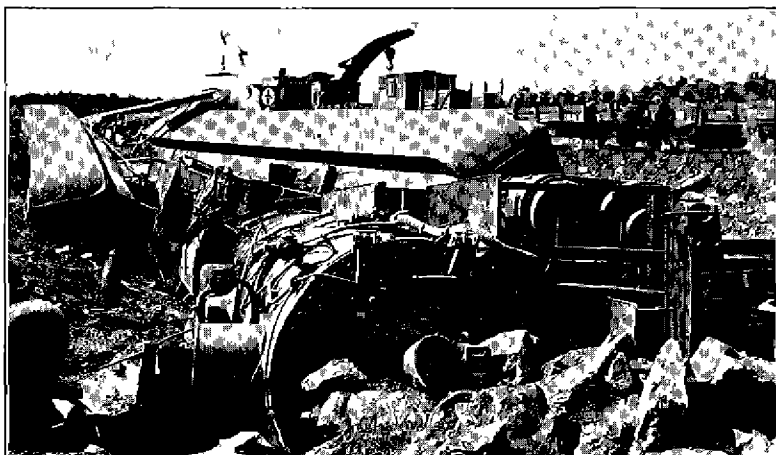
FIGURE 1B—Closer view of engine

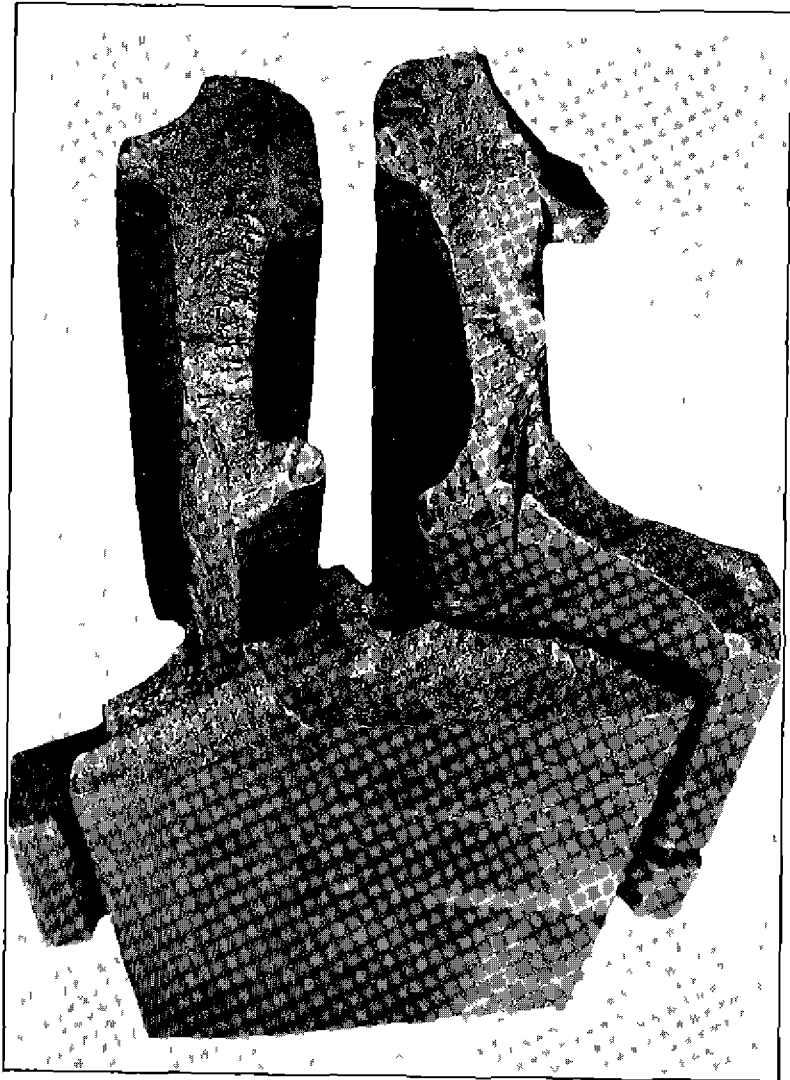
Figure 3 shows an end view of the fracture of the base of rail 4 the receiving end of the first recovered fragment This was photographed in its relative position to the fractured splice bars The splice bars were broken at the middle of their lengths The line of rupture of the inner splice bar changed its vertical course, and terminated at the spike notch in its flange

It will be noted that the lower surface of the base, as the rail appeared when in the track, gave no evidence of longitudinal seaminess The mill scale, a magnetic oxide, extended across and hid from view the surface manifestations An "X" is placed on this cut and on the following figure to indicate the same spot on the rail

FIGURE 3—Fractured splice bars and base of rail No. 4 near receiving end
46415-29

The cause of the present derailment is attributed to a base fracture at the receiving end of rail designated as No 4. It was a fracture of the crescent-shaped type. Occurring at the immediate end of the rail, some of the material which goes to make up an ordinary fracture of this kind was not included in the portion of the rail broken. The primitive portion of the fracture was covered by the splice bars, and therefore hidden from view.

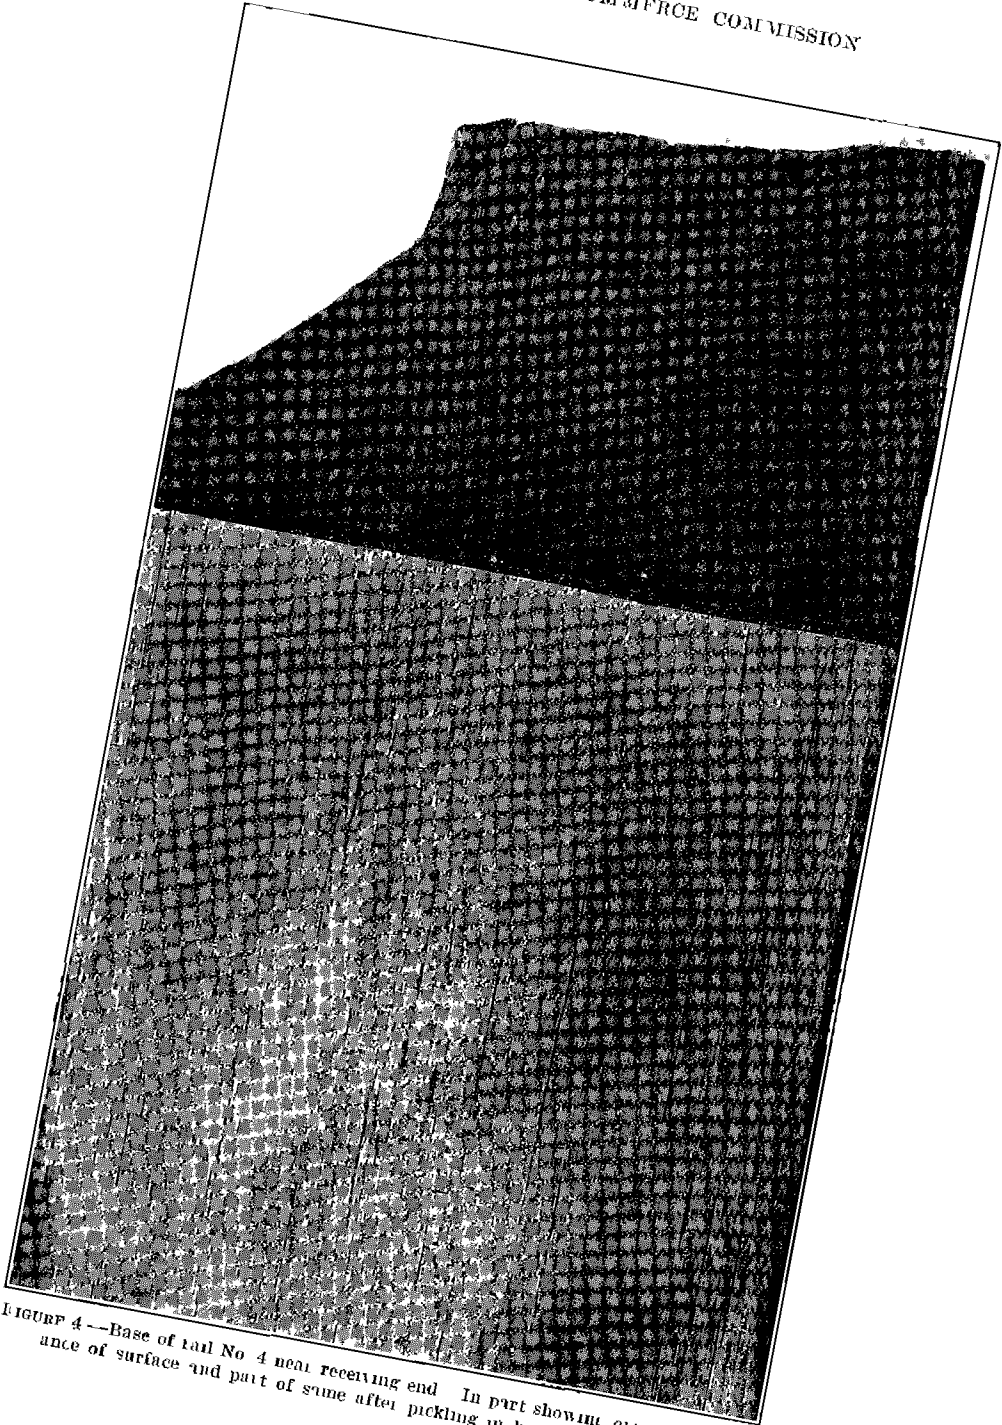
Figure 4 shows the base of the same fragment illustrated in the preceding figure The fragment was cut in two and one part pickled in hot hydrochloric acid This treatment brought into view the presence of surface seams

It has been the experience in the examination of crescent-shaped base fractures that such fractures invariably started at a longitudinal seam In some cases the seam was several hundredths of an inch in depth and displayed blue-black walls Such a seam or lap was made without doubt during the fabrication of the rail Other explanations have been offered for the presence of some of these manifestations Short, intermittent lines have been attributed to the breaking through of small blowholes which had formed near the surface when the ingot was cast

FIGURE 4--Base of tail No. 4 near receiving end. In part showing original appearance of surface and part of same after pickling in hot hydrochloric acid.

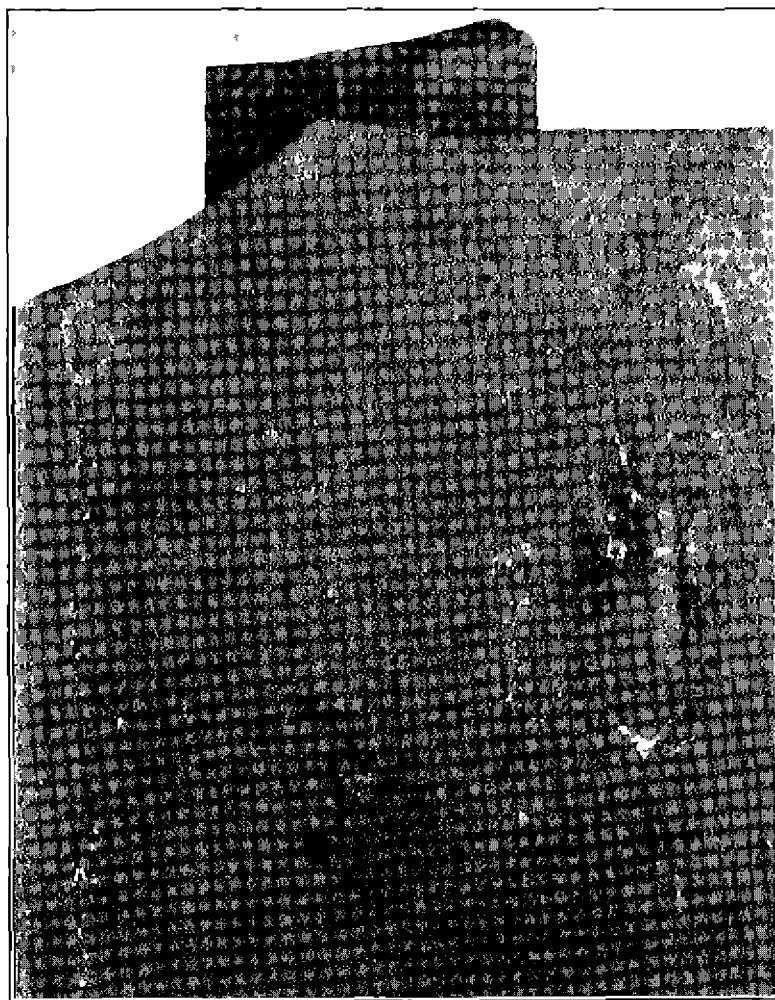
Another example of a crescent-shaped break is presented by Figures 5 and 6, showing the end of a broken rail, corresponding to that of the recovered fragment of the rail involved in the present derailment. These two cuts represent a 110-pound rail which fractured in service. A crescent-shaped fragment which originated at a longitudinal surface seam was detached from the base. At one end the line of rupture was diverted from its course parallel to the axis of the rail, extending obliquely to the edge of one flange. At the other end, after a slight change in direction, the rupture bifurcated and extended each way to the edges of the flanges. From the middle of the base it took an upward course and separated the metal of the web and the head, thus completing the fracture of the rail. The shape of the base at the fractured end was the same in each of these two rails. This being common to all fractures of this type, it is

Figure 5 shows the base of this 110-pound rail as it appeared when removed from the track. No seaminess is shown, nor suggestion of that which existed below the mill scale.

FIGURE 5—Base of a 110 pound rail Appearance before pickling

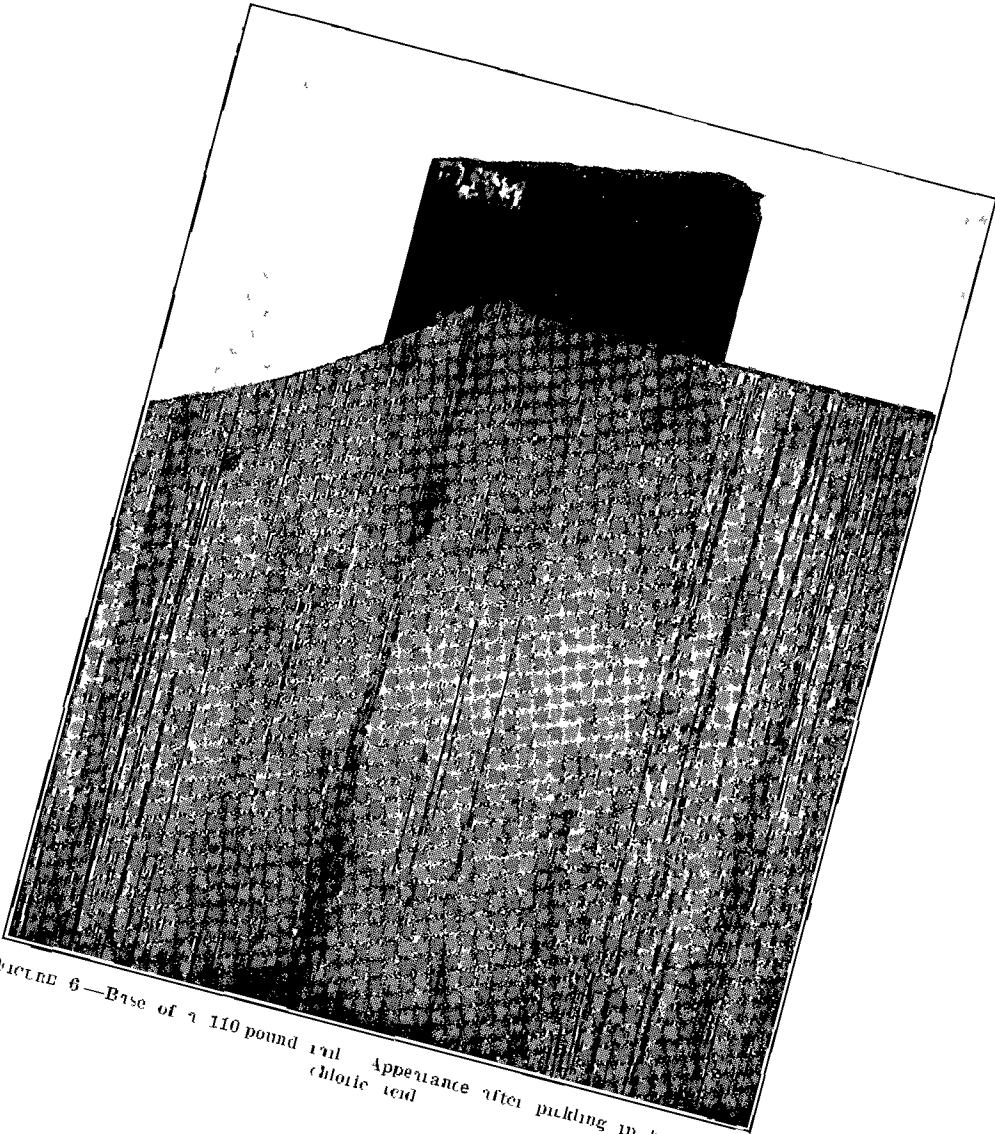
Figure 6 shows its appearance after pickling in hot hydrochloric acid, displaying very pronounced seams. The other end of this rail, not necessary to reproduce here, showed a continuation of the seams and the origin of the crescent-shaped fracture at one of them.

FIGURE 6—Base of a 110 pound rail Appearance after picking in hot hydrochloric acid

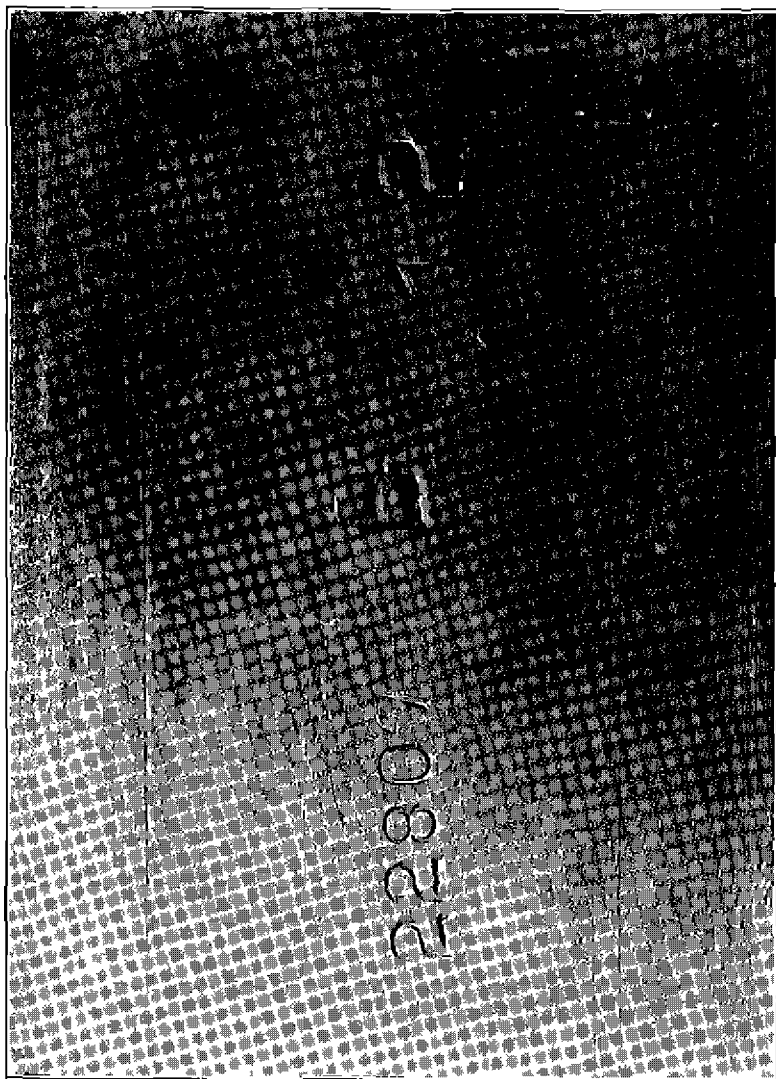
Figure 7 represents a 90-pound rail, ingot letter B. Surface seaminess is most pronounced near the edges of the flanges, although the middle of the width of the base showed a number of sharply defined seams.

FIGURE 7—Base of a 90 pound rail. Appearance after pickling in hot hydrochloric acid. One of a series from different rail mills.

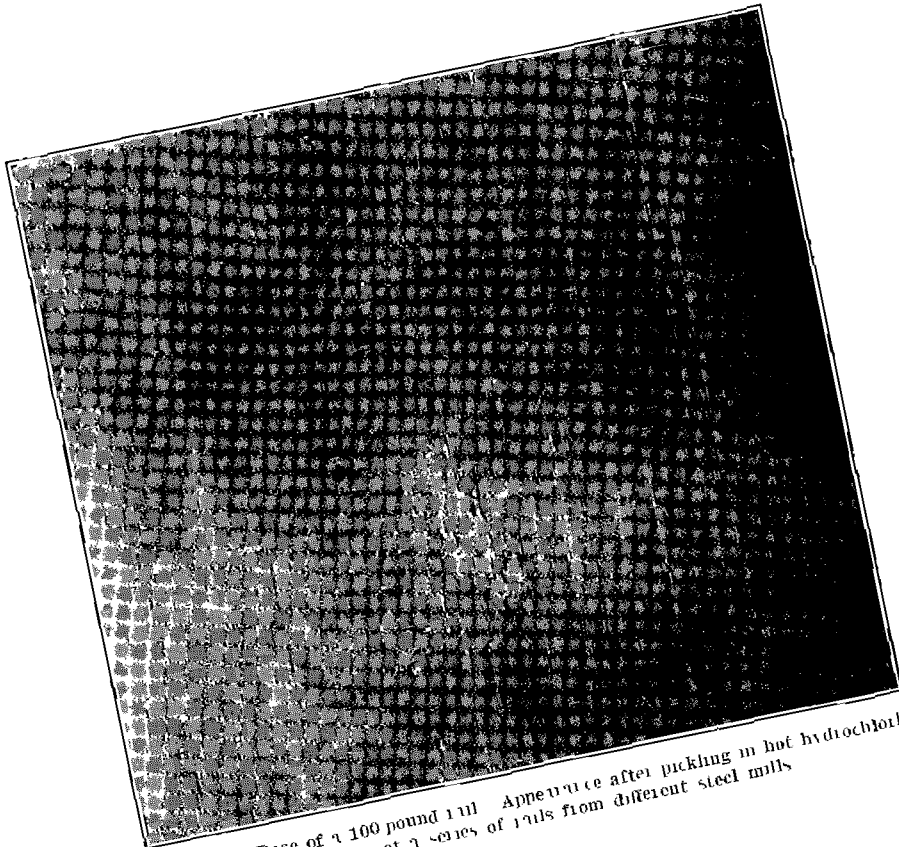
Figure 8 represents a 100-pound rail, ingot letter C. Surface seams and light colored streaks are present but not sharply defined. Duration of exposure in the bath has an effect on the result of the pickling.

FIGURE 8—Base of a 100 pound rail. Appearance after pickling in hot hydrochloric acid. One of a series of rails from different steel mills.

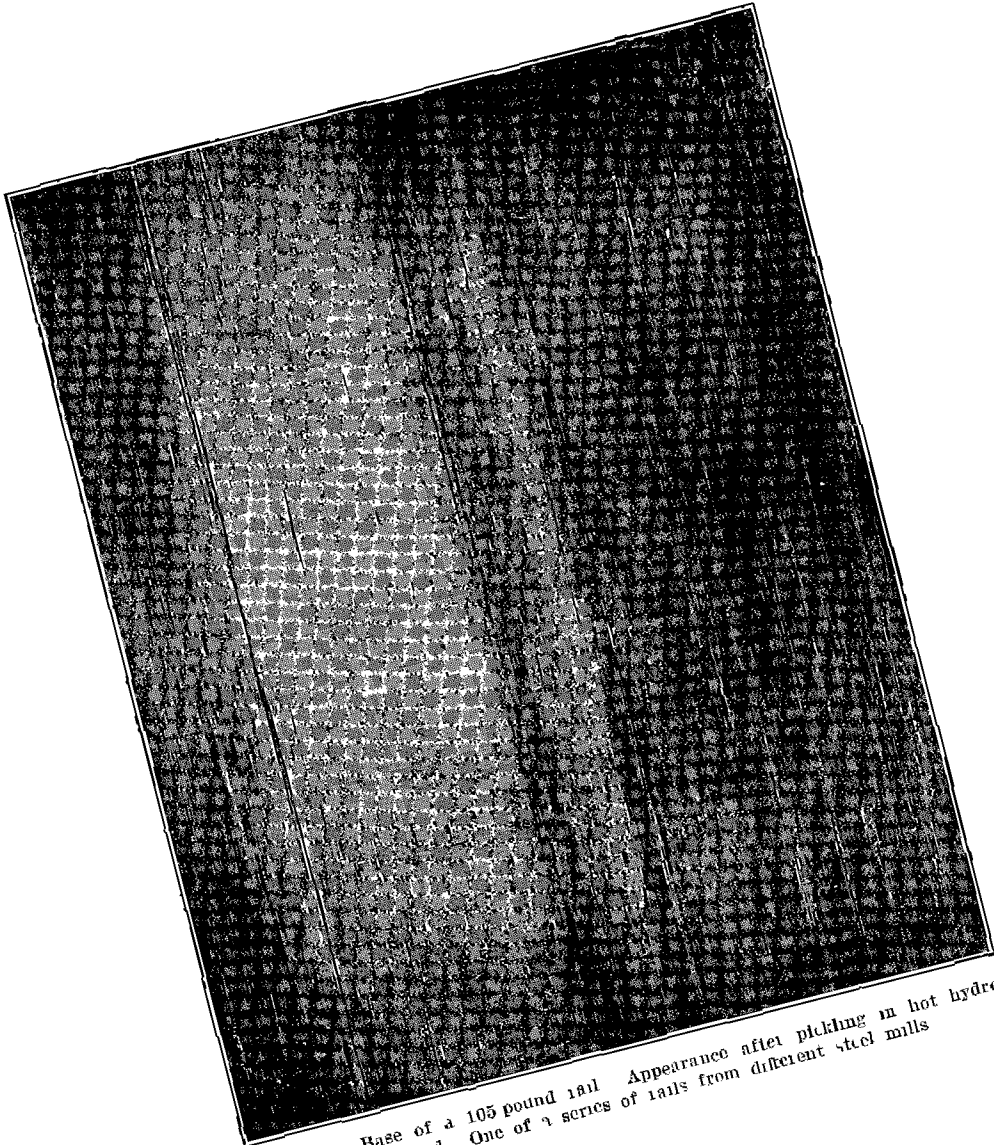
Figure 9 represents a 105-pound rail, ingot letter unknown. Surface seams sharply defined, some, apparently of considerable depth are shown.

FIGURE 9—Base of a 105 pound rail. Appearance after pickling in hot hydrochloric acid. One of a series of rails from different steel mills.

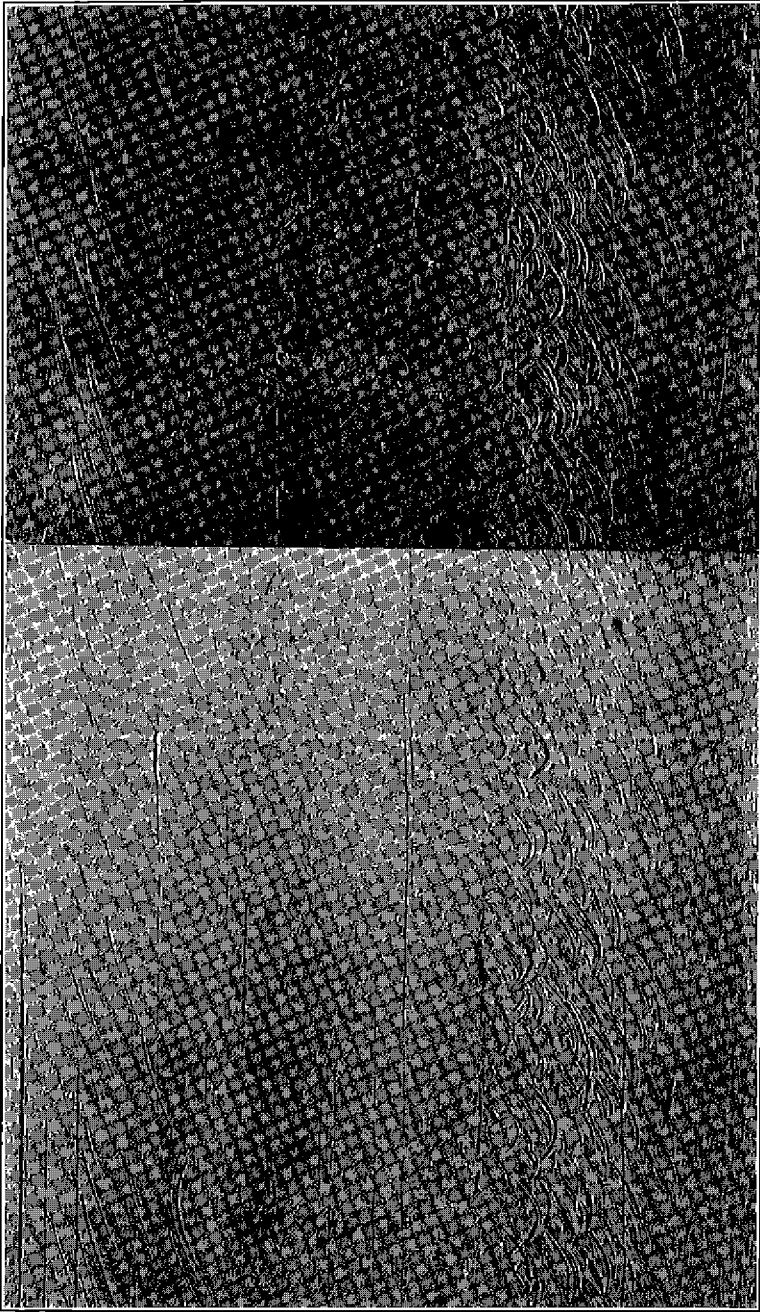
Figure 10 represents the base of a 110-pound rail, one-half of which was pickled, with one-half showing the surface as it came from the rolls. The pickled surface displayed sharply defined seams of which, on the untreated surface, there were no indications.

FIGURE 10—Base of a 110 pound rail. Appearance of base upper part of cut, before pickling, lower part of cut after pickling in hot hydrochloric acid. One of a series of rails from different steel mills.

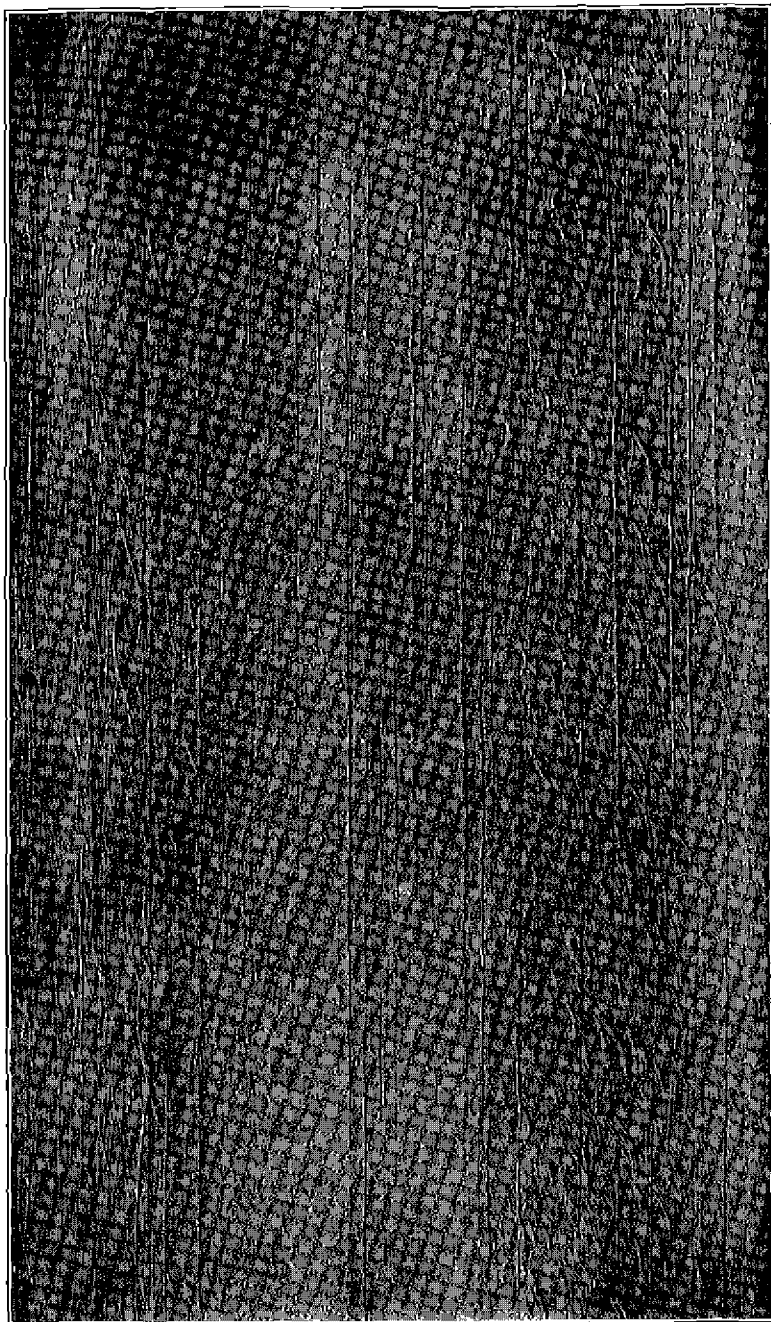
Figure 11 represents the base of a medium manganese steel rail, 127-pound weight, ingot letter A. This rail exhibited a marked state of seaminess. It was an A rail. Rails from different parts of the ingot are expected to show differences in segregation of the

FIGURE 11—Base of a 127-pound rail medium manganese steel. Appearance after pickling in hot hydrochloric acid. One of a series of rails from different steel mills

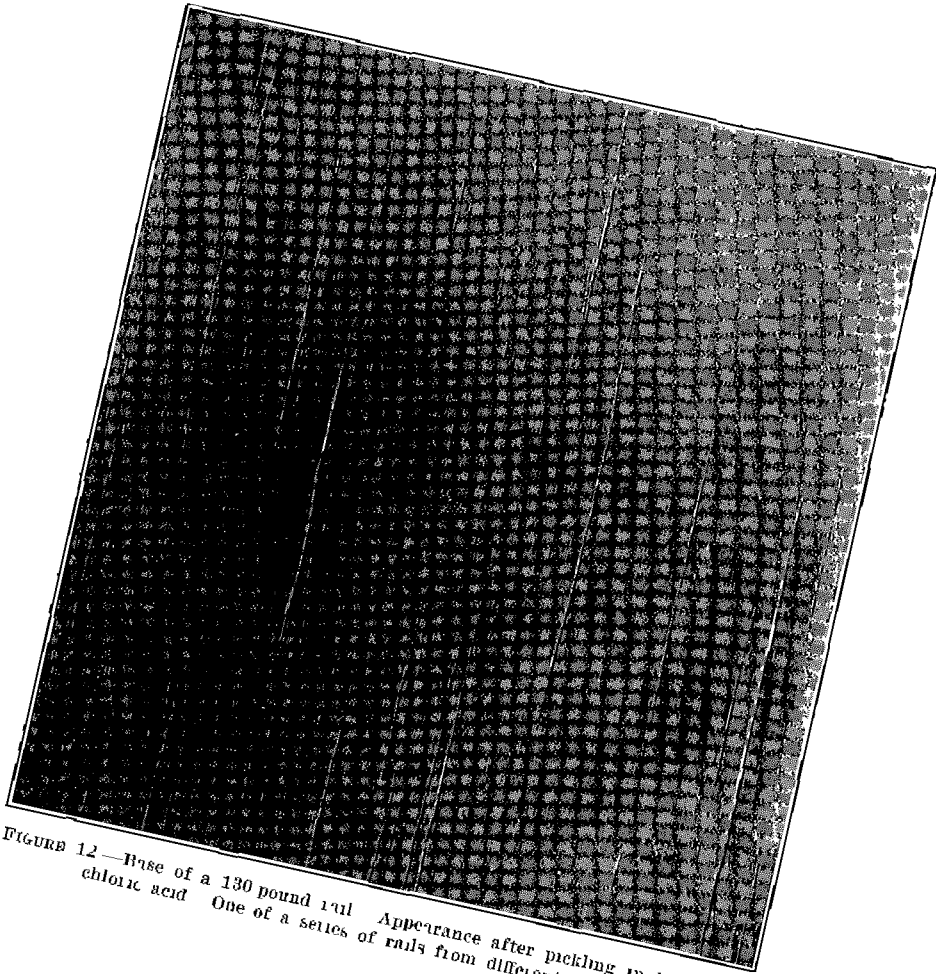
FIGURE 12—Base of a 130 pound rail. Appearance after pickling in hot hydrochloric acid. One of a series of rails from different steel mills.

Figure 12 represents the base of a 130-pound rail, ingot letter C. Surface seams are distributed here and there over the surface.

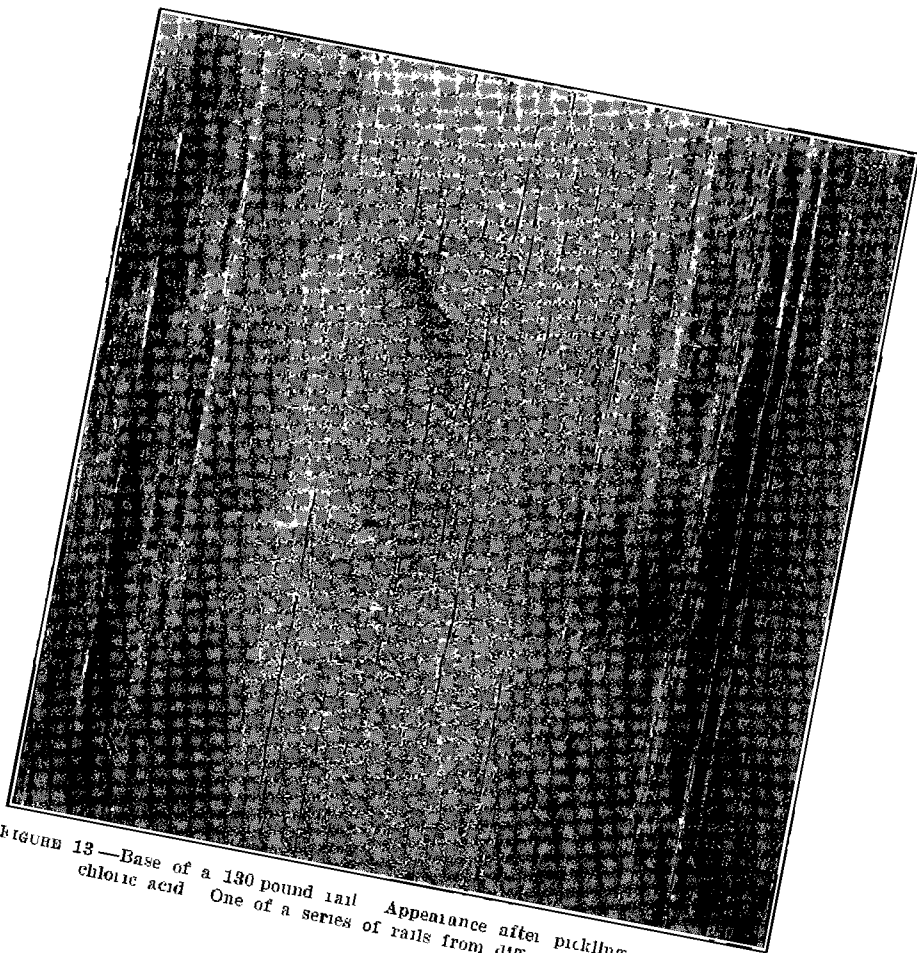
FIGURE 13—Base of a 130 pound rail. Appearance after pickling in hot hydrochloric acid. One of a series of rails from different steel mills.

Figure 13 represents the base of a 130-pound rail, ingot letter unknown. The seams are sharply defined. They are distributed quite generally but most pronounced along the middle of the surface of the base.
