INTERSTATE COMMERCE COMMISSION

REPORT OF THE DIRECTOR OF THE BUREAU OF SAFETY IN RE
INVESTIGATION OF AN ACCIDENT WHICH OCCURRED ON THE
ATLANTA & WEST POINT RAILROAD AT EAST POINT, GA.,
ON OCTOBER 23, 1929.

January 31, 1930.

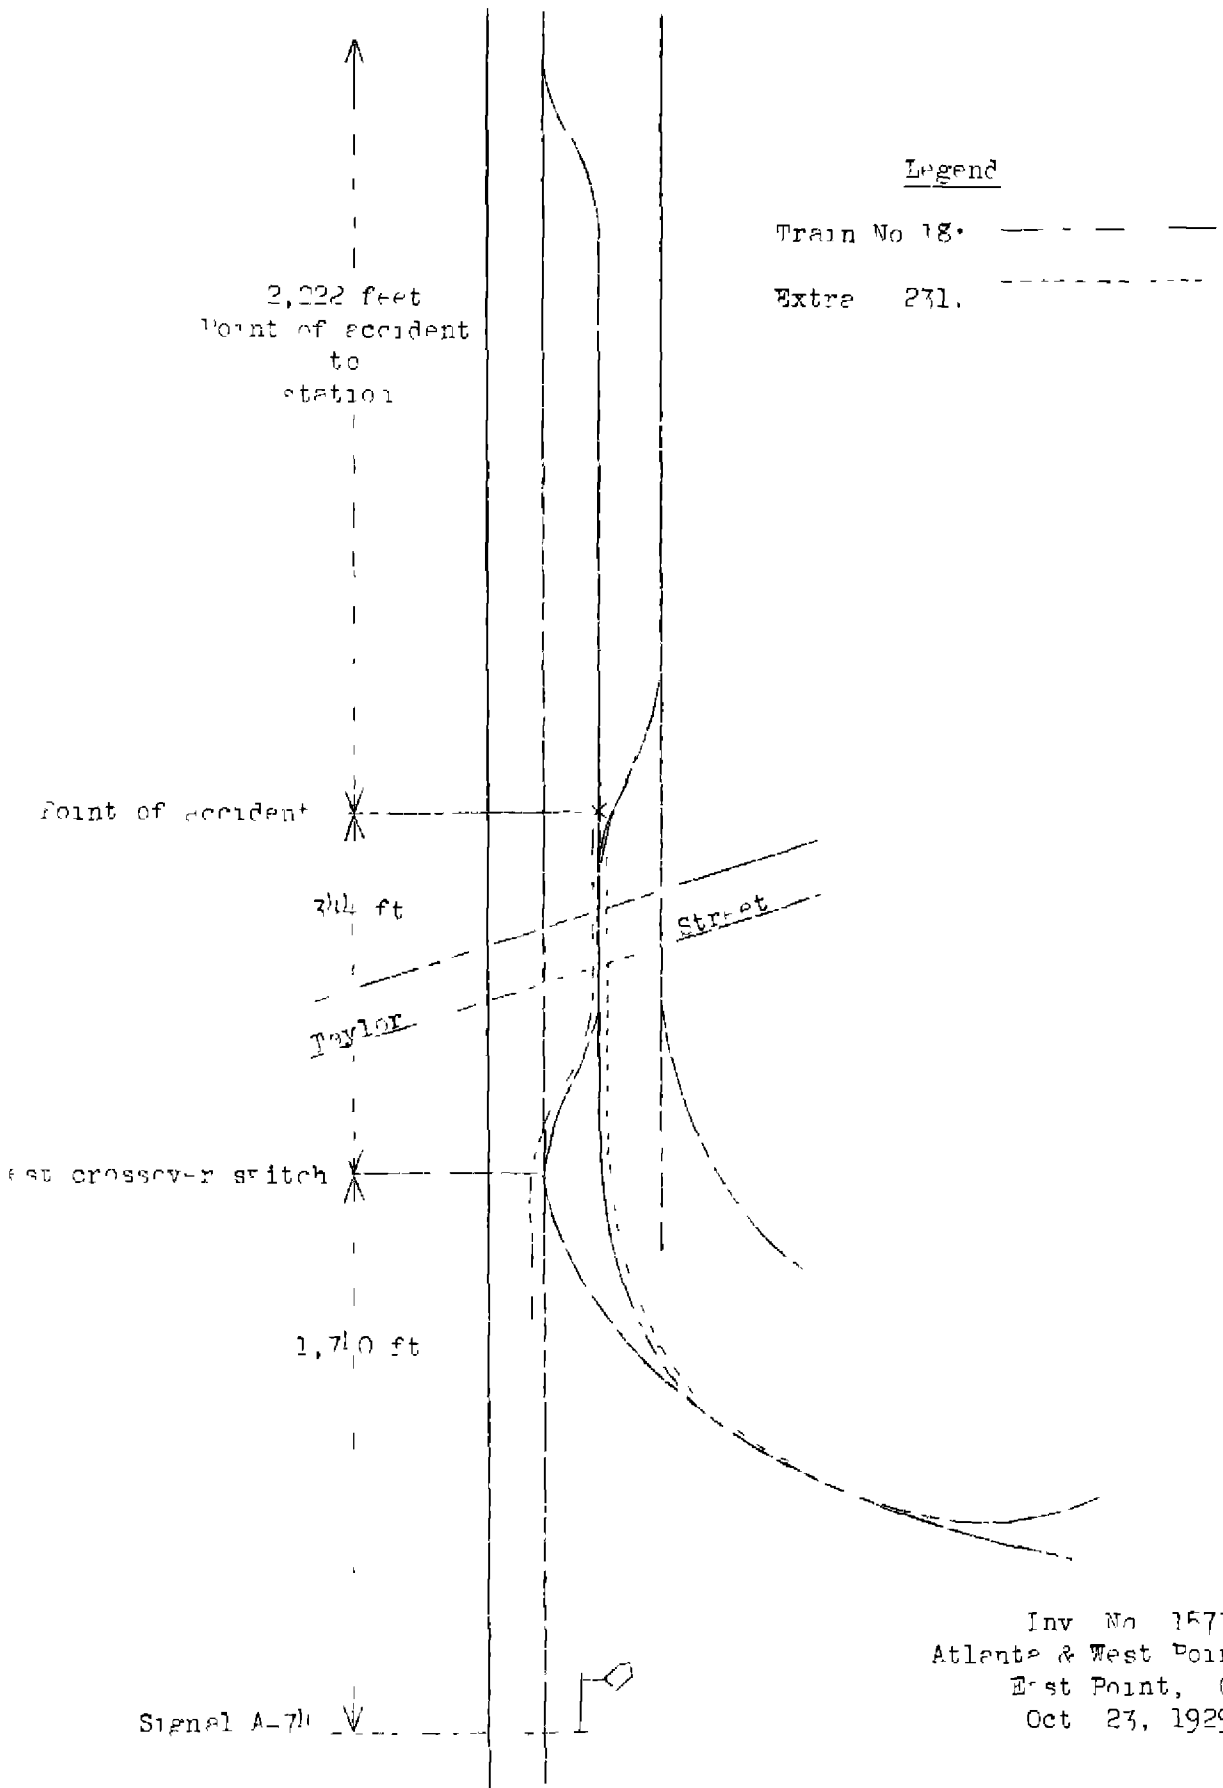
Inv No 1573
Atlantic & West Point R R
East Point, Ga
Oct 23, 1929

Point of accident
