INTERSTATE COMMERCE COMMISSION

REPORT OF THE CHIEF OF THE BUREAU OF SAFETY IN RE INVESTIGATION OF AN ACCIDENT WHICH OCCURRED ON THE ATLANTA, BIRMINGHAM & ATLANTIC RAILWAY NEAR BEN HILL, GA, ON MARCH 12, 1922

OCTOBER 7 1922

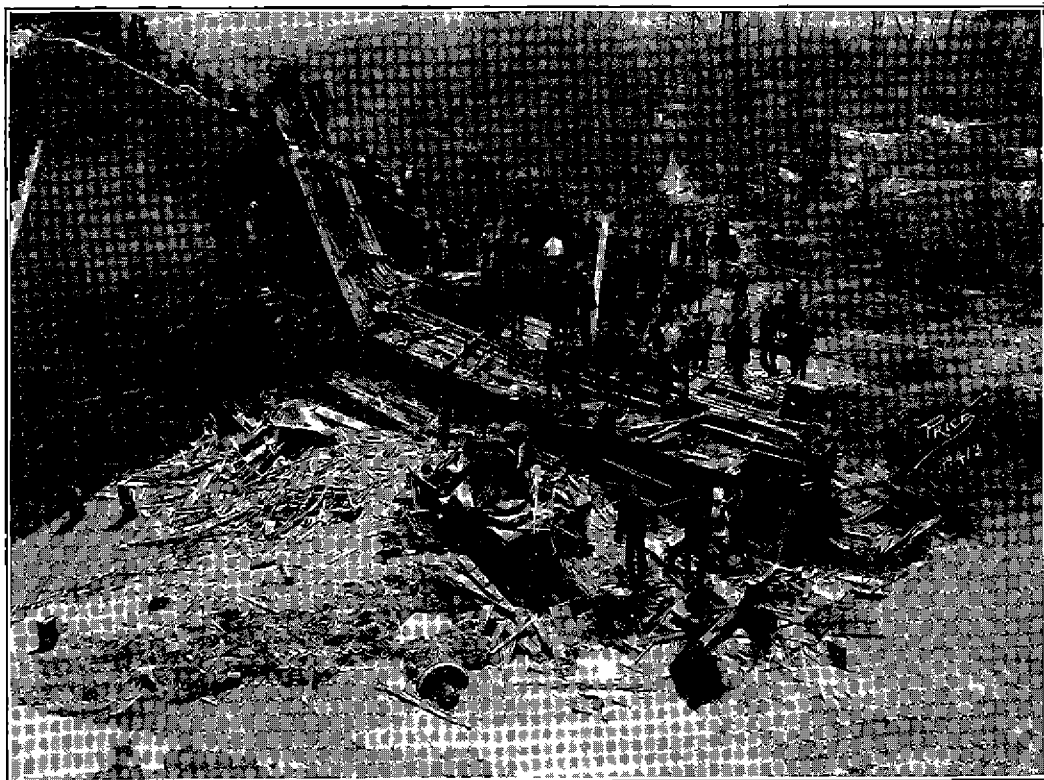
The rear end of the derailed car slewed to the right at the bridge, overturning as it left the west abutment, and turned bottom up as it dropped, its momentum carrying it to the east bank of the creek. It came to rest broken in two at about its center, with the front portion of the car resting against the east abutment, pointing almost straight upward, the car was completely demolished. Figure No 1 shows the condition of this car after the accident, the view being taken from the west abutment of the bridge.

south rail was reached. From this point the south rail was beveled until the pressure of the wheel increased sufficiently to push the rail out of line and turn it over, the wheels, however, continued on the ties, inside the rail location, onto the bridge. The left rear wheel was derailed at a point 115 feet east of the first point of derailment, and marked the ties for a distance of 25 feet, at which point these marks joined the flange marks of the front wheel. The first mark on the outside of the south rail was 33 feet east of the first mark opposite the north rail, the alternate battering of ties, followed by ties which were flange marked, indicating that the broken wheel continued to rotate for a distance of about 36 feet, after which the wheels were dragged the remainder of the distance, the truck came to rest parallel to and about 10 feet north of the rear end of the car on the east bank of the creek, as shown in Figure No. 1.

FIG 1—General view of derailed coach lying bottom side up on bed of Camp Creek with forward end leaning against east abutment of bridge

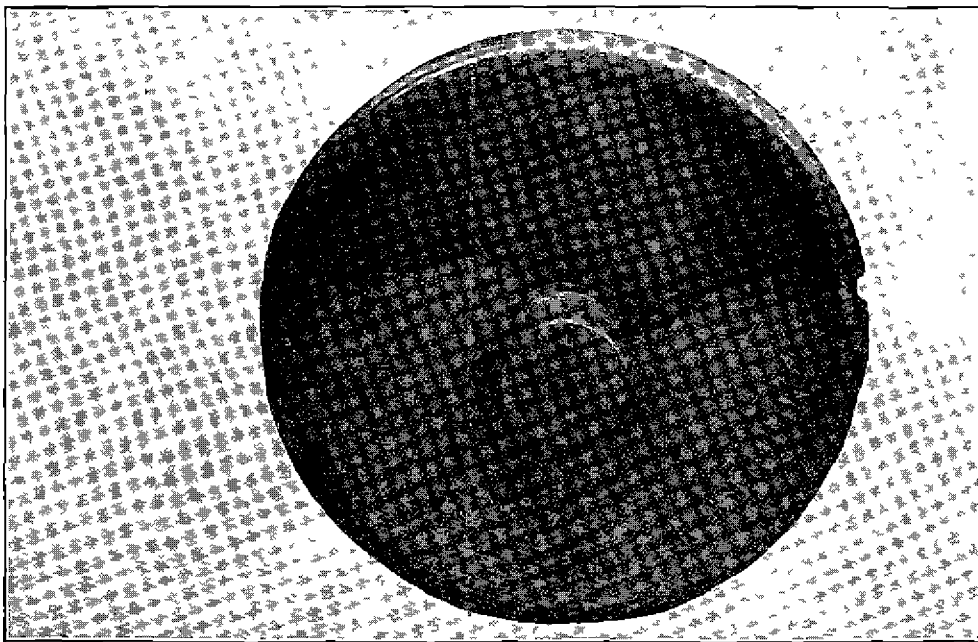
The broken wheel showed two lines of rupture, each approximately radial, passing through the core leg openings of the inner plate and the chaplets of the outer plate. Substantially one-third of the wheel was separated by the sector thus detached at the time of the accident. It was also found that one of these radial lines of rupture separated the metal of the rim at a "slid-flat" spot. This line of rupture was the leading one with reference to the rotation of the wheel when in the truck.

FIG 2—Front view of broken wheel No 57293, showing radial lines of rupture passing through chaplets in front plate. Initial point of rupture believed to be at rim on right side of this cut

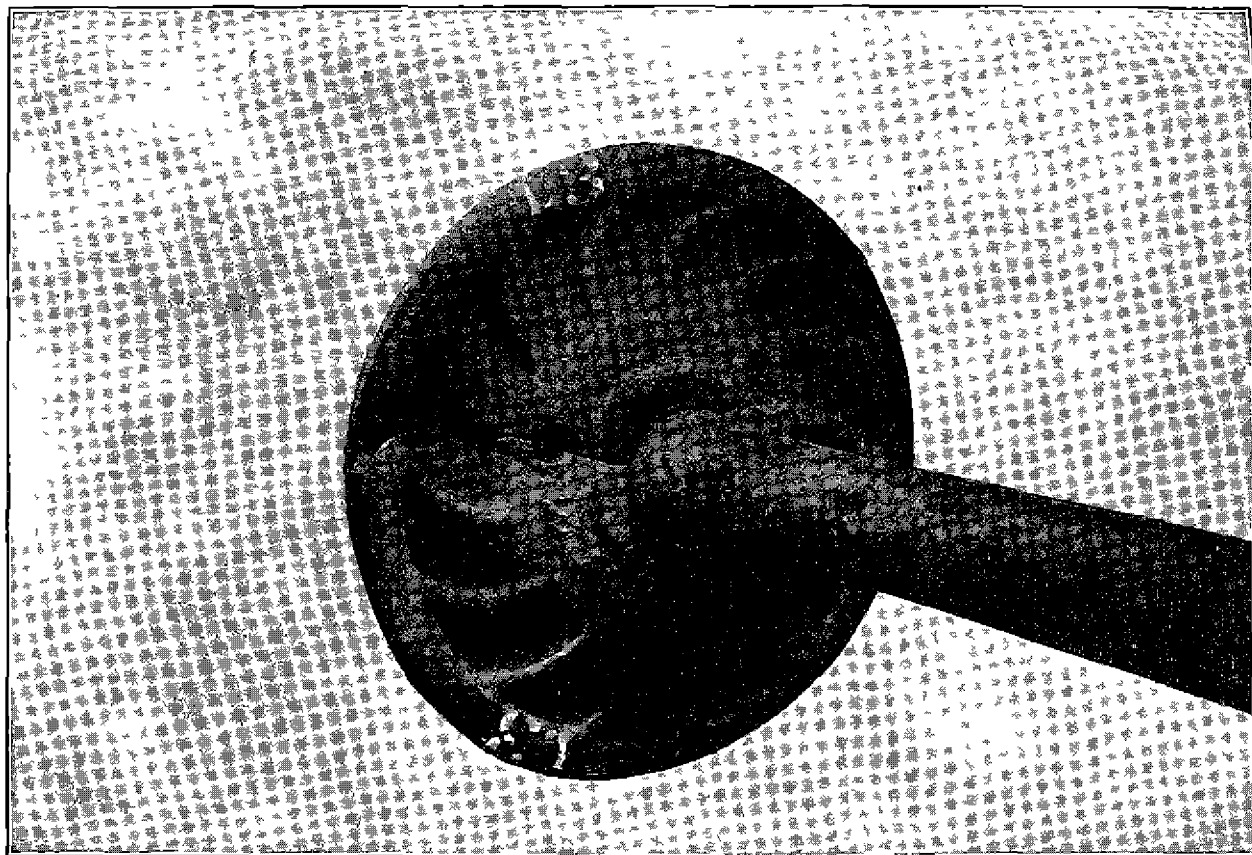
FIG 3—Rear view of broken wheel No 57293 showing radial lines of rupture passing through core leg openings of rear plate
Initial point of rupture believed to be at rim on left side of this cut.

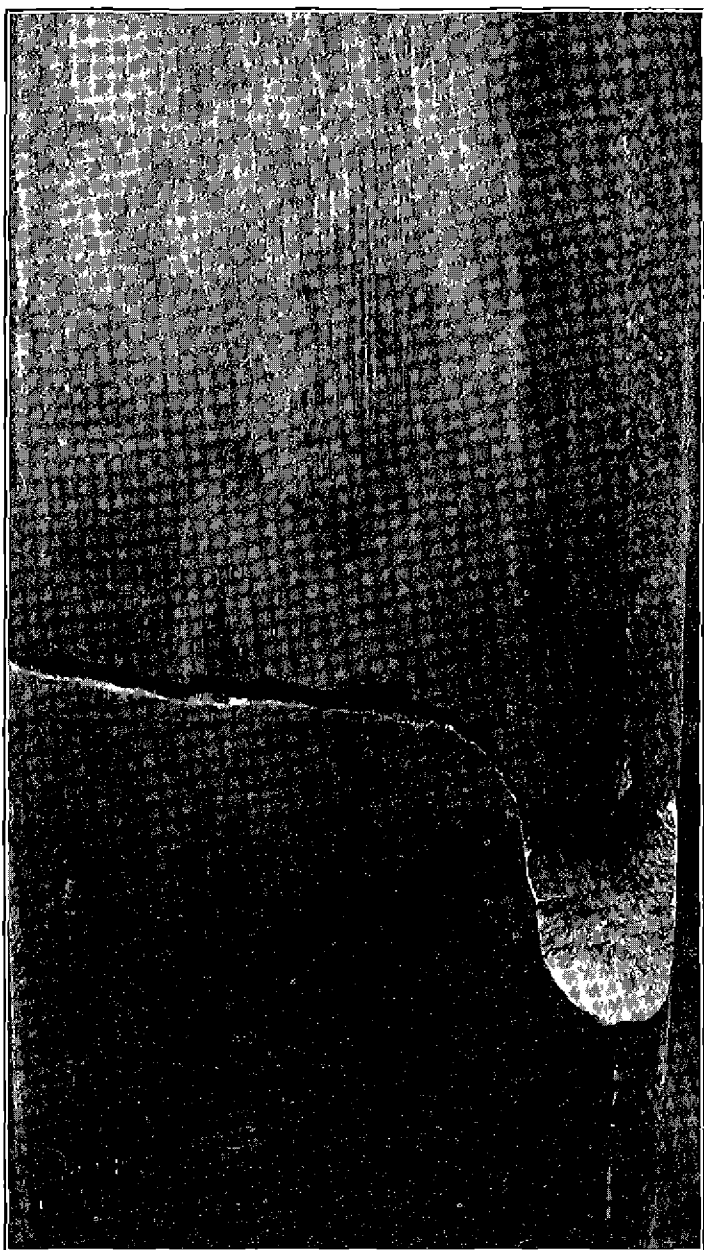
This slid-flat spot may have been instrumental in causing the rupture of the wheel, and possibly was the immediate cause. Information is not at hand whereby the time this slid-flat spot was formed can be ascertained, whether on the particular run on which the accident occurred or on some former occasion. All the wheels of the rear truck, in fact, those of both trucks, are believed to have been heated above an ordinary braking temperature on this particular run of the train.

The line of rupture separating the slid-flat spot, at the middle of its length, is suggestive, however, of the explanation that the initial point of rupture of the wheel occurred at this place, and, if so, necessarily at a time when the metal at this particular part of the rim was in a state of tension.

Overheating the rim locally puts, for the time being, that part into a state of intense compression, into a state of overcompression, which subsequently reverses to one of tension when equalization of temperature in the wheel is reached. It seems tenable to believe that this flat spot was formed during the run on which the accident occurred at a time when the wheel as a whole was abnormally hot, the result of some temporary arrest in its rotation, that is, a flat spot was formed on a wheel of which both the rim and the plate was above the normal temperature. When rotation was resumed this slid-flat spot would promptly cool to the temperature of the adjacent parts of the rim, and in so doing reverse the internal strains to a state of tension, and thus furnish the opportunity to

originate the line of rupture which was followed by complete failure of the wheel. It seems a coincidence that this slid-flat spot chanced to be radially in line with the core leg opening and chaplet of the double plate.

A type of rupture not of common occurrence was witnessed in the failure of this chilled-iron wheel which was under derailed car No 501, from which a sector was detached by the formation of two radial lines of rupture. The engineer-physicist points significantly to the presence of a slid-flat spot on the tread of the wheel, through which the leading line of rupture passed, and regards this slid-flat spot as the probable factor which caused the failure.

FIG 4—View of tread of broken wheel No 57298, showing line of rupture located at a shd flat spot believed to be the initial point of rupture

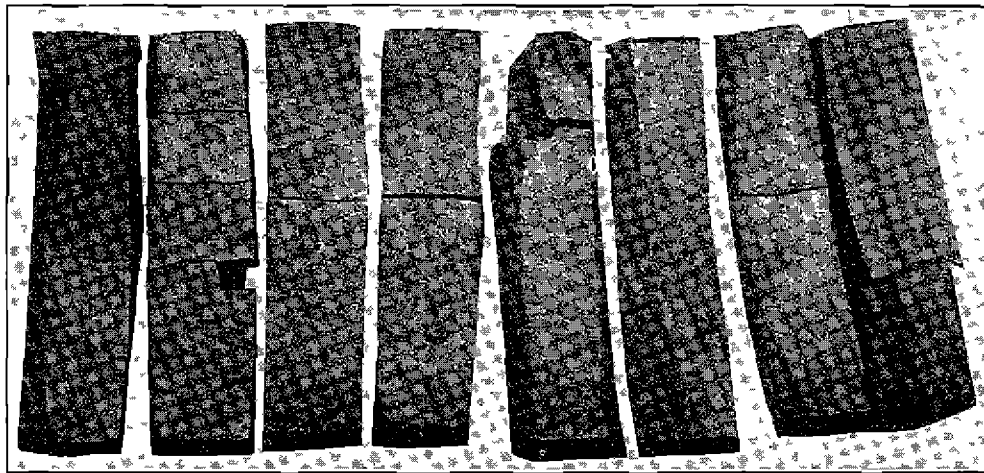
The wheels and trucks of car No 501 were shipped to Atlanta, Ga., from the scene of the accident. They were examined in the Bellwood yard. They showed evidence of recent overheating, indicated by the blue-black surfaces of the rims. Similar indications were shown by the brake shoes—a more common occurrence, however, in brake shoes, since heating effects are confined to a much smaller volume of metal in the shoe than in the wheel. On the shoe the heating influence is continuous while braking conditions continue, whereas such influence is intermittent referring to any given portion of the running surface of the rim, unless perchance the wheel is slid, intense local heating then occurring between the tread of the wheel and the head of the rail. In general brake shoes are exposed to more intense and destructive thermal influences than the rims of wheels.

In the present case the brake shoes displayed thermal cracks, to which special importance does not necessarily attach since brake shoes commonly present such a condition. Such an early result is provided for in the manufacture of brake shoes which are fabricated with a strip of forged steel to retain the parts of the shoe in place after the formation of thermal cracks, and which promptly take

FIG 3—Appearance of brake shoes from wheels of derailed car No 501

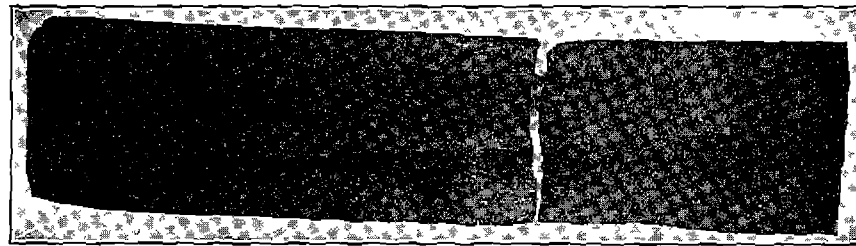
The brake shoe from the broken wheel showed abrasive wear, oblique in direction across its face, the abraded part covering only a portion of the usual contact surface. Unusual conditions prevailed affecting this wheel some time during its period in service and not unlikely the major part occurred shortly before the time of its rupture.

FIG 6—Appearance of brake shoe from broken wheel No 57298, showing obliquely abraded surface

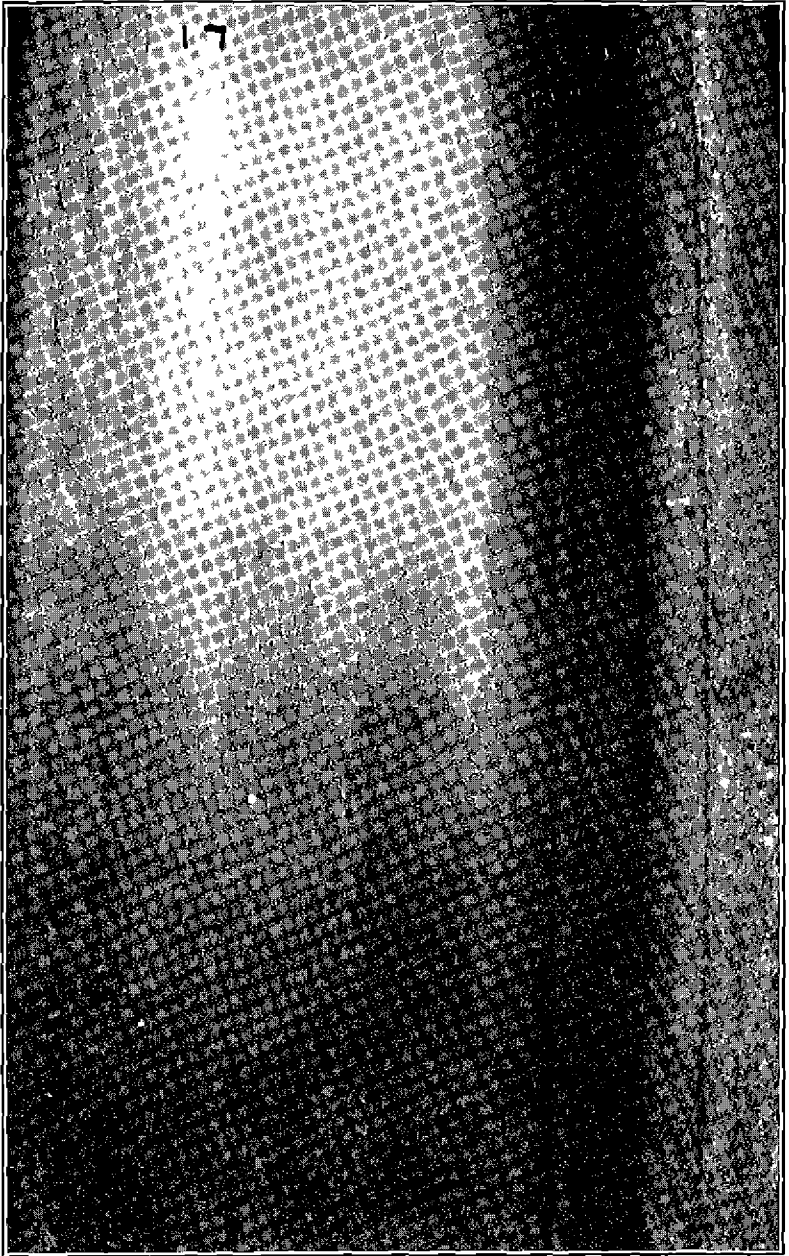
Evidence is frequently presented in the treads of wheels of the formation of incipient cracks which were in evidence in the wheels of this derailed car. Such a crack in the broken wheel penetrated to a depth of nine-sixteenths inch. These cracks, hair lines in appearance, represent the relief of internal strains of tension by rupture of the metal and doubtless formed at a time when the surface of the tread was momentarily at a lower temperature than the metal of the interior of the rim. Such a condition arises when the surface of the tread has been raised to a high temperature, and air cooled over the hot core or interior portion of the rim. Photographs herewith illustrate thermal cracks of this kind which were found in the wheels under examination.

FIG. 8—Thermal cracks in other part of tread of wheel No 57296, shown in Fig 7
