REPORT OF THE DIRECTOR OF THE BUREAU OF SAFETY IN RE
INVESTIGATION OF AN ACCIDENT WHICH OCCURRED ON THE
ATLANTIC COAST LINE RAILROAD AT BUFFALO BLUFF, FLA.,
ON OCTOBER 11, 1931.

December 2, 1931.

Inv. No. 1728
 Atlantic Coast Line R.R.,
 Buffalo Bluff, Florida
 October 11, 1931

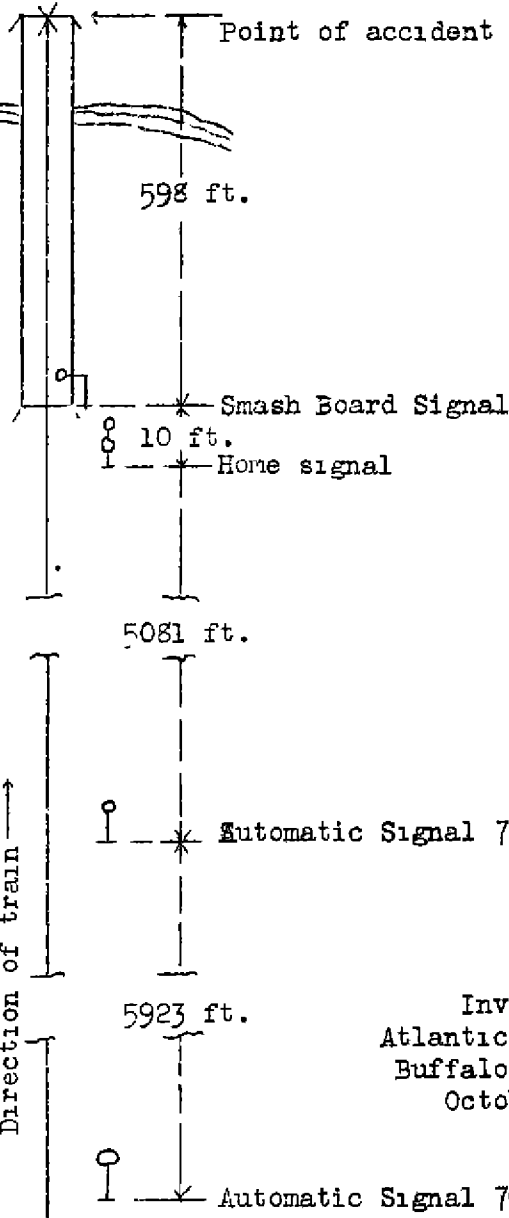
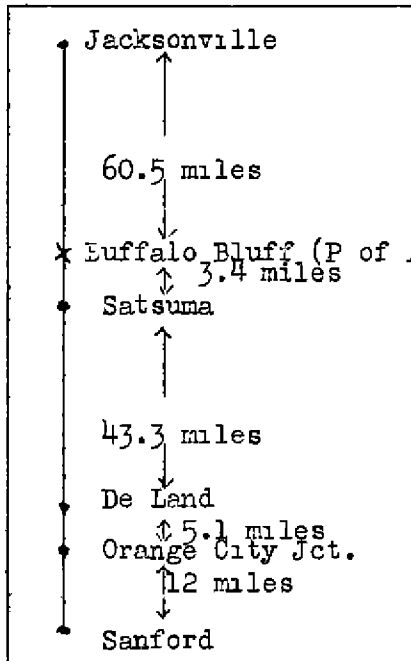
Buffalo Bluff Drawbridge

The drawbridge is a bent frame structure, with a ballast deck and a steel draw span of the pivot type; the total length of the trestle and span is 1,036 feet, the span being 238 feet in length and the southern trestle approach thereto being 598 feet in length. The river flows under the bridge from west to east and the channel is about 40 feet in depth, the draw span being about 15 feet above the water. The bridge operator's tower is located on the east side of the draw span, at the center of the span. There is a marine lamp on the draw span that displays a red indication to an approaching train when the draw is open.

A smash board signal, mechanically operated by the bridge tender, is located 538 feet south of the end of the trestle off which the train plunged, a disk of red reflex buttons is attached to the arm of the smash board, these buttons casting a red reflection when the rays from the headlight of an approaching engine shine upon them.

Engine 1657, its tender, and the first four cars went off the bridge and were submerged, while the rest of the cars in the train stopped on the track. The employee killed was the engineman.
